AIR - HP COMPRESSOR STAGE-7 BLEED VALVES - INTRODUCTION OF CHEVRON SEALS - CATEGORY
CODE 4 - MOD.ENG-75-0053

SB Number 75-30 (Revision 1)

Introduction of HP7 Bleed Valve AC69924 Mod 2 with Chevron Seals in lieu and by conversion of AC69859 & AC69924 Mod 1

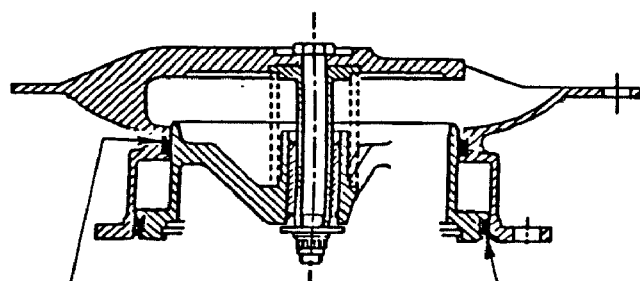
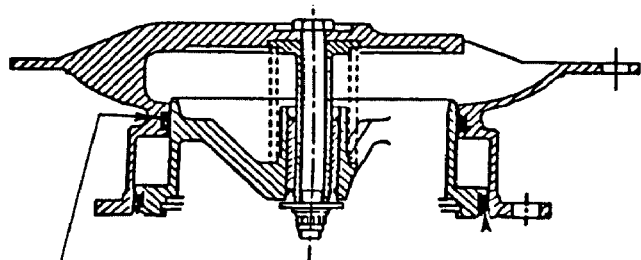
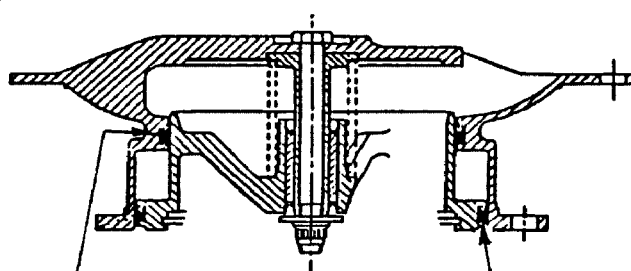
Figure 1 Pre and Post Mod Configuration of HP7 Bleed Valve

Replacement of Piston Triple Seal Assembly DAS2485-1256 by a new 'Chevron' Seal Assembly ACO47190 Issue 2.

Replacement of Body Triple Seal Assembly DAS2505-1225 by a new 'Chevron' Seal Assembly ACO47189 Issue 1.

Replacement of Piston 'Chevron' Seal Assembly ACO47190 Issue 1 by a new 'Chevron' Seal Assembly ACO47190 Issue 2.

(2) Refer to figure 1 for pre and post mod configuration of the Bleed Valve
