AIR - HP COMPRESSOR STAGE 10 BLEED VALVES - INTRODUCTION OF CHEVRON SEALS AND NEW VALVE
CENTRE STEM BUSHING - CATEGORY CODE 4 - MOD.ENG-75-0054

V2500-ENG-75-0054

SB Number 75-31 (Revision 1)

**Introduction of HP10 Bleed Valve AC 69922 Mod 2 with Chevron Seal & Metal Bush in lieu and by conversion of AC69861 & AC69922 Mod 1
DUNLOP MODIFICATION E593 (Issue 2) (IAE SB V2500-ENG-75- 0054 Rev 1)**

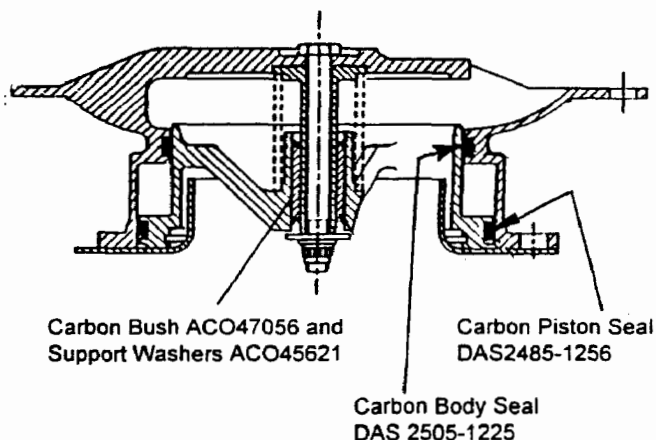
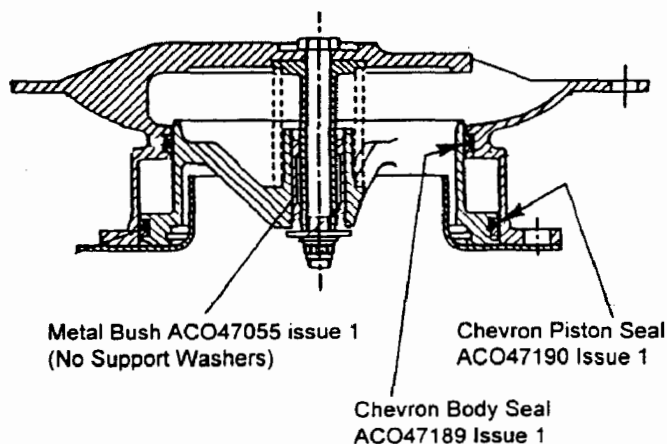
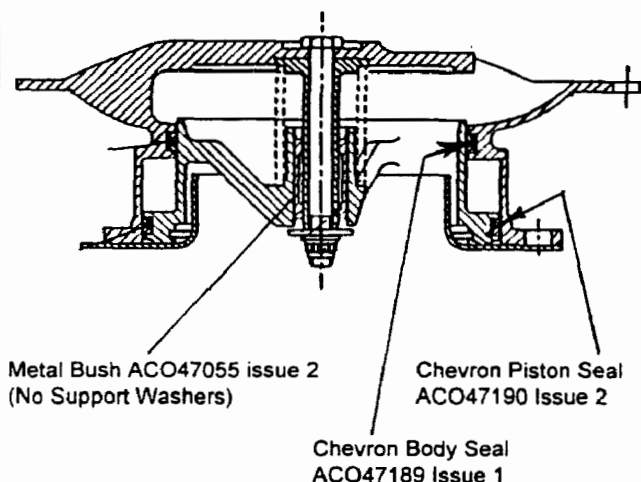
Figure 1 Pre and Post Mod Configuration of HP10 Bleed Valve

- (1) Condition
Valve sticking of HP compressor bleed valves has occurred in service.
- (2) Background
Dry contamination of the triple seals in the valve body and piston, also oxidation of the valve centre stem bushing may cause valve sticking. When the valve sticks in the closed position, starting may be difficult. Valve sticking in the open position may result in EGT shift and loss of surge margin.

Disassembly of HP10 Bleed Valve
Replacement of Piston Triple Seal Assembly DAS2485-1256 by a new 'Chevron' Seal Assembly ACO47190 Issue 2.
Replacement of Body Triple Seal Assembly DAS2505-1225 by a new 'Chevron' Seal Assembly ACO47189 Issue 1.
Replacement of Carbon Bush ACO47056 by new Metal Bush ACO47055 Issue 2.
Renewal of Nut AS20625, Retainer MR59S and Rivet A546791
Assembly & Re-identification of the modified Bleed Valve as **AC69922 Mod 2**.

Disassembly of HP10 Bleed Valve
Replacement of Piston 'Chevron' Seal Assembly ACO47190 Issue 1 by a new 'Chevron' Seal Assembly ACO47190 Issue 2.
Replacement of Metal Bush ACO47055 Issue 1 by a new metal Bush ACO47055 Issue 2.
Renewal of Nut AS20625, Retainer MR59S and Rivet A546791
Assembly & Re-identification of the modified Bleed Valve as **AC69922 Mod 2**.

(2) Refer to figure 1 for pre and post mod configuration of the Bleed Valve
