**V2500-A1/A5/D5 PROPULSION SYSTEMS SERVICE BULLETIN**

**V2500-ENG-75-0063**

ENGINE - AIR - INTRODUCTION OF A HPT/LPT ACC AIR VALVE WITH NEW SLOTTED ENTRY TYPE  
ROD END ASSEMBLY

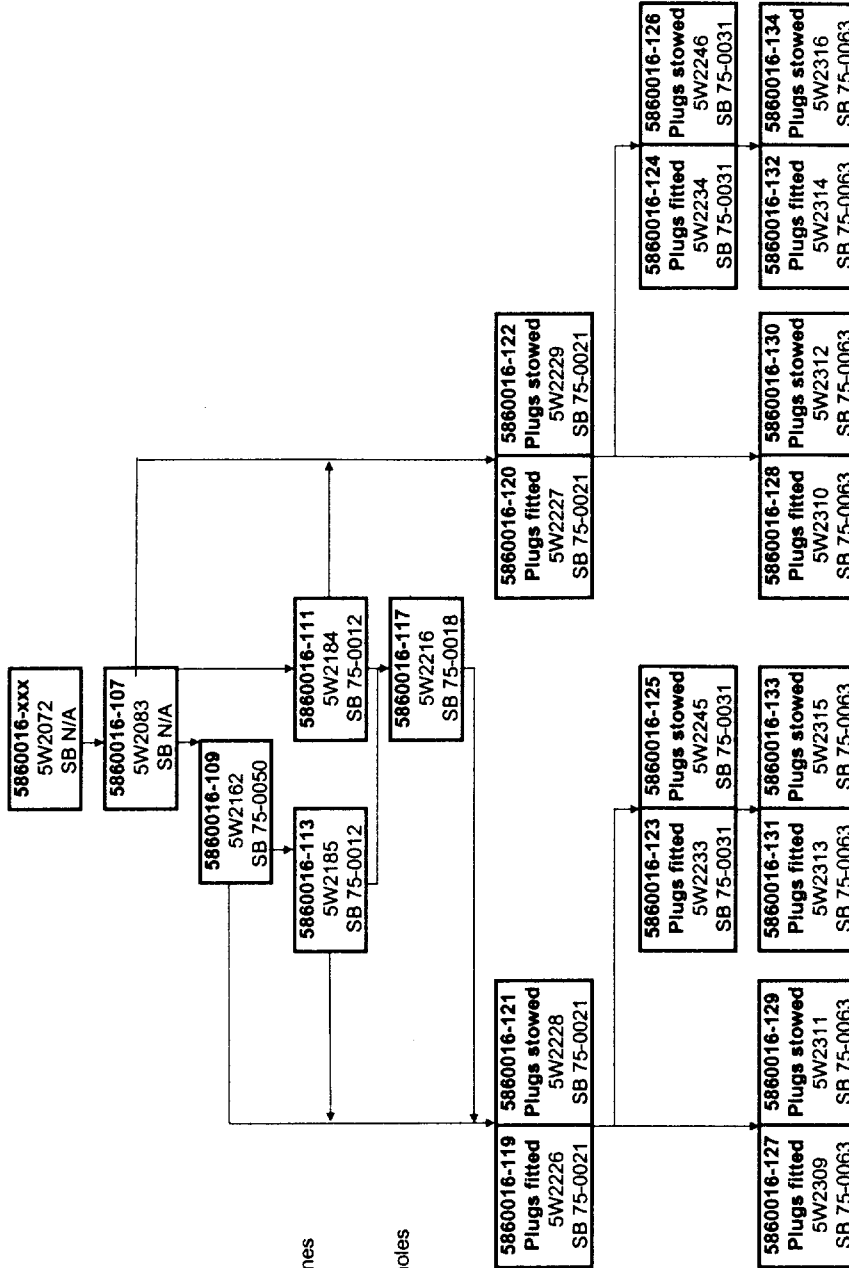
Fig 1

Family Tree - HPT/LPT ACC Air Valve for V2500-A1 Ref. Catalog Sequence No. 75-24-51

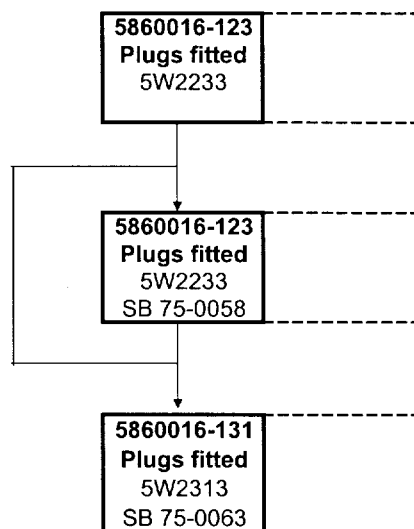
Family Tree - HPT/LPT ACC Air Valve for V2527-A5 and V2530-A5 Ref. Catalog Sequence  
No. 75-24-51 Fig. 01 Item 100 (Part No. 5860016)  
Fig 2
