International Aero Engines
SERVICE BULLETIN

Subject: Transmittal of Revision 1 to Service Bulletin V2500-ENG-77-0075

AIR - HP COMPRESSOR VARIABLE STATOR VANE ACTUATOR - INTRODUCTION OF REVISED
TORQUE MOTOR STRAINERS

ENGINE COMPRESSOR CONTROL - VARIABLE STATOR VANE ACTUATOR INTRODUCTION OF TORQUE MOTOR WITH REVISED FILTRATION TO PREVENT BLOCKAGE WITH FUEL DEGRADATION PRODUCTS

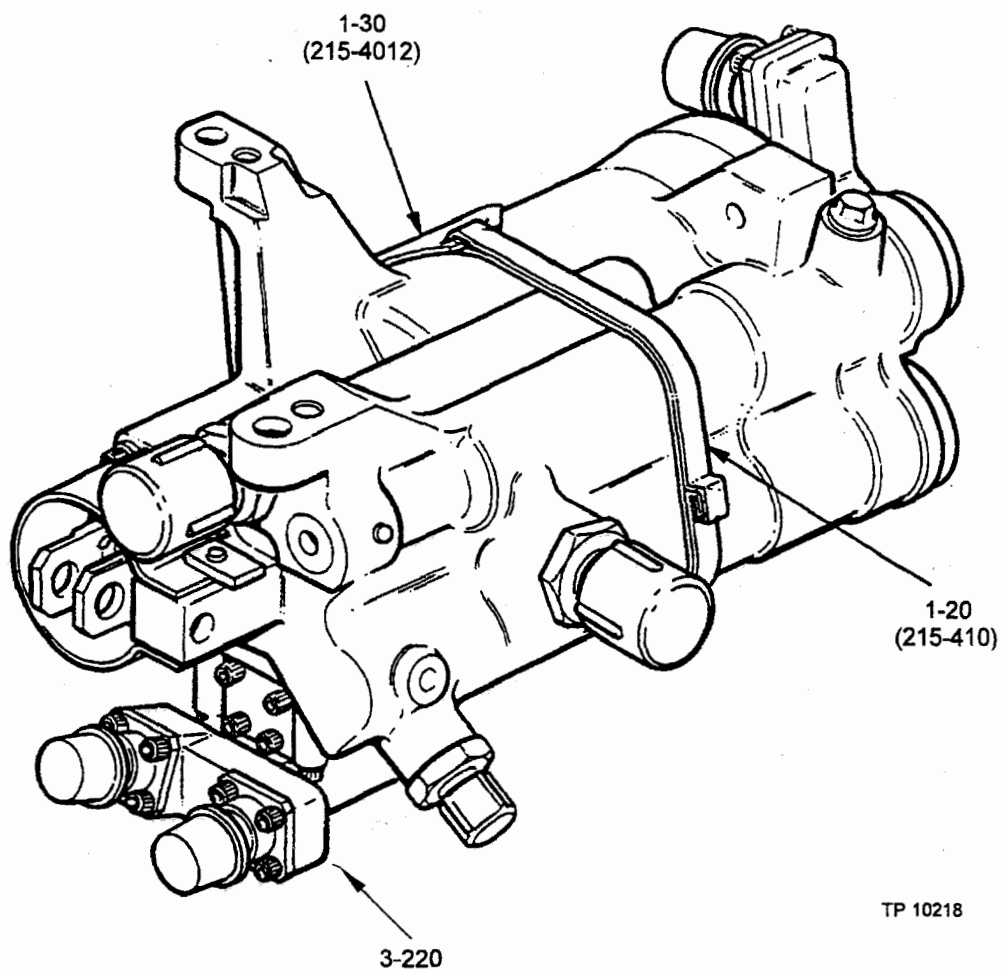
VSVA Identification
Figure 1

The current standard of Torque Motor (in the Variable Stator Vane Actuator) is prone to blockage of the filters by fuel degradation products.

Install the Torque Motor in accordance with the Component Maintenance Manual. Existing Torque Motors can be reworked by the manufacturer (Moog Controls Ltd).

D. Re-identify the Actuator

- (1) When ASSEMBLY is complete, get the new identification plate (1-30) part no. 215-4012 and strap (1-20) part no. 215-410 supplied with the Mod. Kit.
- (2) Refer to the information marked on the first identification plate (1-30) and mark the new identification plate as follows (use 1/16in. (1,6mm), letter/number stamps). Use the stamps with the identification plate held on a flat surface:

- (3) Fill the stamped letters and numbers with black paint and wipe away the surplus.
- (4) Install the new identification plate (1-30) on the unit with the new strap (1-20).
- (5) Discard the first identification plate.
