AIR - LP COMPRESSOR BLEED, MASTER ACTUATOR - INTRODUCTION OF REVISED TORQUEMOTOR STRAINERS - CATEGORY CODE 6 - MOD.ENG-75-0076

LPC BLEED MASTER ACTUATOR
TYPE 1666

ENGINE COMPRESSOR CONTROL - LPC BLEED MASTER ACTUATOR INTRODUCTION OF TORQUE MOTOR WITH REVISED FILTRATION TO PREVENT BLOCKAGE WITH FUEL DEGRADATION PRODUCTS

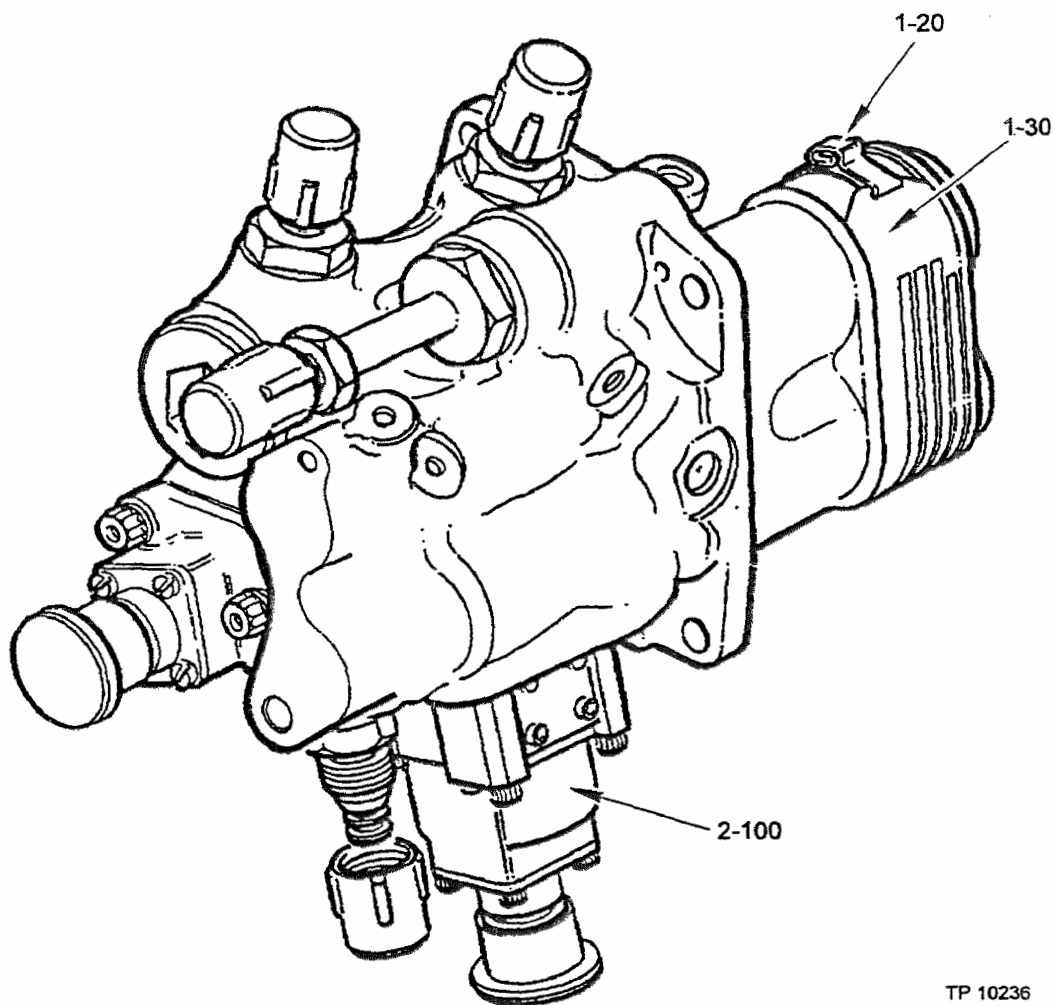
LPC Bleed Master Actuator Identification
Figure 1

The current standard of Torque Motor (in the Master L.P.C. Bleed Unit Actuator) is prone to blockage of the filters by fuel degradation products.

2. Accomplishment Instructions (Fig 1)

Install the Torque Motor in accordance with the Component Maintenance Manual. Existing Torque Motors can be reworked by the manufacturer (Moog Controls Ltd).

- (1) Put the new identification plate (1-30) part number 215-4009 on a flat surface. Mark the identification plate with 1.60 mm (1/16in) letter/number stamps:

- (2) Fill the stamped letters and numbers with black paint and wipe away the surplus.
- (3) Install the new identification plate (1-30) part number 215-4009 on the unit with the new strap (1-20) part number 215-410.

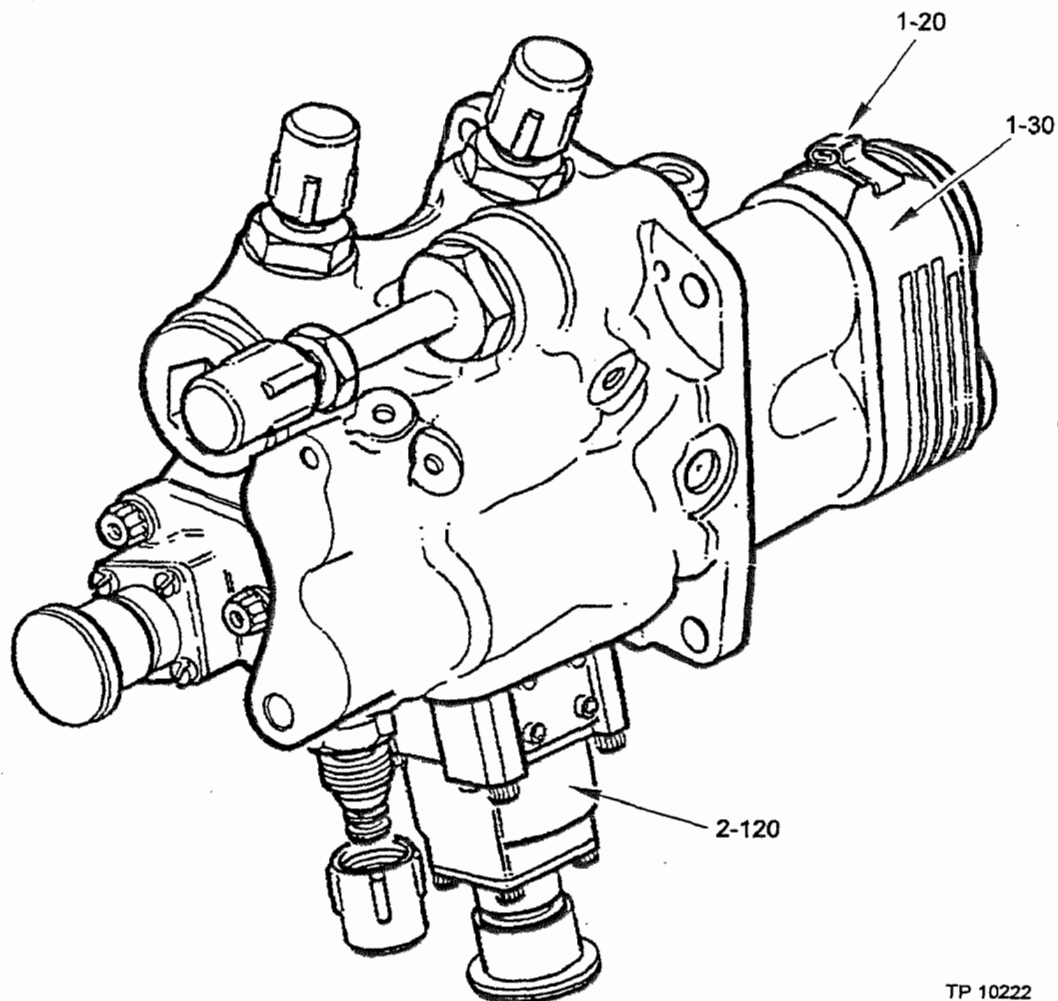
Figure 1

The current standard of Torque Motor (in the Master L.P.C Bleed Unit Actuator) is prone to blockage of the filters by fuel degradation products.

2. Accomplishment Instructions (Fig 1)

Install the Torque Motor in accordance with the Component Maintenance Manual. Existing Torque Motors can be reworked by the manufacturer (Moog Controls Ltd).

- (1) Put the new identification plate (1-30) part no. 215-4009 on a flat surface. Mark the identification plate with 1.60 mm (1/16in) letter/number stamps:

- (3) Install the new identification plate on the unit with the new strap (1-20) part no. 215-410.

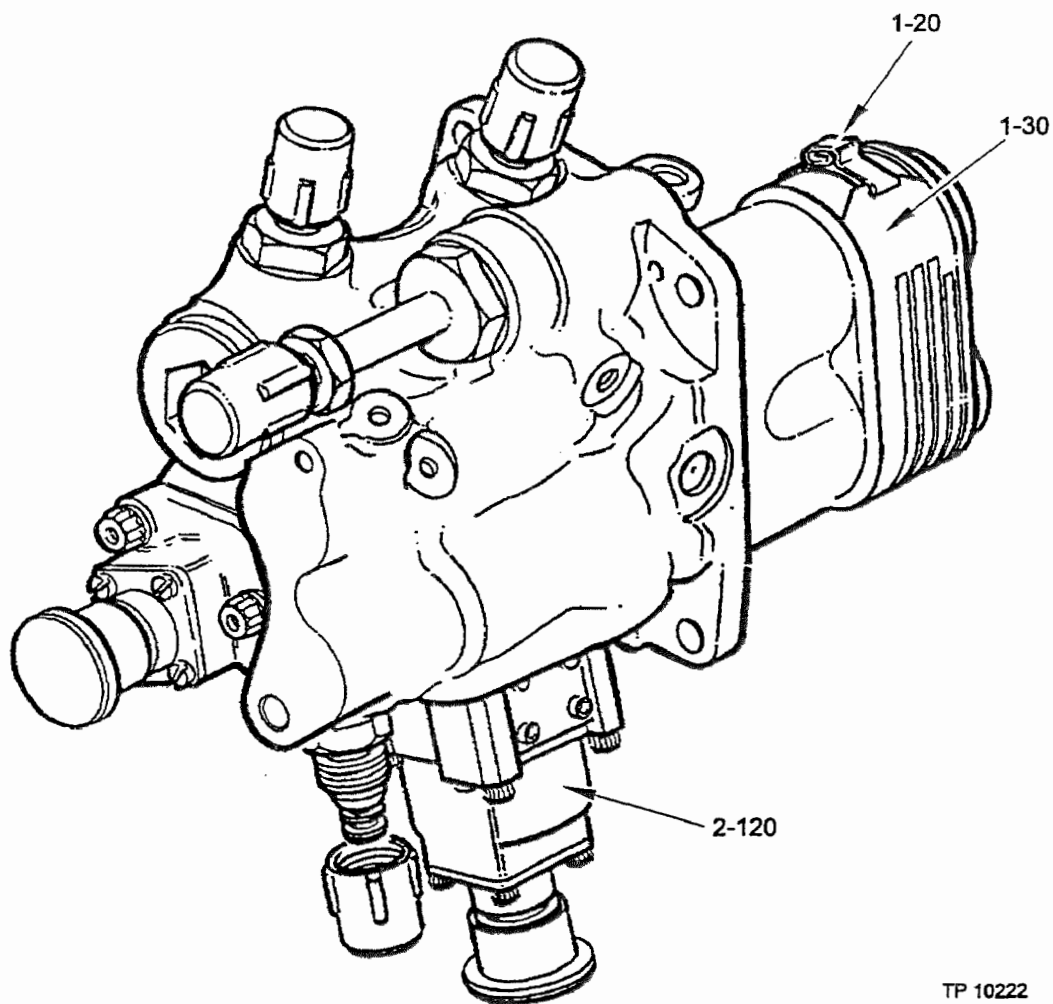
LPC Bleed Master Actuator Identification
Figure 1

The current standard of Torque Motor (in the Master L.P.C Bleed Unit Actuator) is prone to blockage of the filters by fuel degradation products.

This Service Bulletin (Modification) introduces a Torque Motor with revised filtration to prevent blockage by fuel degradation products.
