V2500-D5 PROPULSION SYSTEMS SERVICE BULLETIN

V2500-ENG-75-0087

AIR – HP COMPRESSOR STAGE 7 SOLENOID VALVE – INTRODUCTION OF A REVISED MOUNTING
BRACKET ASSEMBLY AND SUPPORT BRACKETS

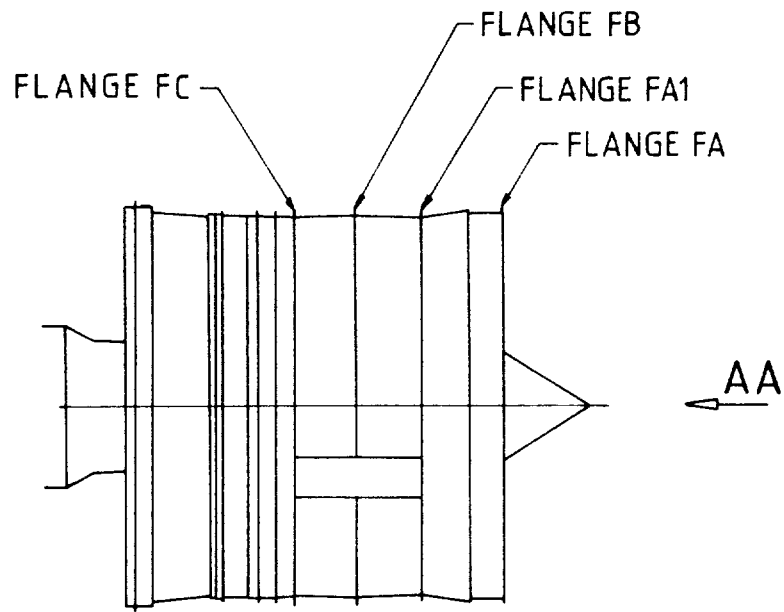
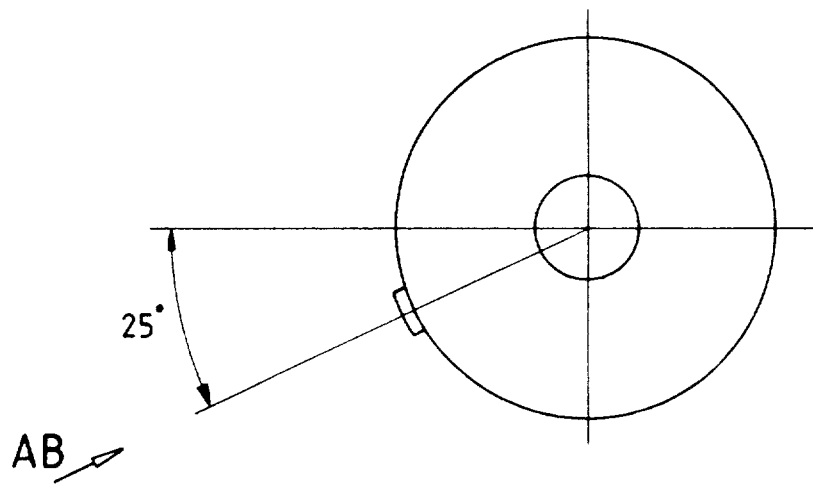
Location diagram
Fig 1

- (a) A revised bleed valve solenoid mounting bracket similar to the existing item except for the following:
- (i) The two holes that locate the solenoid bracket to the fan case at flange FC (see Fig 1) have been changed from plain holes to slotted holes.
 - (ii) The shape of the base of the bracket has been changed to maintain clearance with the fancase.
 - (iii) The five plunged holes located under each solenoid have been changed to plain holes.
- (b) A washer under the base of each nut on the slotted holes.
- (c) Two support brackets similar to the existing items except for the following:
- (i) The fancase locating holes have been moved to ensure the brackets sit nominally level.
 - (ii) The web feature has been removed.
 - (iii) Anchor nuts have been riveted to the brackets to attach the solenoid mounting bracket (in place of the deleted clip nuts in (d) below).

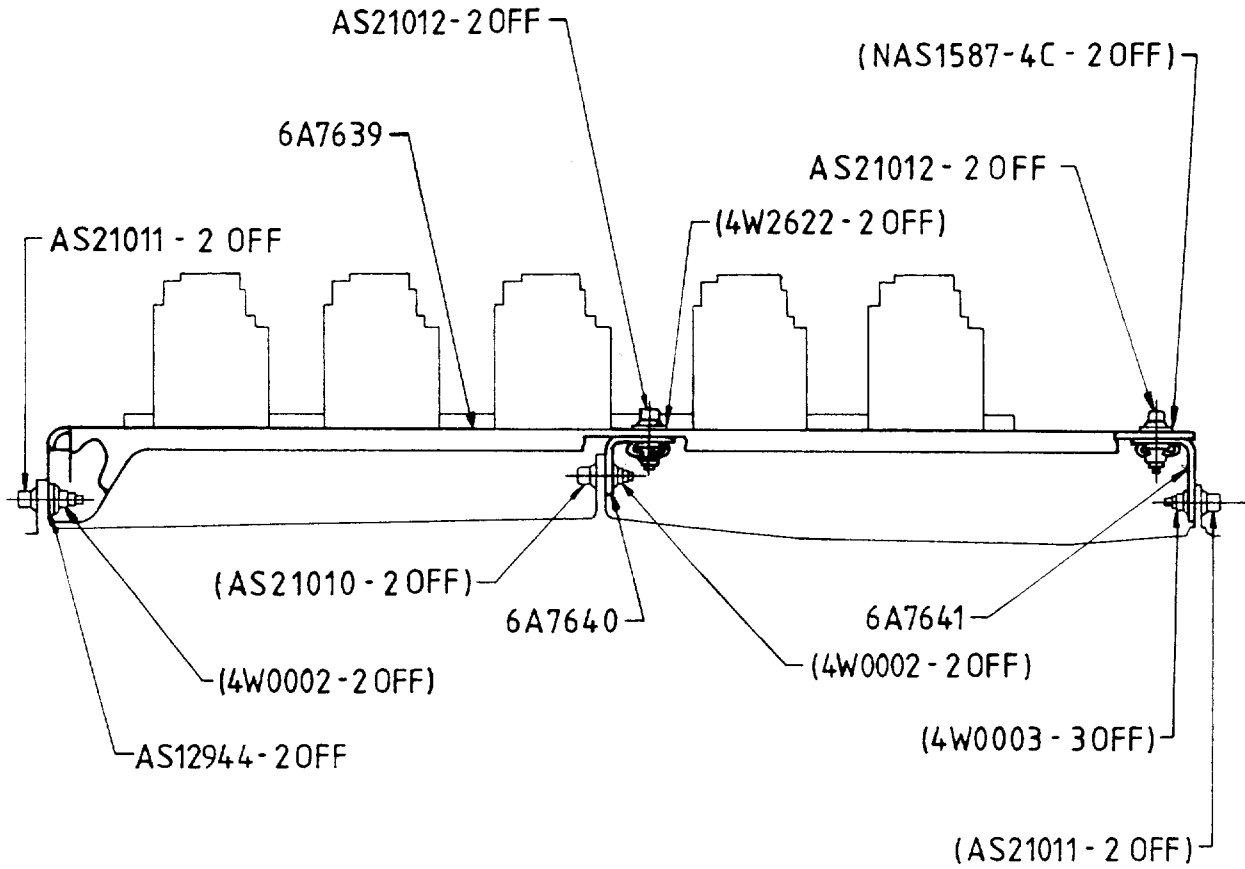
View of support bracket assembly after alteration
Fig 3

- (1) This Service Bulletin introduces a revised HP compressor stage 7 solenoid valve mounting bracket assembly to reduce the potential for misalignment and minimise residual stresses.

- (7) Tighten bracket 6A7639 to the fancase at flange FC
- (8) Loosen by one quarter turn, both fasteners AS21012 (2 off) between bracket 6A7639 and bracket 6A7641

- (9) Tighten bracket 6A7639 to bracket 6A7640
- (10) Tighten bracket 6A7639 to bracket 6A7641
