V2500-A1/A5/D5 SERIES PROPULSION SYSTEMS SERVICE BULLETIN

This document transmits Revision 2 to Service Bulletin EV2500-75-0091 and the Initial Issue of the Supplement

V2500-ENG-75-0091

ENGINE – LP TURBINE – RELEASE OF SALEABLE DETAIL PARTS FOR ACC DUCT REPAIR

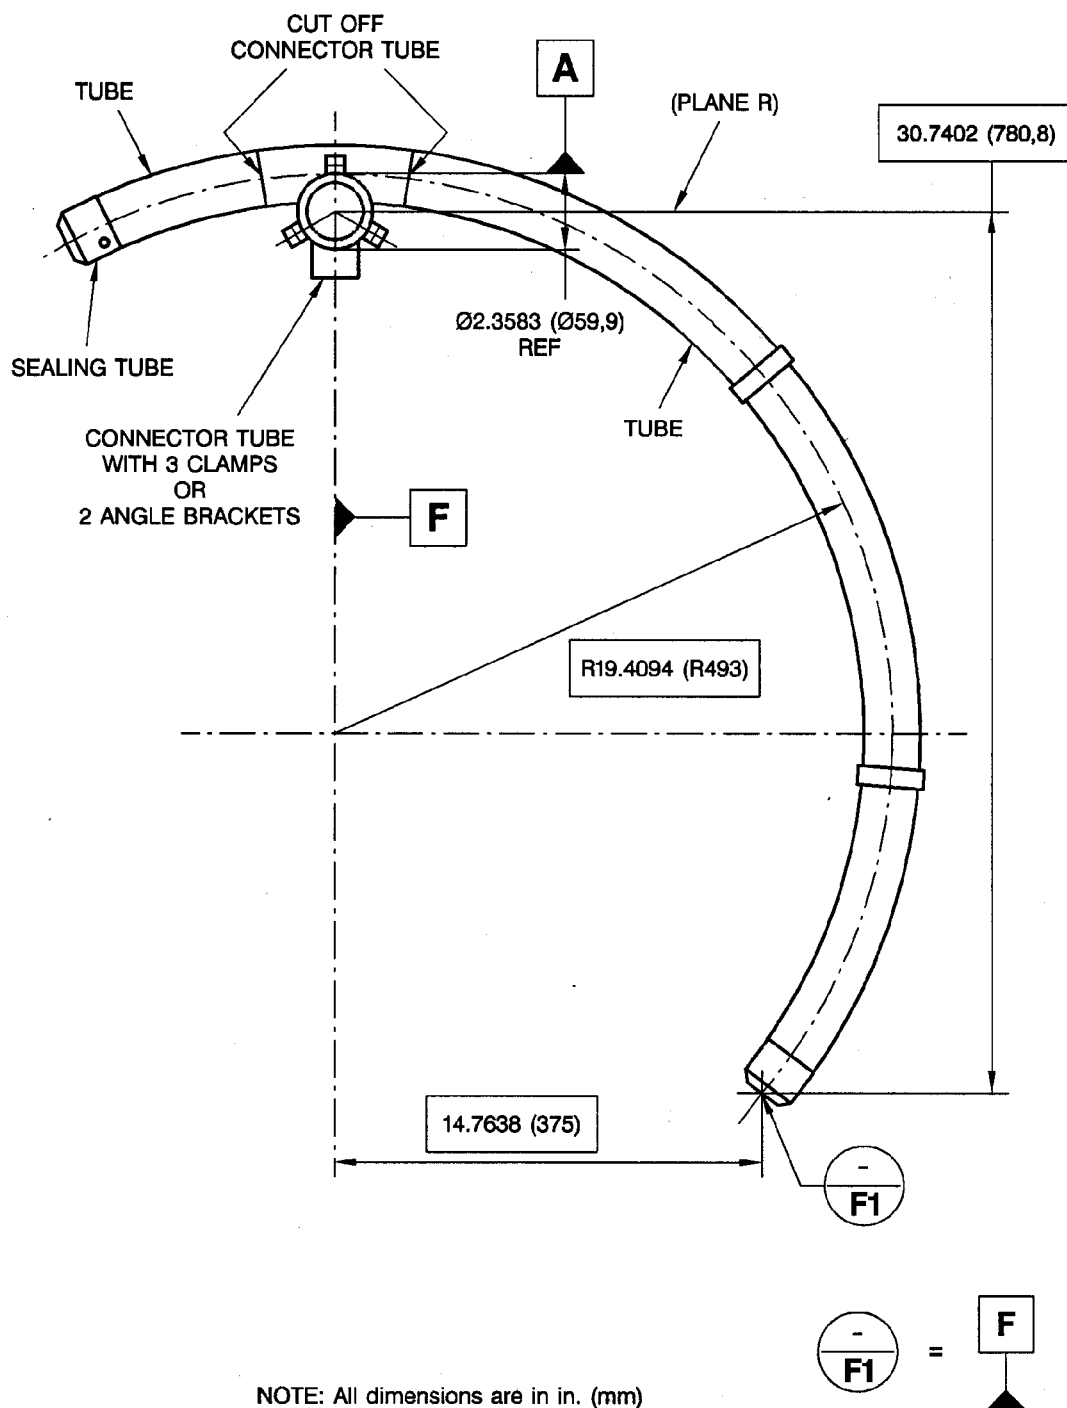
Connector Tube Assembly – Replacement of Connector Tube
Fig.1 (Sheet 1 of 3)

Release of rework of ACC connector tube of the old configuration (P/N 3A0494, 3A1549, 3A2316, 3A2335, 3A2003 and 3A2319) in case EM-Limits are exceeded and no existing repair can be applied.

| (3) Remove the Connector Tube | Refer to Fig 1 (sheet 1 of 3) . Use applicable machining equipment and IAE 3M14523 cut off and welding fixture 1 off. |
