V2500-A1/A5 SERIES PROPULSION SYSTEMS SERVICE BULLETIN

AIR – HP COMPRESSOR STAGE 7 BLEED VALVE – INTRODUCTION OF A BLEED VALVE SPACER

V2500-ENG-75-0092

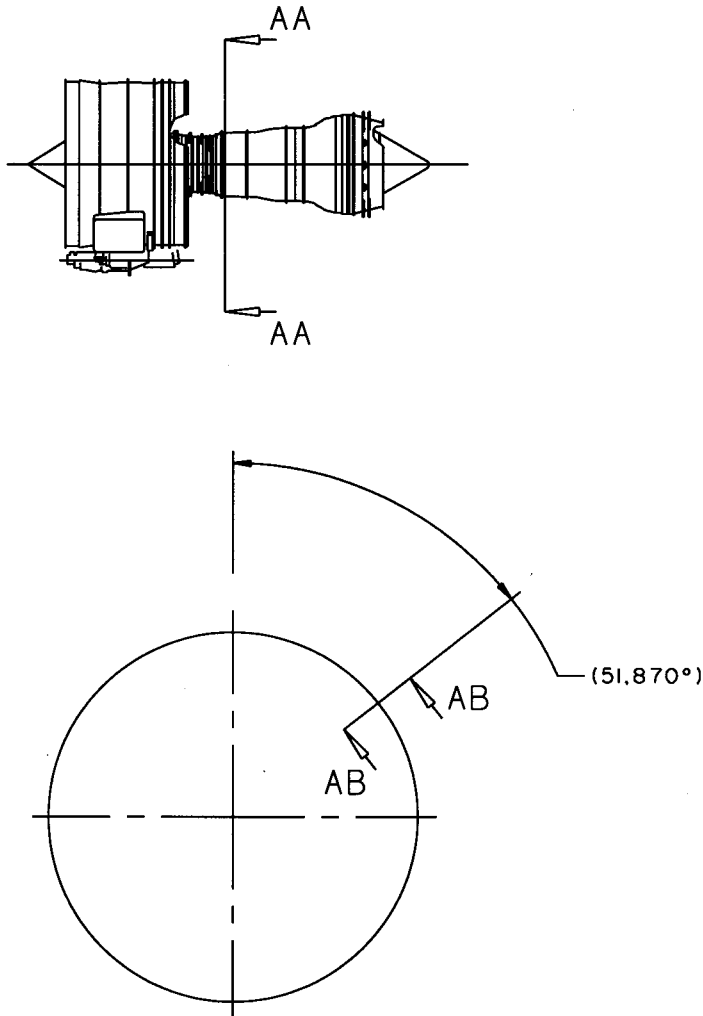
Thrust Reverser Unit (TRU) filler loss and panel disbond around the HP Compressor Stage 7 RH upper (Stage 7A) bleed valve porthole may occur. The damage is caused by air from the bleed valve silencer impinging on the rim of the TRU port coupled with normal vibration.

The problem has been attributed to insufficient height of the bleed valve silencer outlet in relation to the Stage 7A bleed valve port in the TRU.

SECTION AA
DIAGRAMMATIC VIEW LOOKING FORWARD
THROUGH STAGE 7 BLEED VALVE SILENCER

(a) A new spacer is introduced beneath the HP Compressor Stage 7A bleed valve silencer assembly.

(b) A revised bolt is introduced similar to the existing bolt except for an increase in length to accommodate the spacer.

- (iii) Torque the nuts to between 85 and 105 lbfin (0.96 and 1.18 m.daN).
- (g) Install the silencer assembly.
 - (i) Hold the silencer assembly and spacer 6A8319 in position on the bleed valve. Refer to Fig. 1 and Fig. 2.

- (ii) Attach the silencer assembly and spacer to the valve with bolts AS21013 and the nuts 4W0002. Refer to Fig. 1 and Fig. 2.
 - (iii) Torque the nuts to between 85 and 105 lbfin (0.96 and 1.18 m.daN)
