V2500-A1/A5/D5 SERIES PROPULSION SYSTEMS SERVICE BULLETIN

V2500-ENG-75-0096

AIR – ACTIVE CLEARANCE CONTROL (ACC) ACTUATOR – INTRODUCTION OF AN ACC ACTUATOR WITH
A REVISED SERVO VALVE

AIR	HPT/LPT ACTIVE CLEARANCE CONTROL ACTUATOR (ACC ACTUATOR)	UPGRADE TO 5860017-140 THRU 5860017-144 BY INCORPORATING AN IMPROVED ELECTRO HYDRAULIC SERVO VALVE (EHSV).
-----	--	---

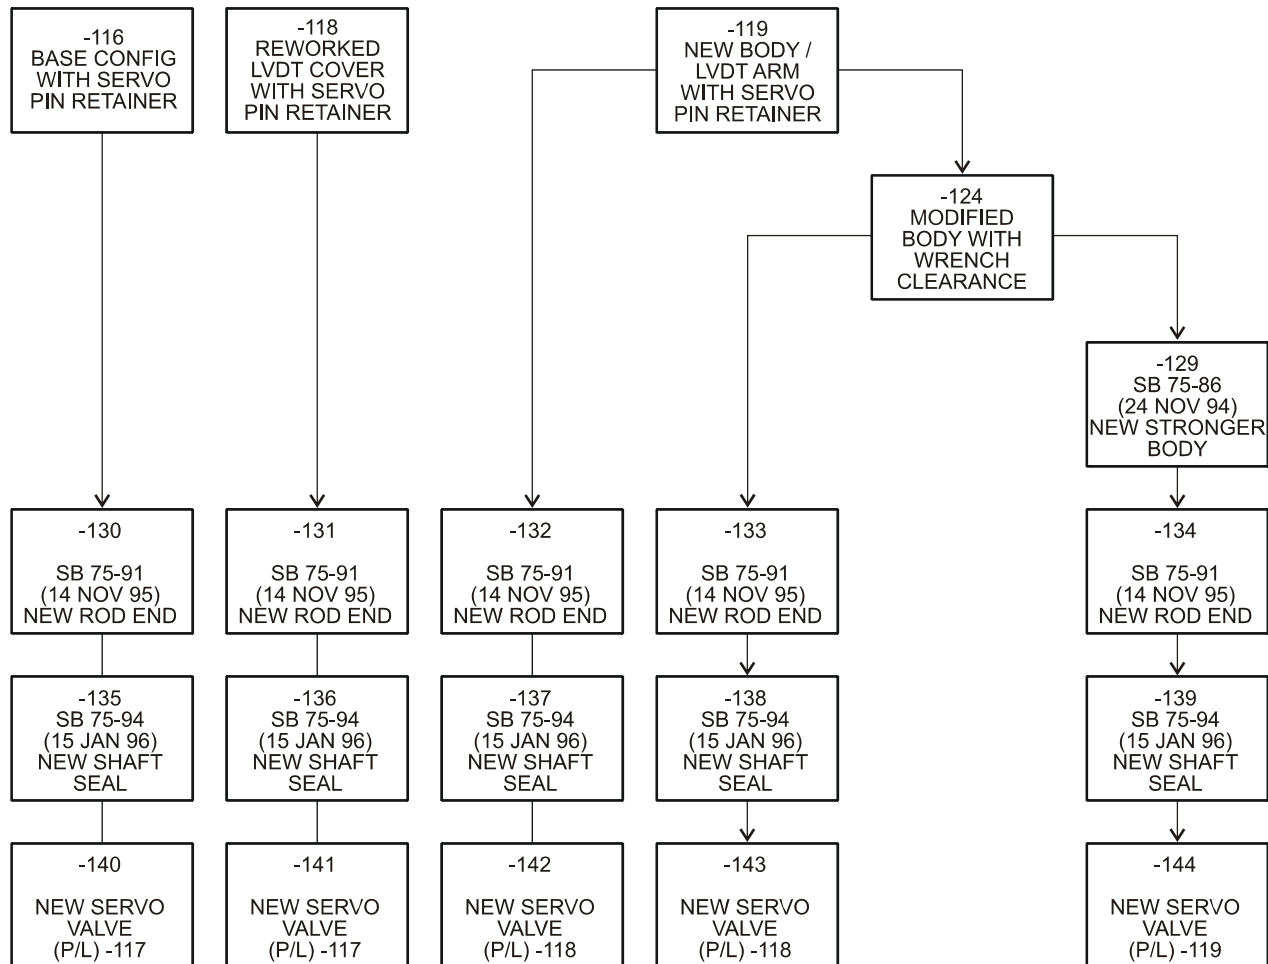
SB5860017-75-220FIGA

NOTE: THIS FAMILY TREE INCLUDES ONLY THE ACTIVE CONFIGURATIONS OF BASIC PART NUMBER 5860017 THAT CAN BE UPGRADED WITH THE NEW SERVO. CONFIGURATIONS NOT LISTED MUST INCORPORATE THE APPROPRIATE IMPROVEMENTS THAT CONFORM TO THE CONFIGURATIONS SHOWN.
