## V2500-A1/A5 SERIES PROPULSION SYSTEM SERVICE BULLETIN

# V2500-ENG-75-0105

AIR – HP COMPRESSOR STAGE 7 BLEED VALVES – INTRODUCTION OF AN ALTERNATIVE BLEED VALVE  
WITH NEW DESIGN

**POWER PLANT - AIR – BLEED VALVE  
Introduction of Bleed Valve EB101729B  
as an Alternative to Bleed Valve AC69924**

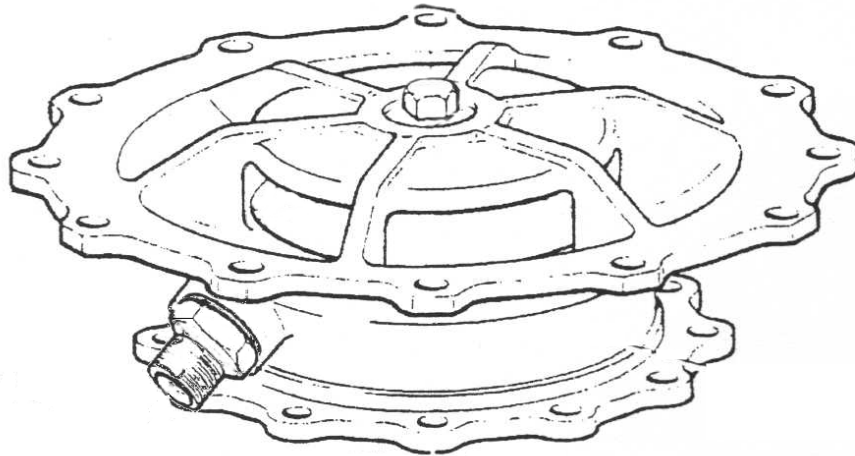
Old Type Bleed Valve p/n AC69924  
Figure 1

Operators in the field have reported contamination of the triple seal assembly in the Dunlop Stage 7 Bleed Valve p/n AC69924. Contamination of this triple seal assembly reduces the reliability of the Bleed Valve.

(1) There are no rework procedures introduced by this Service Bulletin. This Service Bulletin introduces the Dunlop HP 7 Bleed Valve p/n EB101729B (Figure 3) as an alternative to the Dunlop Stage 7 Bleed Valve p/n AC69924 (Figure 1).

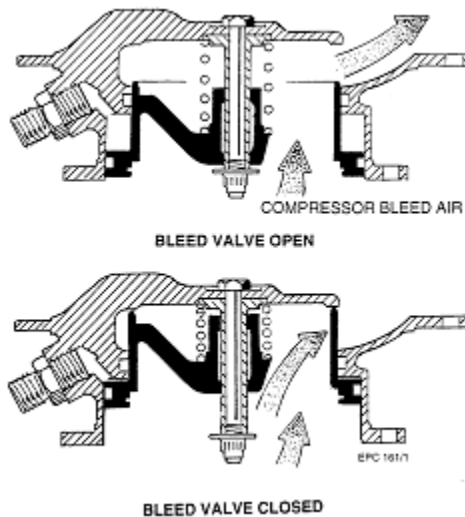
Bleed Air Flow Through Old Type Bleed Valve p/n AC69924  
Figure 2

(a) The new Bleed Valve p/n EB101729B is of the 'Bullet Type' design (Figure 4). It is designed to flow bleed air around the piston and not, in the case of Bleed Valve p/n AC69924 (Figure 2), through the piston. This change in design reduces the entry of bleed air contamination into the Bleed Valve.

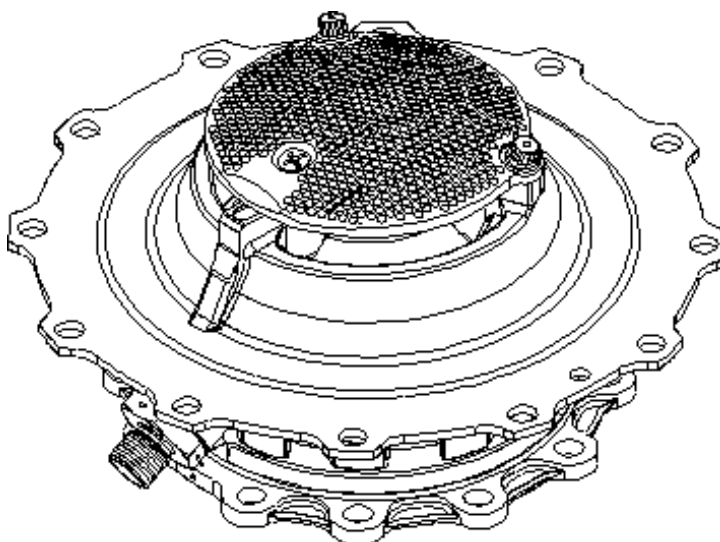
Figure 3

(b) The new Bleed Valve p/n EB101729B has an attached perforated dome plate. The perforated dome plate keeps noise levels within permitted levels.
