V2500-A1/A5/D5 SERIES PROPULSION SYSTEMS SERVICE BULLETIN

V2500-ENG-75-0108

AIR – ACTIVE CLEARANCE CONTROL (ACC) – INTRODUCTION OF A PERISEAL HOUSING WITH
INCREASED INNER LIP DIAMETER

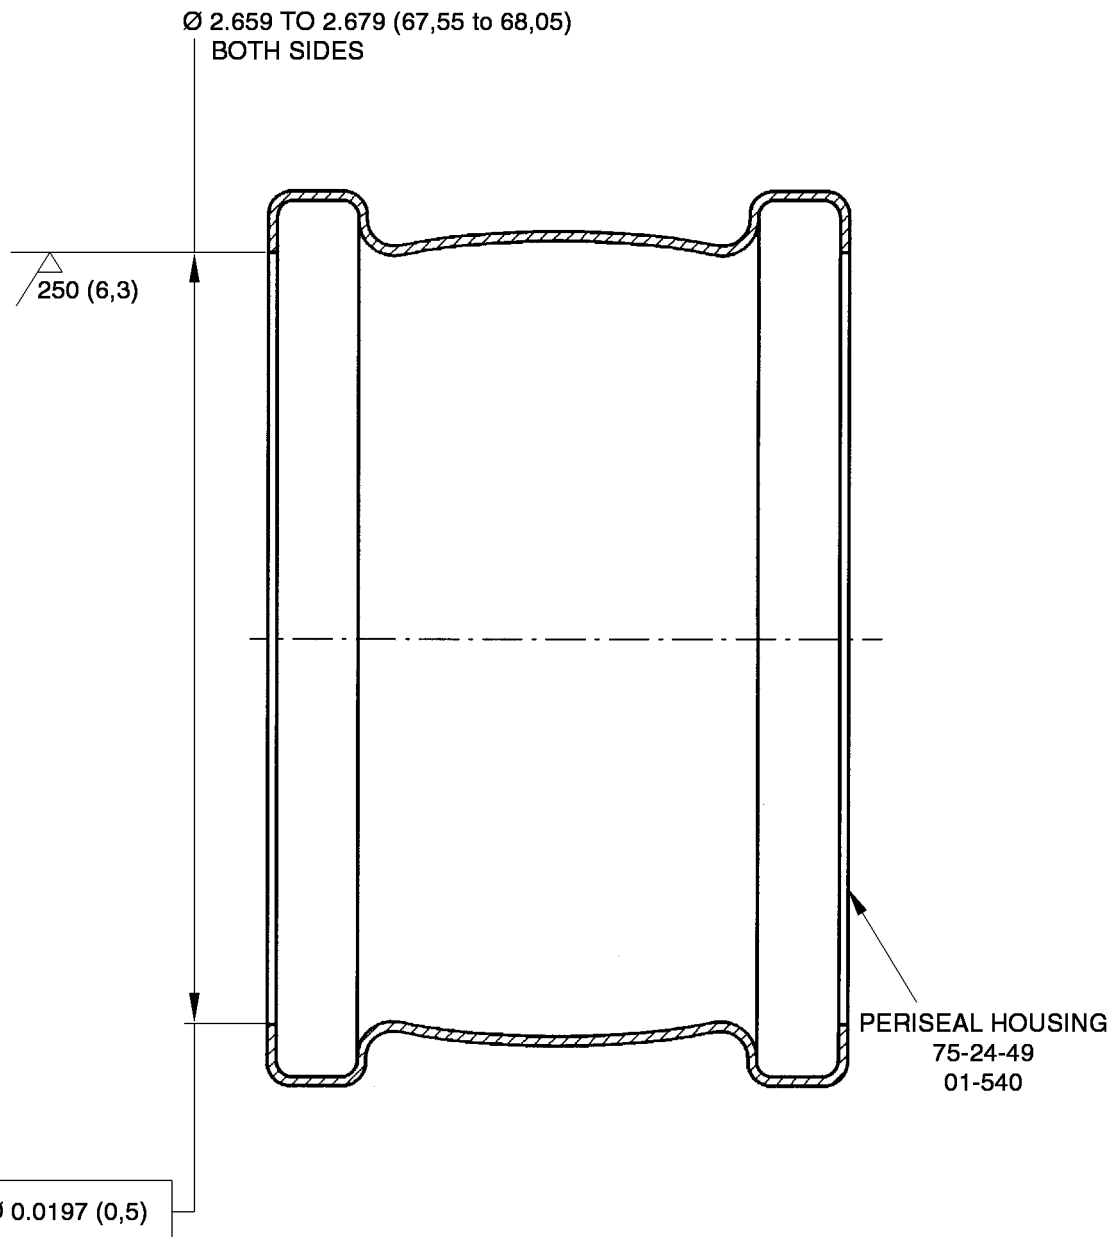
Figure 1 – Rework Limits of Periseal Housing 01-540

R The V2500 production engine suffer from wear as a result of contact
R between the inner lip diameter of the periseal housing and the Active
R Clearance Control (ACC) connector tube end.

Due to shrinkage of the periseal seal ring as a result of high temperature exposure, contact between the inner lip diameter of the seal housing and the ACC connector tube end, upon which it sits, can occur. By increasing the lip diameter by 0.08 in. (2 mm), the problem can be obviated. A leakage check has been carried out successfully to confirm this.

| (4) Machine the periseal housing. | Refer to Figure 1 or Figure 2.
| (5) Examine the machined area dimensionally. | Refer to Figure 1 and Figure 2.
