SERVICE BULLETIN

NON-MODIFICATION SERVICE BULLETIN – TURBINE COOLING AIR (TCA) TUBES
– INSPECTION FOR CABLE OR LOCKWIRE INSTALLATION

V2500 Series 75-0124

V2500-ENG-75-0124

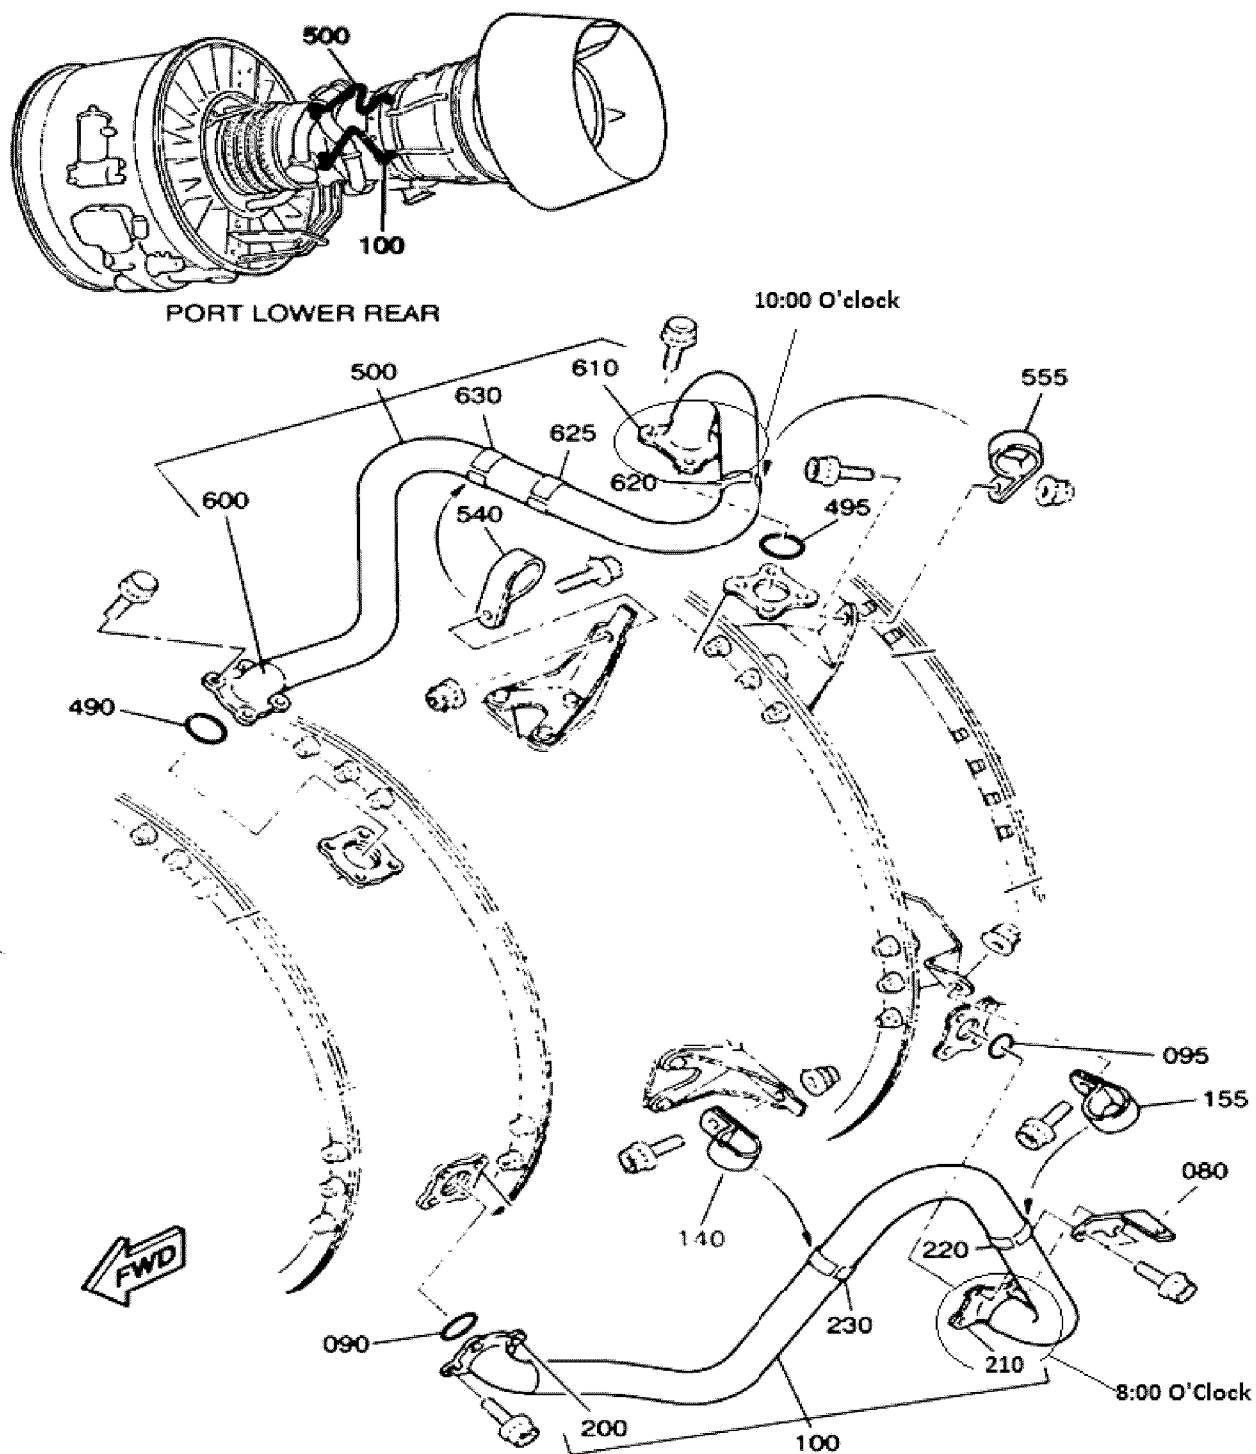
LOCATION OF THE TCA TUBE BOLTS
75-23-42
FIGURE 1

1. Visual Inspection
 - A. At "A" Check and each subsequent aircraft "C" check, visually inspect that four bolts are properly installed and secured with PN AS3510-02 Cable or lockwire at four locations on the outer diameter of the HPT case at 2:00, 4:00, 8:00 and 10:00 O'clock positions.
 - B. If PN AS3510-02 Cable or lockwire is found broken or loose, correct the condition per the SPM Reference 2 and report it to the local IAE Field Service Representative.
2. Recording Instructions
 - A. A record of accomplishment is required.
