ENGINE INDICATING - REPLACEMENT OF EGT LOOP CLAMP BRACKETS AND ATTACHING BOLTS -
CATEGORY CODE 3 - MOD.ENG-77-0002

V2500-ENG-77-0002

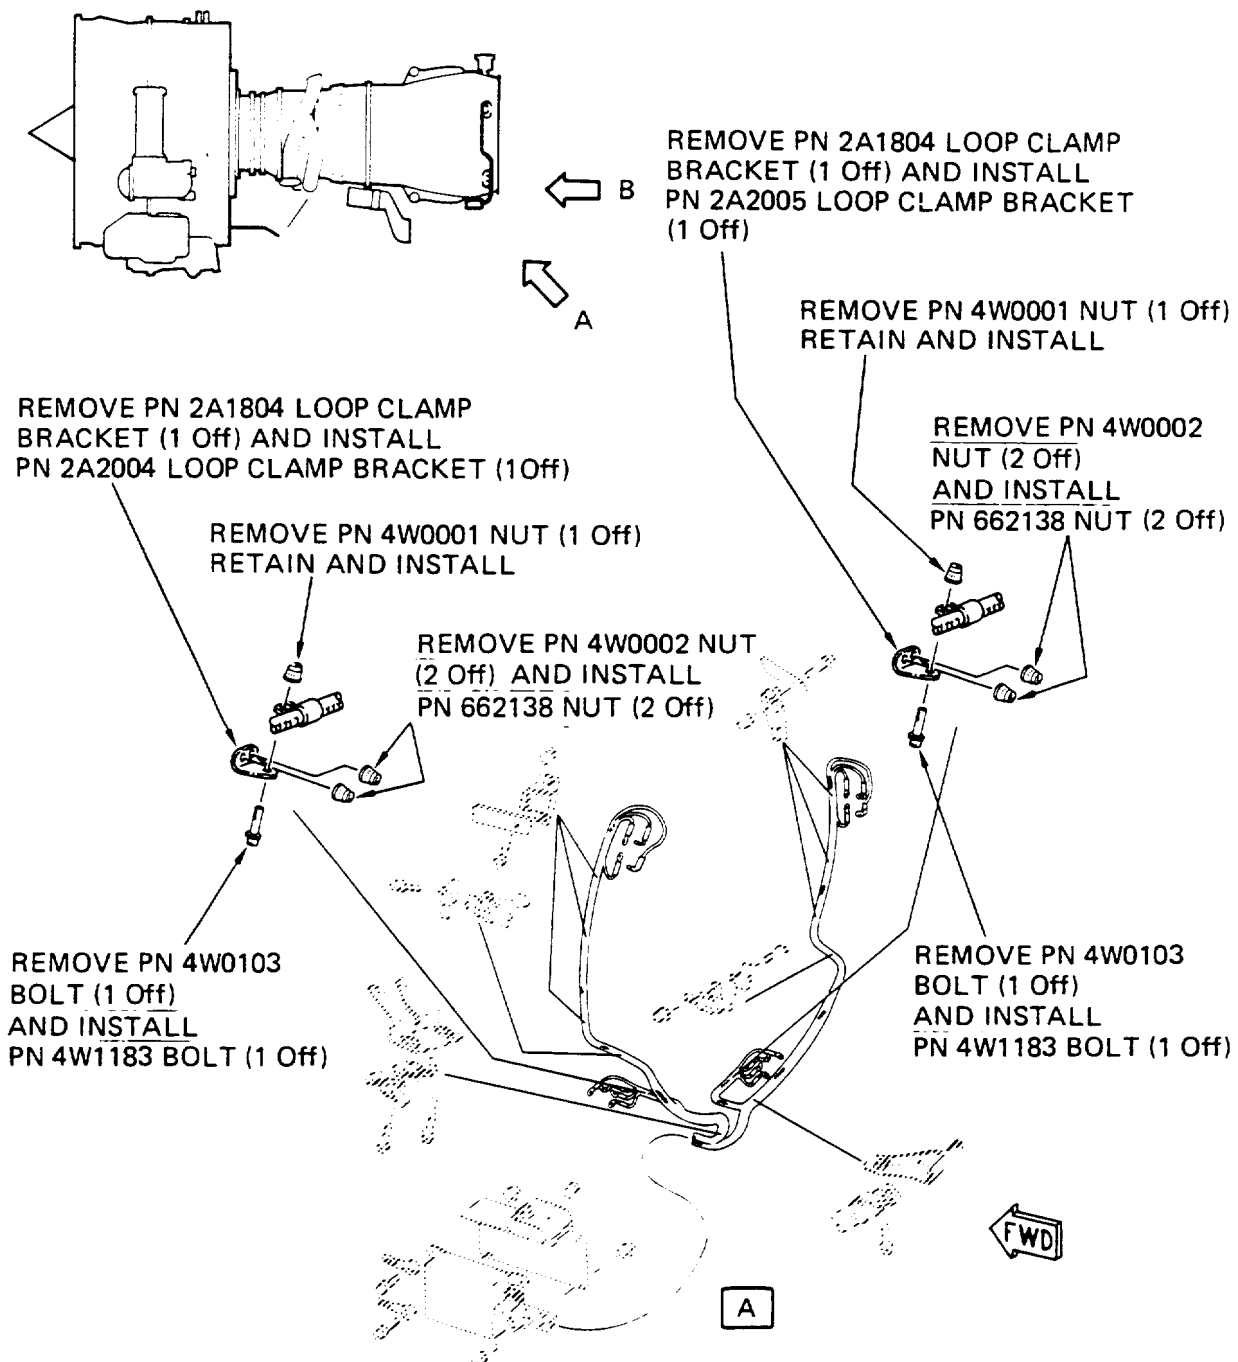
Replacement of EGT loop clamp brackets and attaching bolts
Fig.1 Sheet 1 of 2

The present configuration EGT Brackets on flange P at hole location 52, 53, 62 and 63 can physically interfere with the Hold Open Rod Brackets for the C-Ducts.

It can be difficult to close the C-Duct. This could cause damage to the EGT Brackets, Hole Open Rod Brackets, and C-Duct.

- (1) Remove the Nuts and Bolts which hold the two 2A1804 loop clamp brackets to the Loop Clamps. Refer to Figure 1.

- (5) Put the 2A2004 Loop Clamp Bracket (1 off) at the location of holes 62 and 63. Refer to Figure 1.

- (7) Put the 2A2005 Loop clamp Bracket (1 off) at the location of holes 52 and 53. Refer to Figure 1.
