SERVICE BULLETIN

ENGINE INDICATING - ENGINE - EXHAUST GAS TEMPERATURE (EGT) INDICATING SYSTEM
REPLACEMENT OF EGT LOOP CLAMP BRACKETS - CATEGORY CODE 5 - MOD.ENG-77-0003

V2500-ENG-77-0003

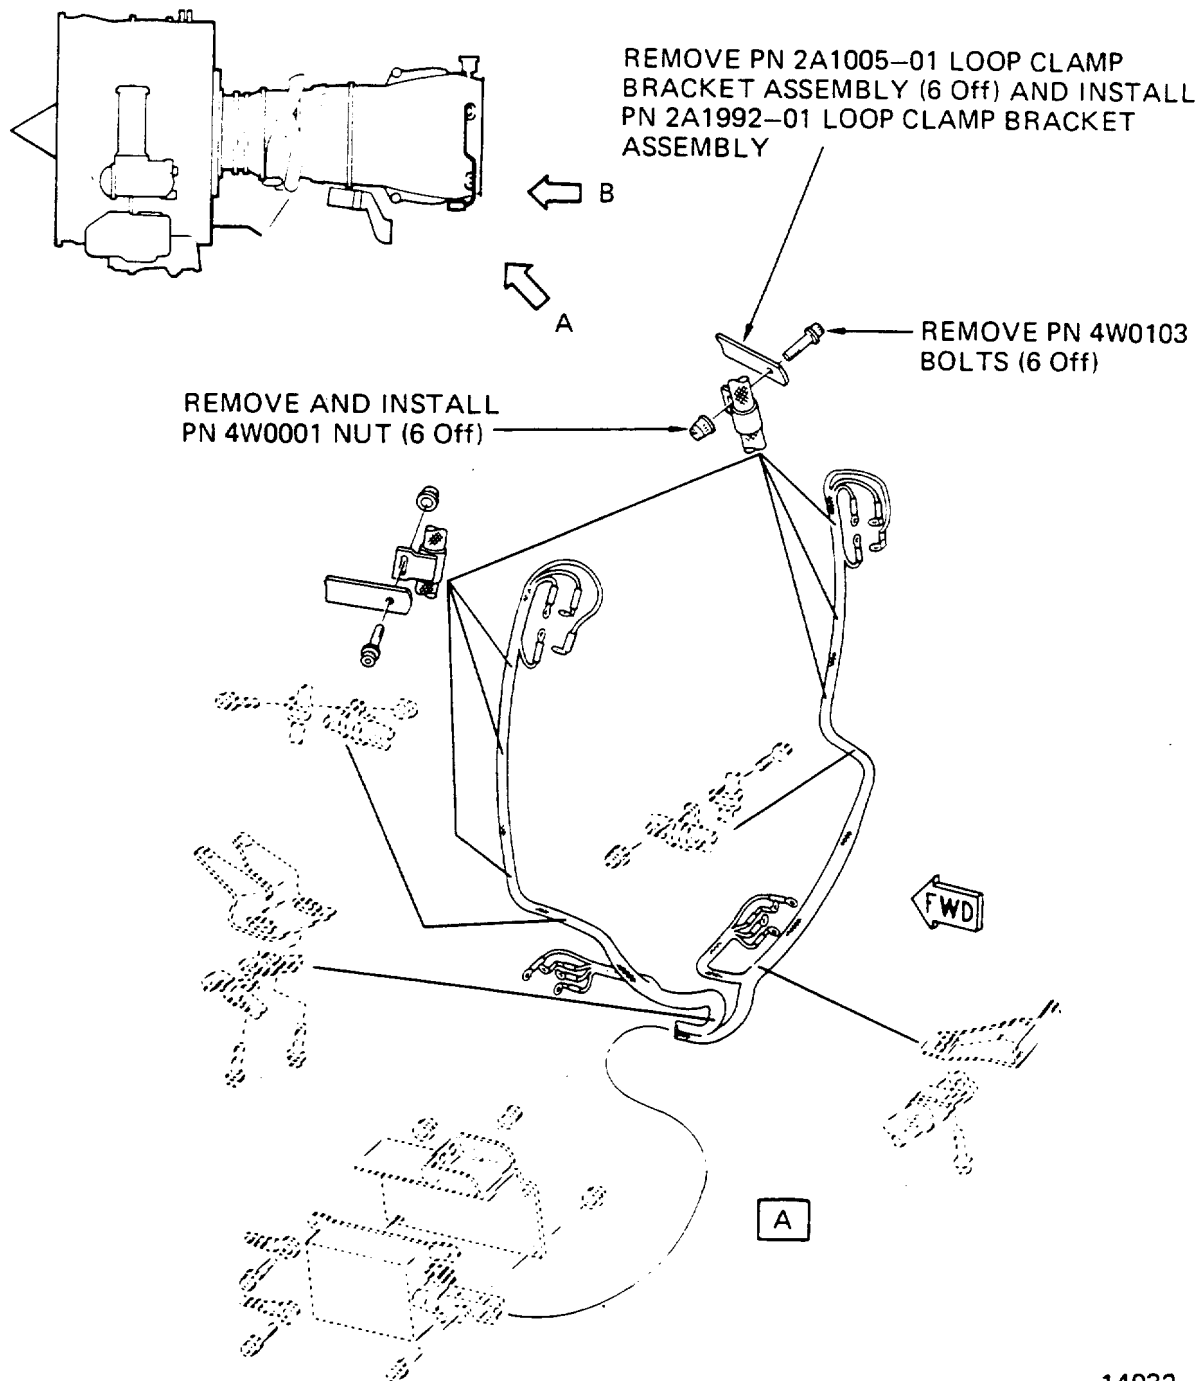
Replacement of Exhaust Gas Temperature (EGT) Indicating System Loop Clamp Brackets
Fig.1 (Sheet 1 of 3)

There is contact between the EGT Bracket, Loop Clamp, and Harness at six locations.

Contact causes distress of the C-Duct Heat Shielding and can cause fretting of the EGT Harness Bundle.

- (1) Remove the Nuts and Bolts which hold the Loop Clamps to the Loop Clamp Brackets. Retain the Nuts and Bolts. Refer to Figure 1.
- (2) Remove the Nuts and Bolts which hold the Loop Clamp Brackets to the T Flange and discard the Nuts and Bolts. Refer to Figure 1.

- (b) Put the 2A1992-01 Loop Clamp Bracket Assembly at the location of holes 16 and 17. Refer to Figure 1.
 - (c) Install the Nuts and Bolts, through the holes in the Flange and Bracket Assembly, and tighten them with your hand.

- (h) Install the 4W0001 Nut. Refer to Figure 1.
 - (i) Torque the Nut to 36 to 45 lbfin (4,07 to 5,08 Nm) by the approved procedure in Reference (2), Chapter/Section 70-41-00, Torque Tightening Technique.
