## SERVICE BULLETIN

ENGINE INDICATING - ENGINE - INDICATING - ADD WASHERS AT CLIPPING POINTS CP6004 AND CP6009 - CATEGORY CODE 6 - MOD.ENG-77-0005

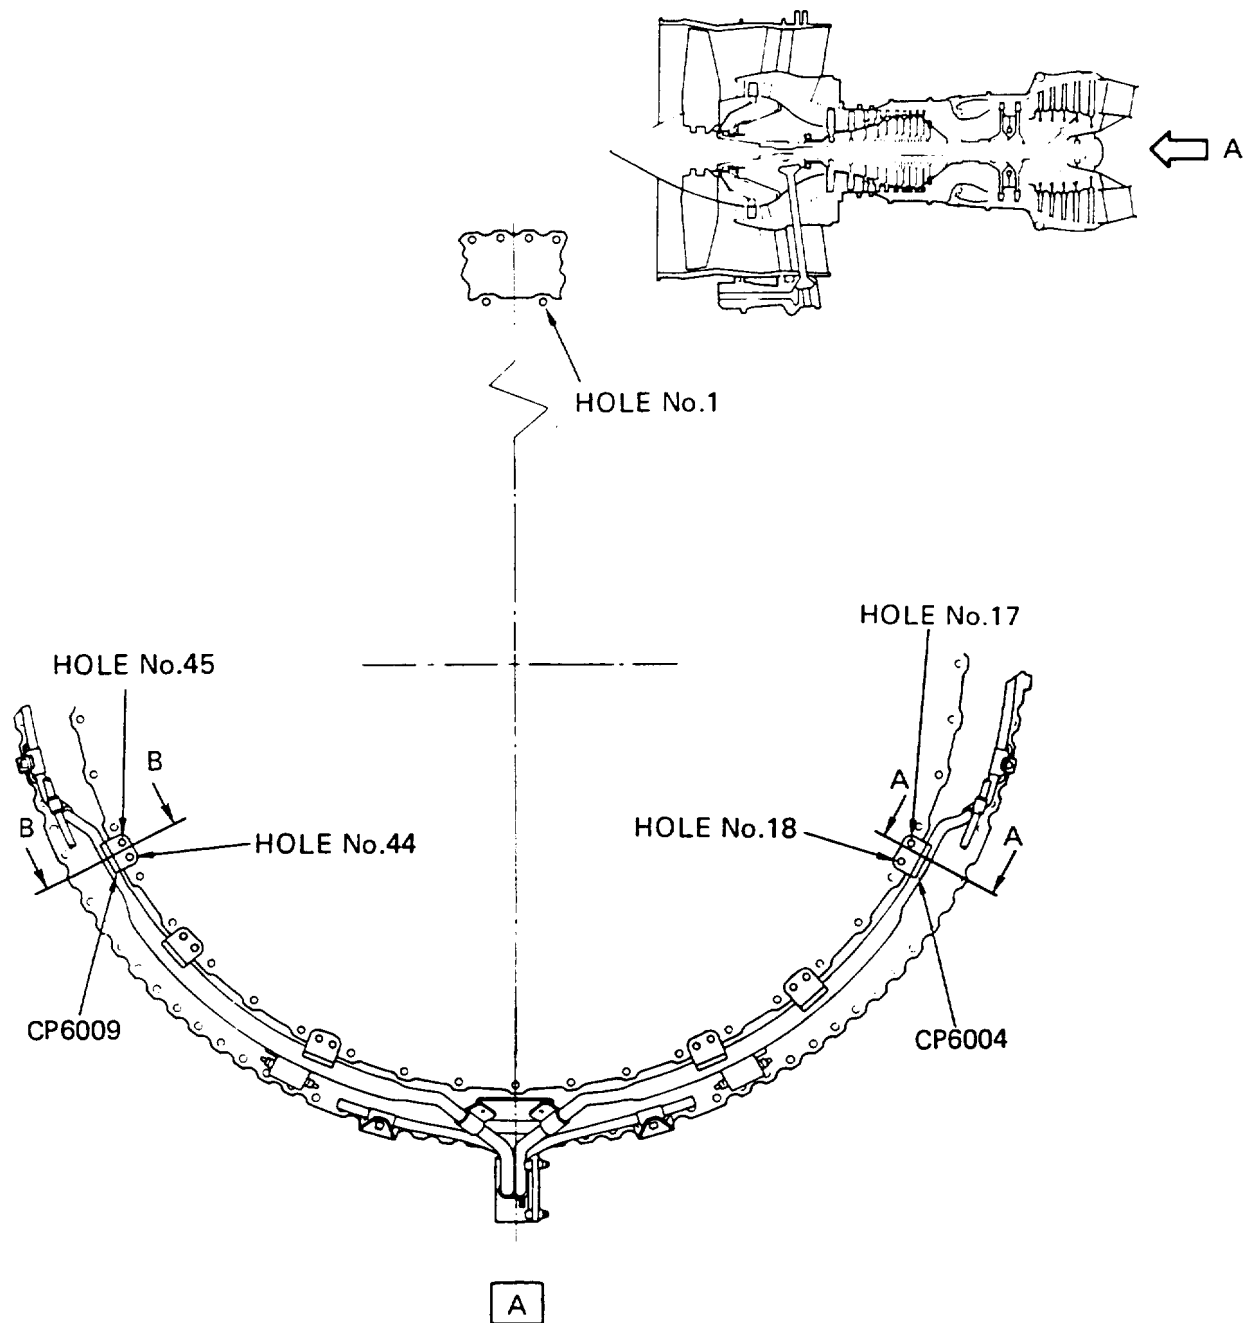
Exhaust gas temperature (EGT) Harness clipping point locations  
Fig.1 (Sheet 1 of 2)

The clearance between the Exhaust Gas Thermocouple (EGT) Harness and the adjacent Stiffening Rib on the Turbine Exhaust Case may not be sufficient at the Clipping Points CP6004 and CP6009 located on Flange FT.

- (i) Lubricate the threads of the 4W0001 Nut (1 off) with CoMat 10-039 engine oil. Refer to Figure 1.
    - (ii) Install a new 347493 Washer (1 off) on the Bracket Assembly Bolt.

- (iii) Connect the EGT Harness Clip to the Bracket Assembly and Washer.
    - (iv) Install the 4W0001 Nut and tighten it with your hand.
  - (b) Install the EGT Harness Clip to the Bracket at Clipping Point CP6009 (No.44 and 45 hole locations located on Flange FT) as follows:

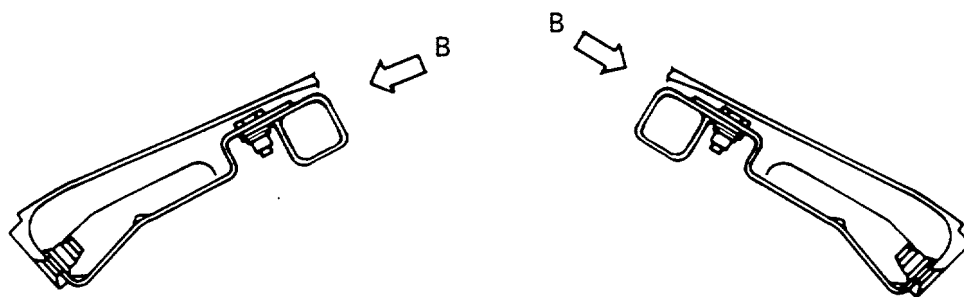
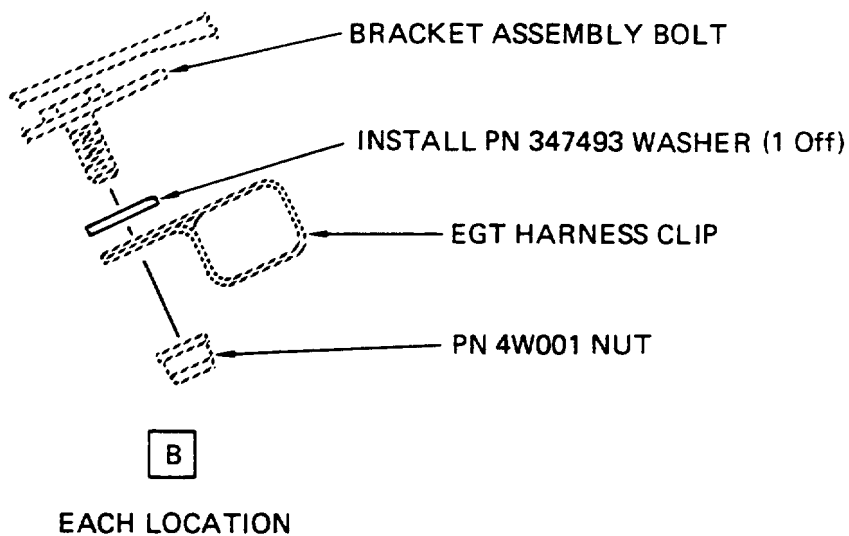
Exhaust gas temperature (EGT) harness clipping point locations  
Fig.1 (Sheet 2 of 2)

SECTION A-A  
CLIPPING POINT CP6004

SECTION B-B  
CLIPPING POINT CP6009

- (i) Do step (a)(i) through (iv) again.
  - (c) Torque the nuts to 36 - 45 lbfin. (4,00 - 5,00 Nm). See Reference (2), Control No./TASK No.70-41-00-400-501.
