ENGINE INDICATING - ENGINE - INDICATING - PROVIDE PERMANENTLY ATTACHED WASHERS TO BRACKET AT CLIPPING POINTS CP6004 AND CP6009 - CATEGORY CODE 6 - MOD.ENG-77-0007

V2500-ENG-77-0007

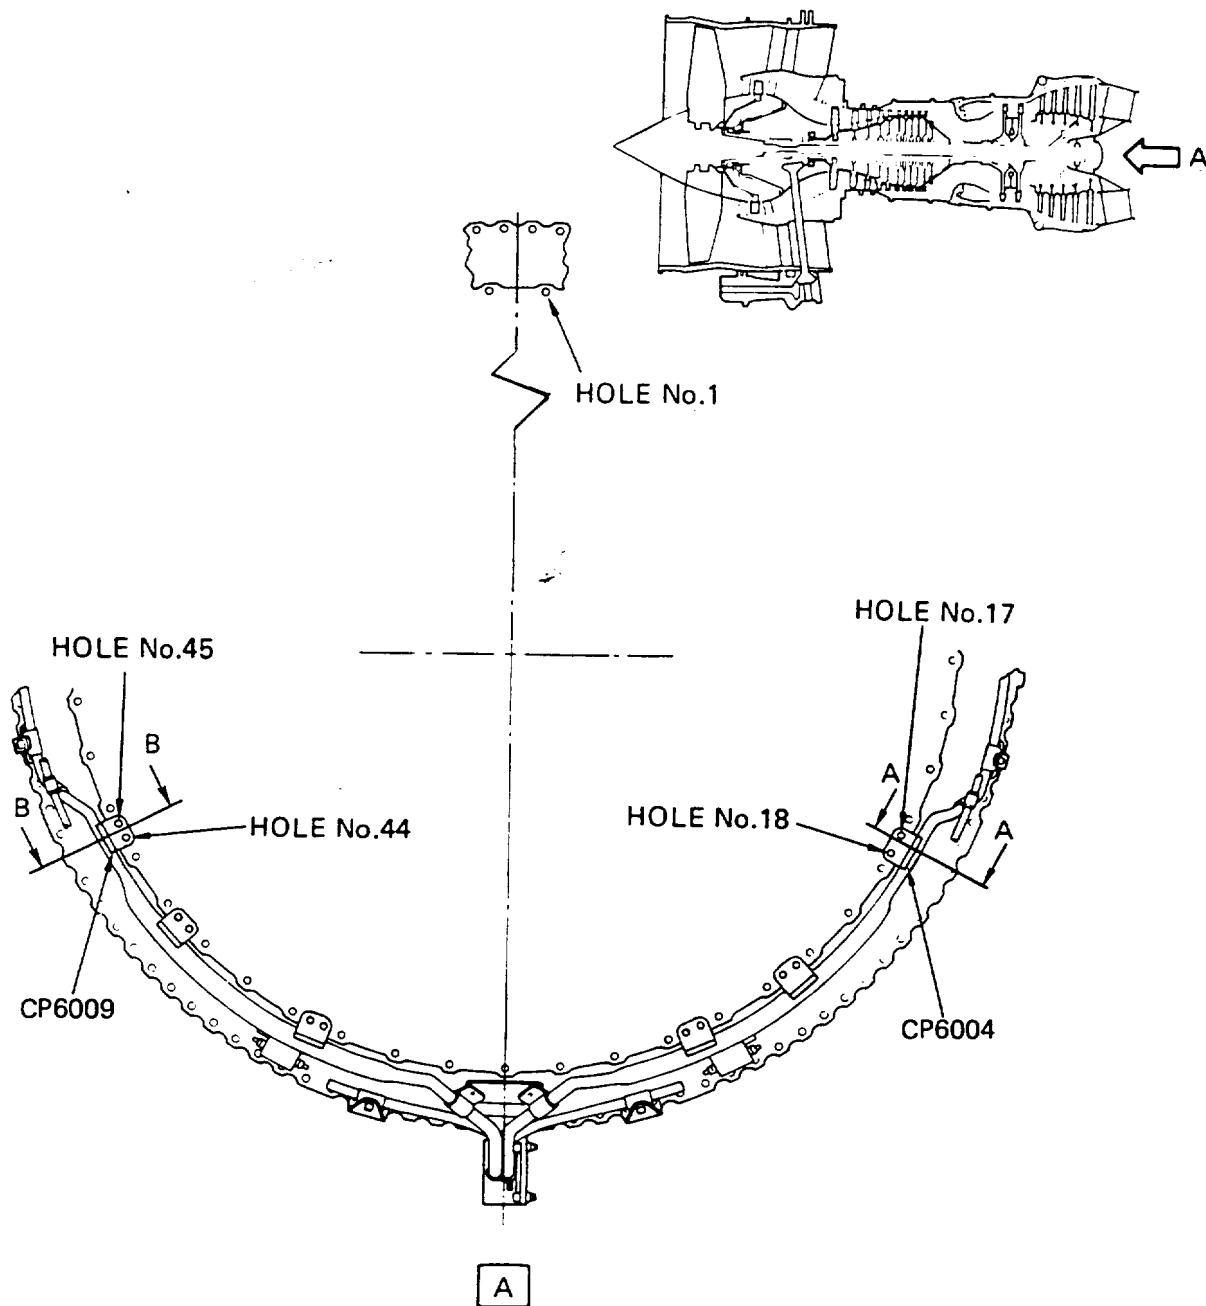
Location of Loop Clamp Bracket Assemblies
Fig.1 (Sheet 1 of 2)

There may be insufficient clearance on some installations between the Exhaust Gas Temperature (EGT) Harness and the adjacent stiffening rib on the Turbine Exhaust Case (TEC). The condition occurs due to the misassembly of loose Washers. Loose Washers can be installed on the wrong side of the Loop Clamp Brackets.

- (2) Install the 2A1763-01 Loop Clamp Bracket Assemblies (2 off) at clipping points CP6004 and CP6009 on Flange "FT" and connect the EGT Harness as follows:

- (a) Lubricate the threads of the 4W2386 Screws (4 off) and 4W0002 Nuts (4 off) with CoMat 10-039 Engine Oil.
 - (b) Put one of the Loop Clamp Bracket Assemblies (2 off) at the No's.17 and 18 hole locations on Flange "FT", clipping point CP6004. Refer to Figure 1.

- (c) Install two of the 4W2386 Screws and the 4W0002 Nuts and tighten them with your hand.
 - (d) Do steps (2)(b) and (c) again at the location of the hole No's.44 and 45 on Flange "FT", clipping point VCP6009. Refer to Figure 1.

- (f) Lubricate the threads of the 4W0001 Nuts (2 off) with CoMat 10-039 Engine Oil.
 - (g) Connect the Loop Clamp to the Loop Clamp Bracket Assembly at hole location No.17 and 18 on Flange "FT", clipping point CP6004. Refer to Figure 1.

- (h) Install one of the 4W0001 Nuts and tighten it with your hand.
 - (i) Do steps (2)(g) and (h) again and install one Loop Clamp at the location of hole No's.44 and 45 on Flange "FT", clipping point CP6009. Refer to Figure 1.
