DATE ~~R~~ Jul.15/02**V2500-A1/A5 PROPULSION SYSTEMS SERVICE BULLETIN**

This document transmits Revision 2 to Service Bulletin EV2500-77-0009 and
 Revision 2 to the Supplement

ENGINE – PROVIDE NEW EGT HARNESS JUNCTION BOX TERMINAL NUTS

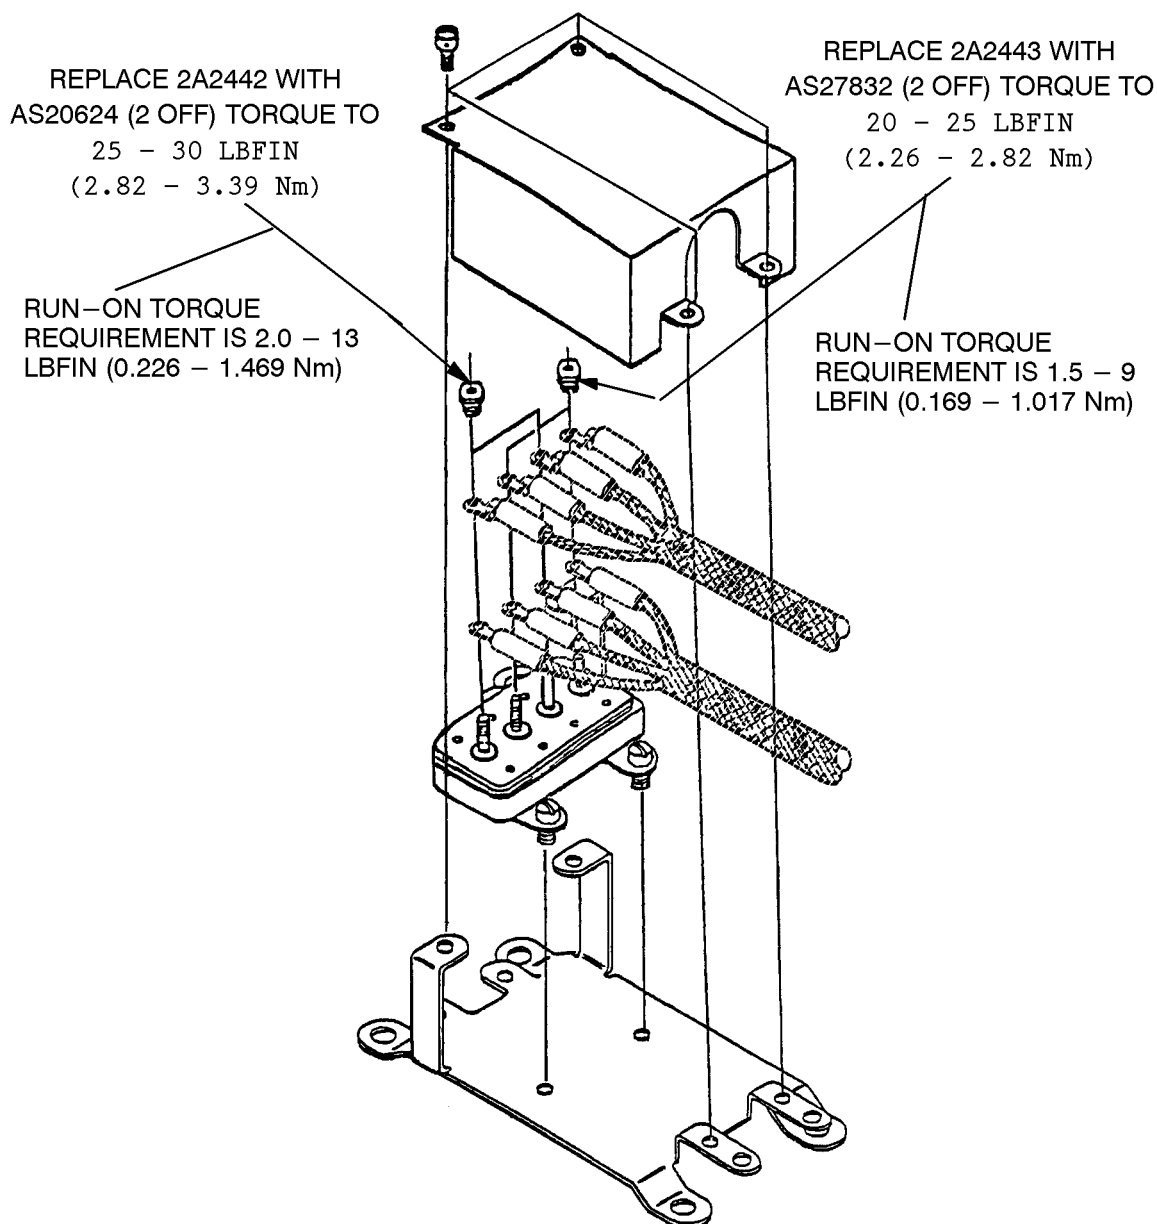
E8434

Exhaust Gas Temperature (EGT) display fluctuations and loss of EGT display events in service have been correlated with the loosening of the EGT harness junction box terminal nuts.

The current EGT junction box harness connection nuts on the V2500 use a spring type locking feature. This type of nut has very specific torque requirements and is also subject to incorrect installation. Service experience has also shown that nuts may become loose over time.

Engine - Indicating EGT harness and junction box
Fig 1

- (i) Install 2 larger thread (0.190-32) diameter nuts, PN AS20624 onto the larger thread diameter terminal studs. See Figure 1.
- (ii) Install 2 smaller thread (0.164-32) diameter nuts, PN AS27832 onto the smaller thread diameter terminal studs. See Figure 1.
- (iii) Perform a Run-On Torque Test as follows:
 - (1) Use a torque wrench with a resolution of 1 lbfin (0.113 Nm) or smaller.
 - (2) Run the nut onto the stud until finger tight so that the locking thread is in contact with the stud thread.
 - A Minimum Run-On torque for the smaller thread (0.164-32) diameter nut shall be 1.5 lbfin (0.169 Nm).
 - B Maximum Run-On torque for the smaller thread (0.164-32) diameter nut shall be 9 lbfin (1.017 Nm).

(iv) Torque the larger thread (0.190-32) diameter Nut to 25 - 30 lbfin (2.82 - 3.39 Nm).

(v) Torque the smaller thread (0.164-32) diameter Nut to 20 - 25 lbfin (2.26 - 2.82 Nm).

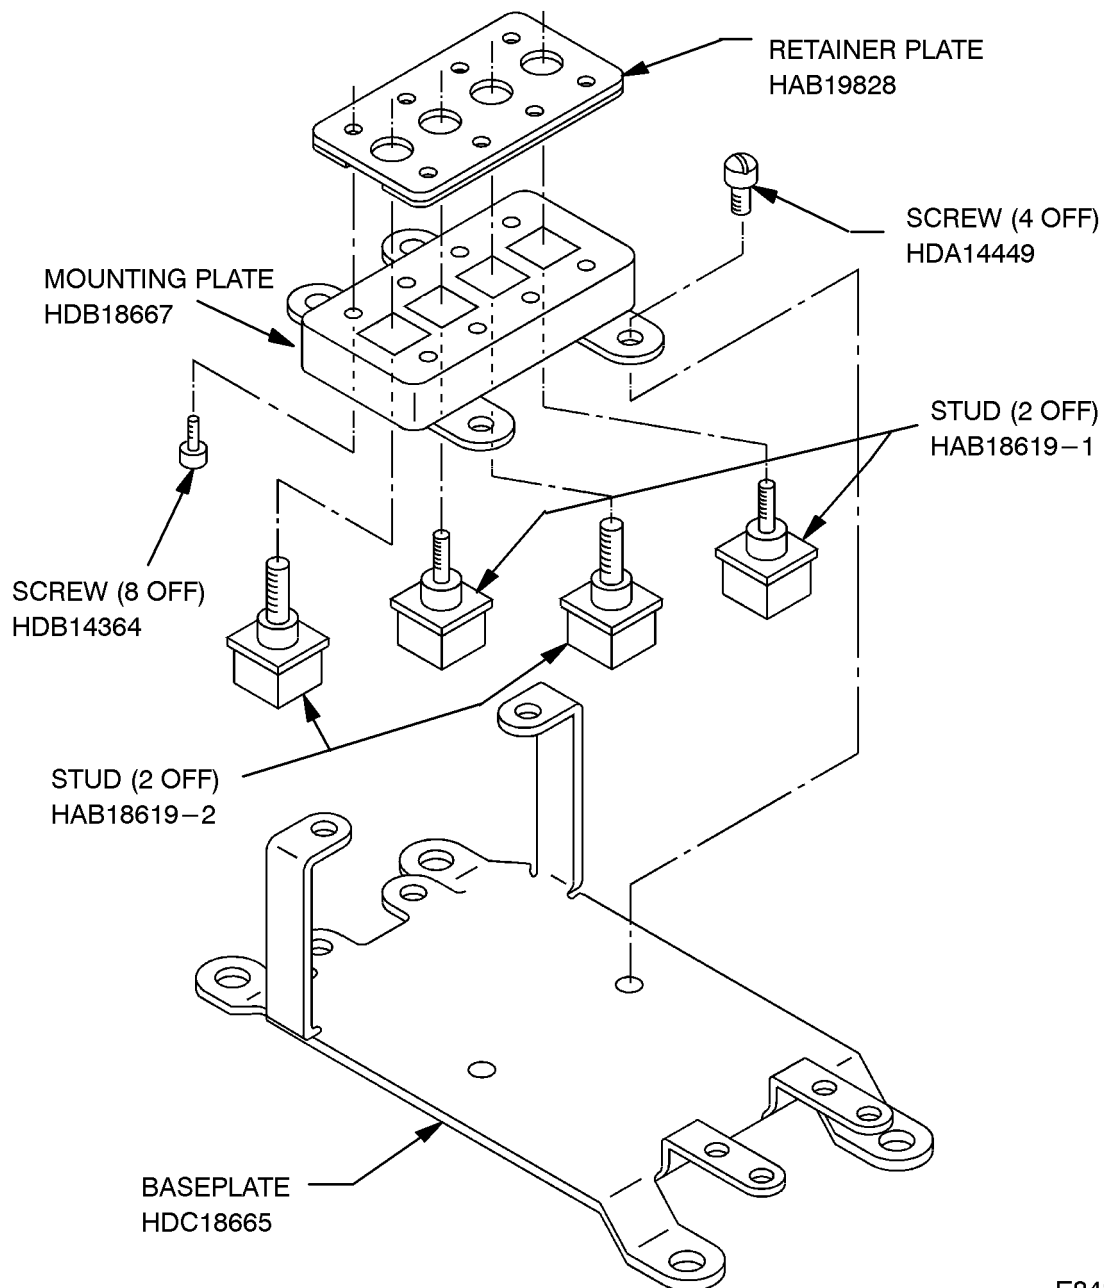
E8435

Harness and junction box stud replacement
Fig 2

(i) Remove the safety wire and four Screws PN HAD14449. See Figure 2.

(ii) Remove Mounting Plate PN HDB18667. See Figure 2.

(iii) Remove the safety wire and eight Screws PN HDB14364, and disconnect the Retainer Plate PN HAB19828 from the Mounting Plate PN HDB18667. See Figure 2.

(iv) Identify terminal positions for Studs PN HAB18619-1 or PN HAB18619-2 with labels, and remove the Stud PN HAB18619-1 or PN HAB18619-2 from the Mounting Plate. See Figure 2. Dispose of the removed Studs in an approved method.

(v) Install new Studs PN HAB18619-1 and/or PN HAB18619-2 in the Mounting Plate PN HDB18667. See Figure 2.

(vi) Install the Retainer Plate PN HAB19828 over the new Studs on to the Mounting Plate PN HDB18667. Line up the Screw holes on the Retainer Plate with those on the Mounting Plate and attach the Retainer Plate to the Mounting Plate with the eight Screws PN HDB14364. See Figure 2. Safety wire all screws.

(vii) Attach the Mounting Plate PN HDB18667 to the Base Plate PN HDC18665) with the four Screws PN HDA14449. See Figure 2. Safety wire all screws.
