V2500 Series 77-0012

SERVICE BULLETIN

ENGINE INDICATING — HARNESS AND JUNCTION BOX ASSEMBLY, EXHAUST
GAS TEMPERATURE (EGT) — INTRODUCTION OF

V2500-ENG-77-0012

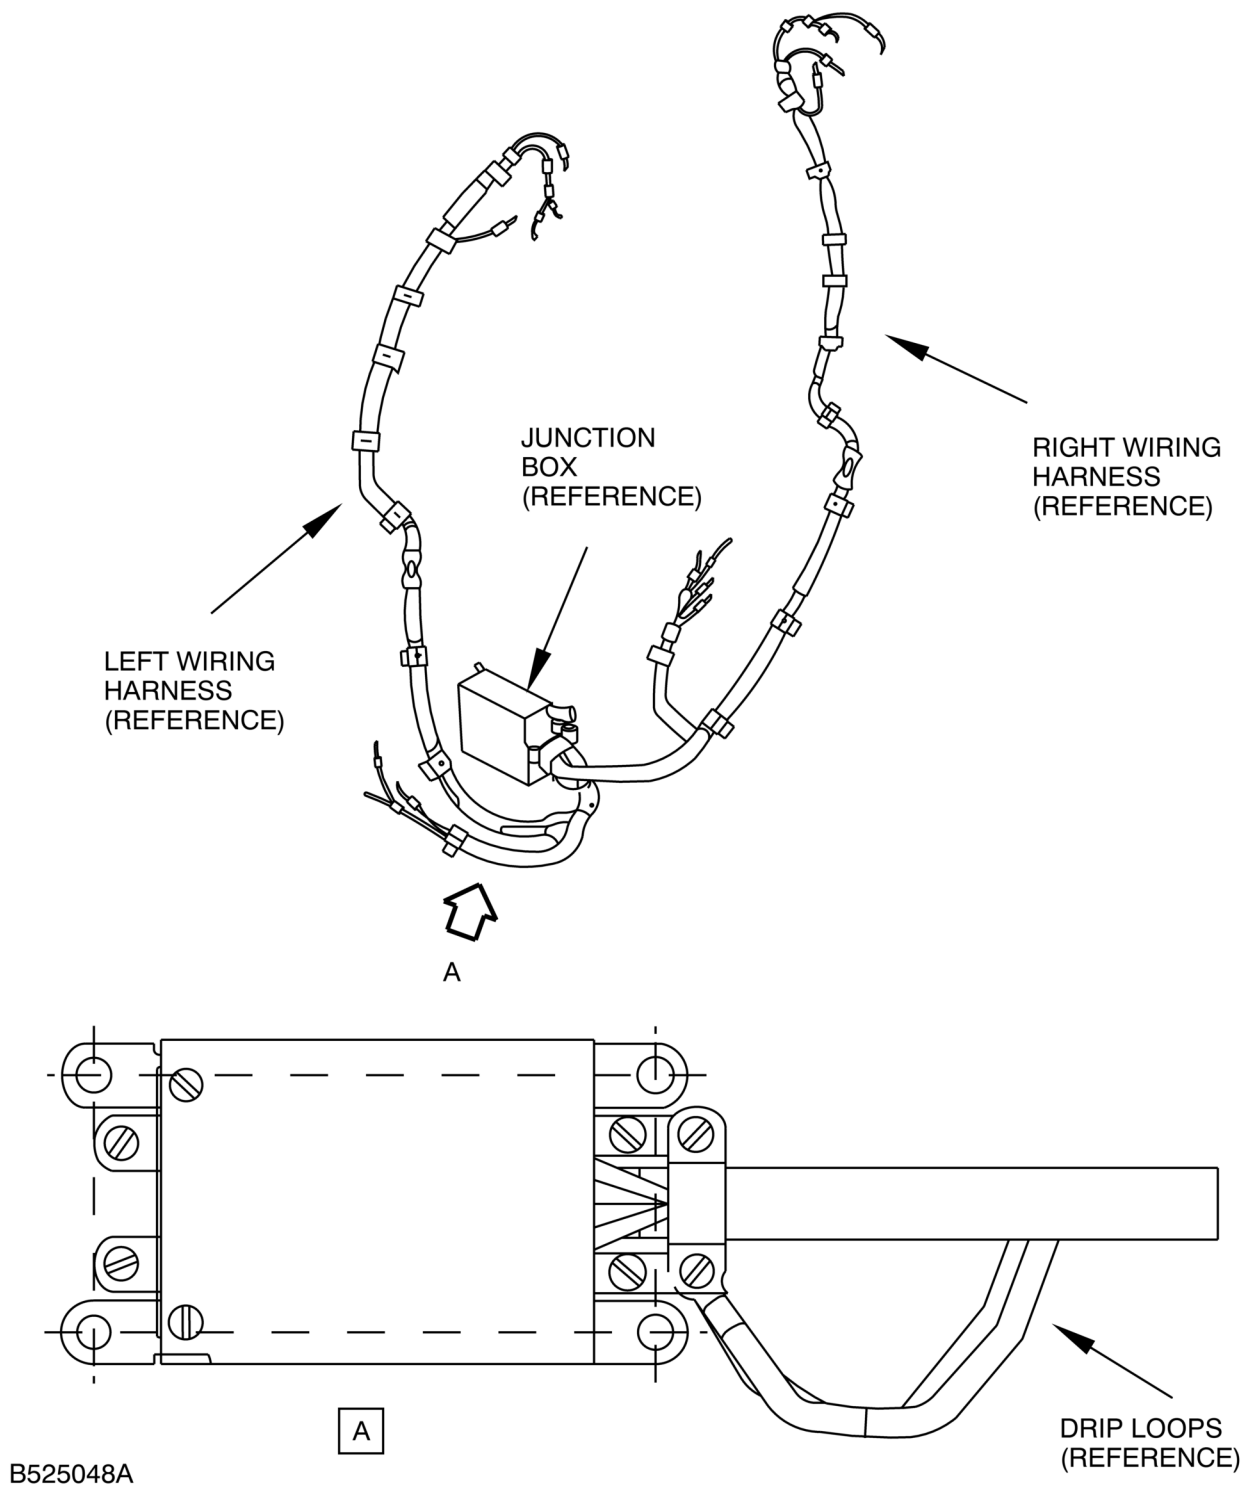
77-21-43
FIGURE 1

To correct left and right designation within Figure 1.

NOTE: The new EGT Harness has an additional feature called 'drip loops'. See Figure 1.

LOCATION OF THE EGT HARNESS AND JUNCTION BOX ASSEMBLY

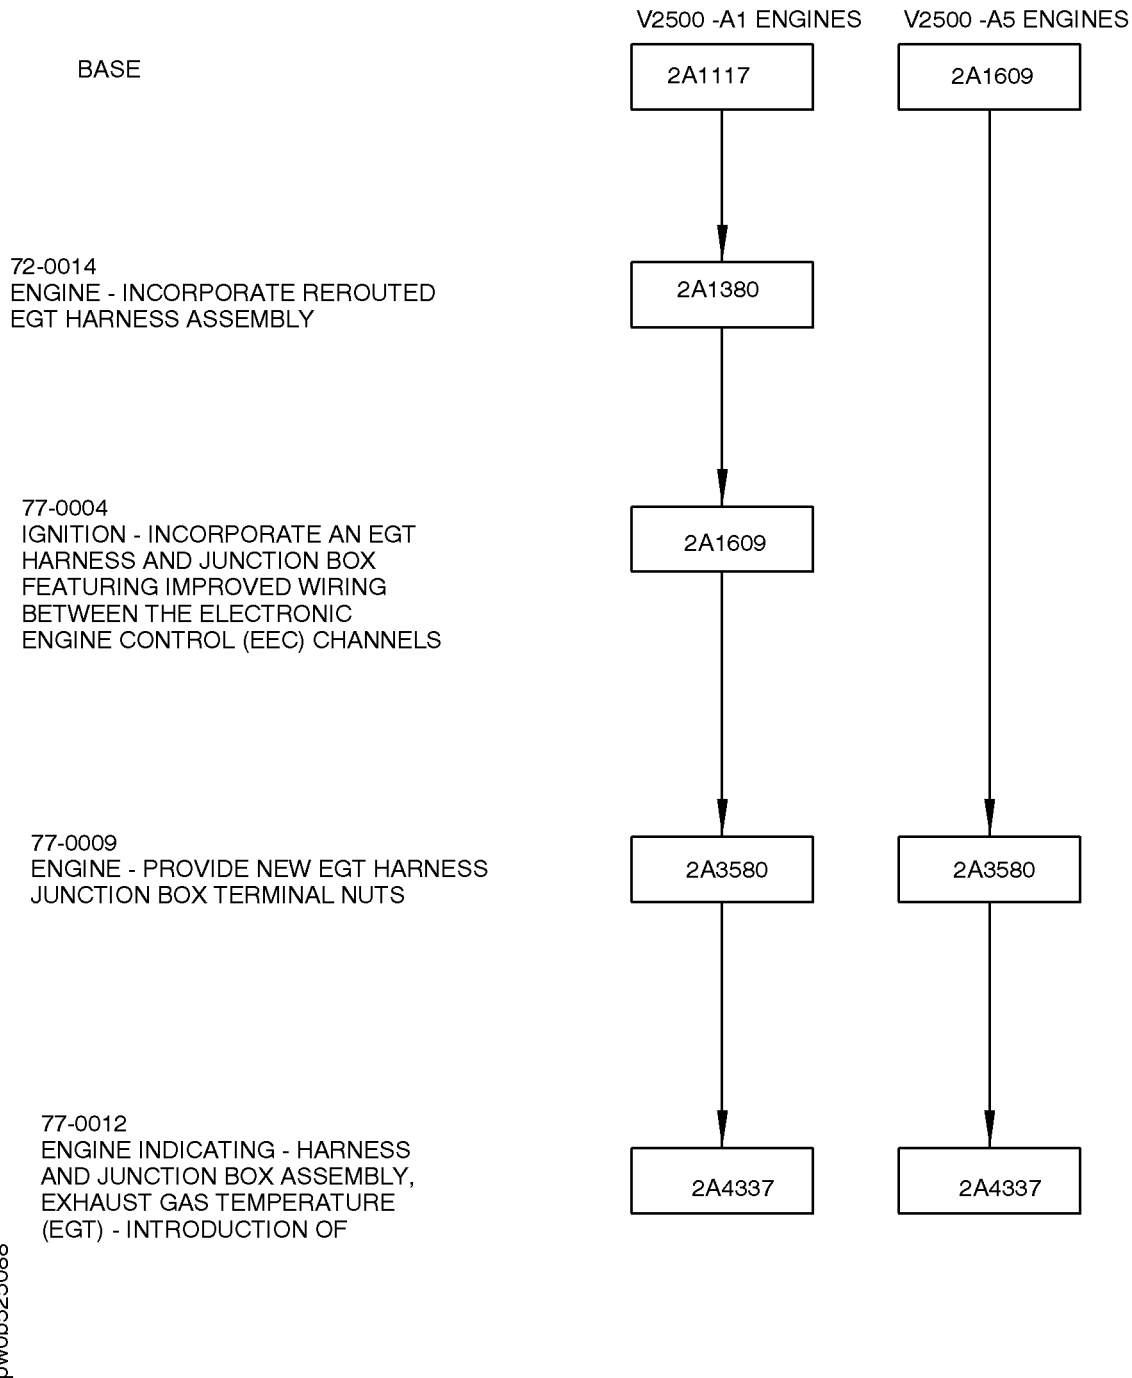
EGT HARNESS AND JUNCTION BOX ASSEMBLY
CHART A

Parts Progression To Show the Changed Part in Relation to Other Parts
