SERVICE BULLETIN

OIL - INCORPORATE REVISED NO.4 AND NO.5 BEARING OIL SCAVENGE TUBE ASSEMBLIES - CATEGORY CODE 3 - MOD.ENG-79-0001

(2) Engine: V2500-A1 Engine Serial No.s V0014, V0015, V0016 and V0017

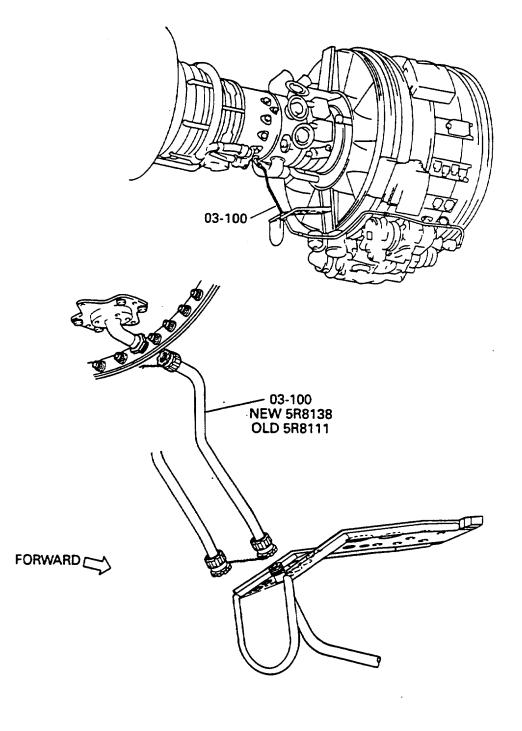
No.4 Scavenge Tube Fig.1

No.4 Scavenge Tube, Diffuser Case to Bifurcation Panel, is too short. This can cause unwanted load to No.4 Scavenge Tube, No.4 Bearing Compartment that may break the No.4 Scavenge Tube.

No.4 Scavenge Tube, No.4 Bearing Compartment has broken on the development engine. After investigation of the cause, it was found that unwanted load was applied to the above Scavenge Tube.

(1) No.4 Scavenge Tube is lengthened to fit properly.

- (2) Install PN 5R8138 No.4 Scavenge Tube (03-100, Figure 1
 - (a) Put a new No.4 Scavenge Tube in position on the engine.

(b) Torque nuts to 525 to 625 lbfin (59,32 to 70,61 Nm) and safety with CoMat O2-126 lockwire.
