OIL - REPLACE THE CLIPPING BRACKETS ON THE OIL TANK AT CP0787 AND CP0788 - CATEGORY
CODE 3 - MOD.ENG-79-0004

V2500-ENG-79-0004

Jul. 7/89

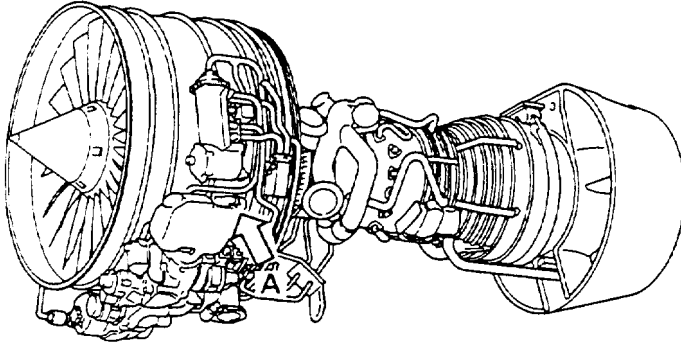
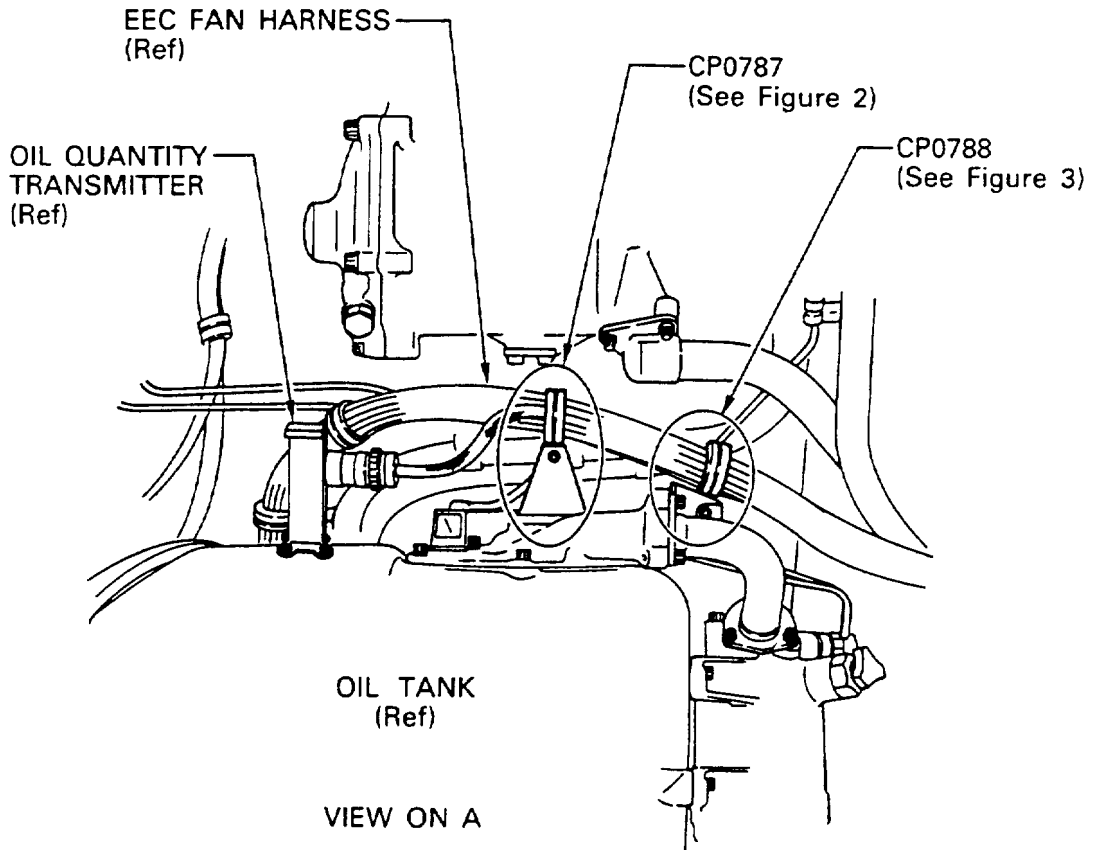
Chaffing of the EEC Fan Harness may occur because of the excessive vibration of the EEC Fan Harness, which is held by the Clipping Brackets at CP0787 and CP0788 where the EEC Fan Harness is routed close to the Oil Quantity Transmitter on the Oil Tank.

The cause for the problem is the insufficiency of rigidity of the Clipping Brackets, which permit the excessive movement of the Harness due to resonances.

Location of the clipping brackets at CP0787 and CP0788
Fig.1

To replace the Clipping Brackets with new gusset-reinforced Clipping Brackets to maintain engine reliability.

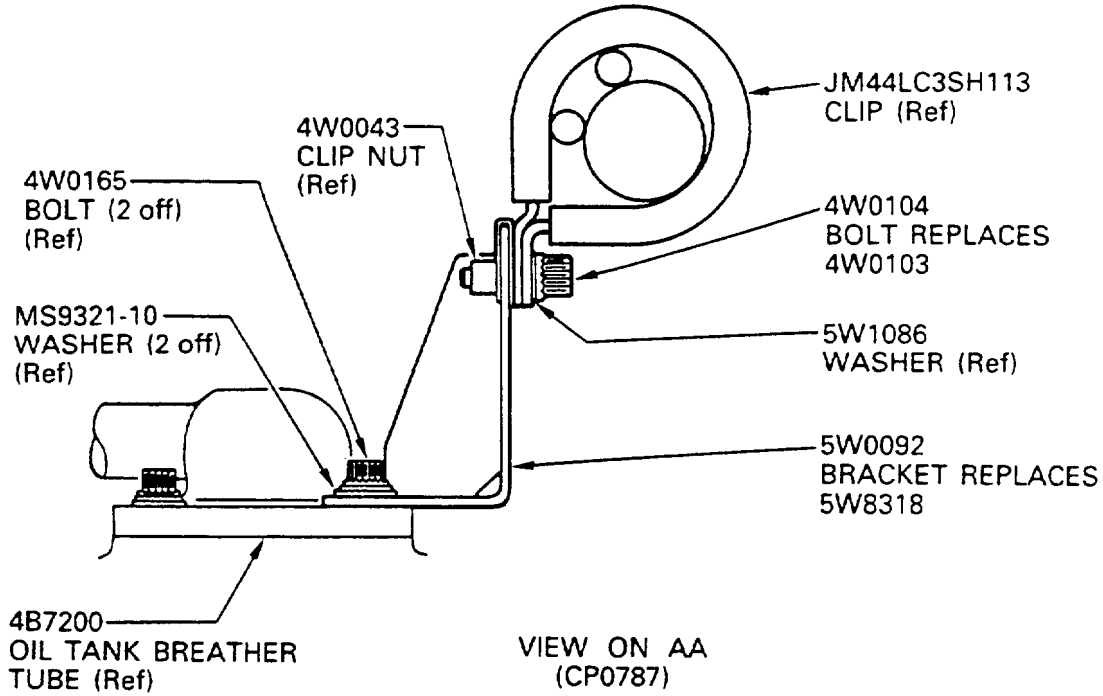
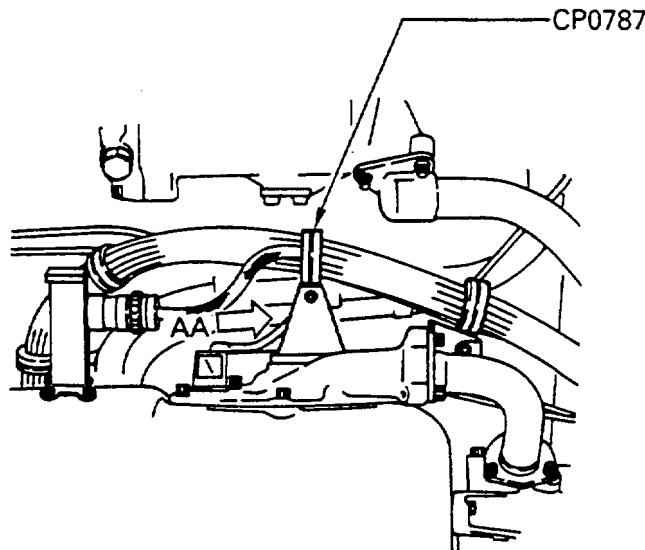
Replacement of the clipping brackets at CP0787
Fig.2

- (1) At CP0787, replace PN 5W8318, Clipping Bracket, on the Oil Tank Breather Tube, with new PN 5W0092, Clipping Bracket as follows: (See Figures 1 and 2).

- (a) Remove PN 4W0103, Bolt, and PN 5W1086, Washer, which attach PN JM44LC3SH113, Clip to PN 5W8318, Clipping Bracket.
 - (b) Remove two PN 4W0165, Bolts and PN MS9321-10, Washers which attach PN 5W8318, Clipping Bracket, to PN 4B7200, Oil Tank Breather Tube flange.

- (c) Remove 5W8318, Clipping Bracket, and remove PN 4W003, Clipnut.
 - (d) Attach new PN 5W0092, Clipping Bracket, to PN 4B7200, Oil Tank Breather Tube flange with two PN 4W0165, Bolts and PN MS9321-10, Washers. Torque the Bolts to 85 to 105 lbfin (10 to 12 Nm).

- (e) Attach PN 4W0043, Clipnut to PN 5W0092, Clipping Bracket.
 - (f) Attach PN JM44LC3SH113, Clip to PN5W0092, Clipping Bracket, with new PN 4W0104, Bolt and PN 5W1086, Washer. Torque the Bolt to 36 to 45 lbfin (4,00 to 5,00 Nm).

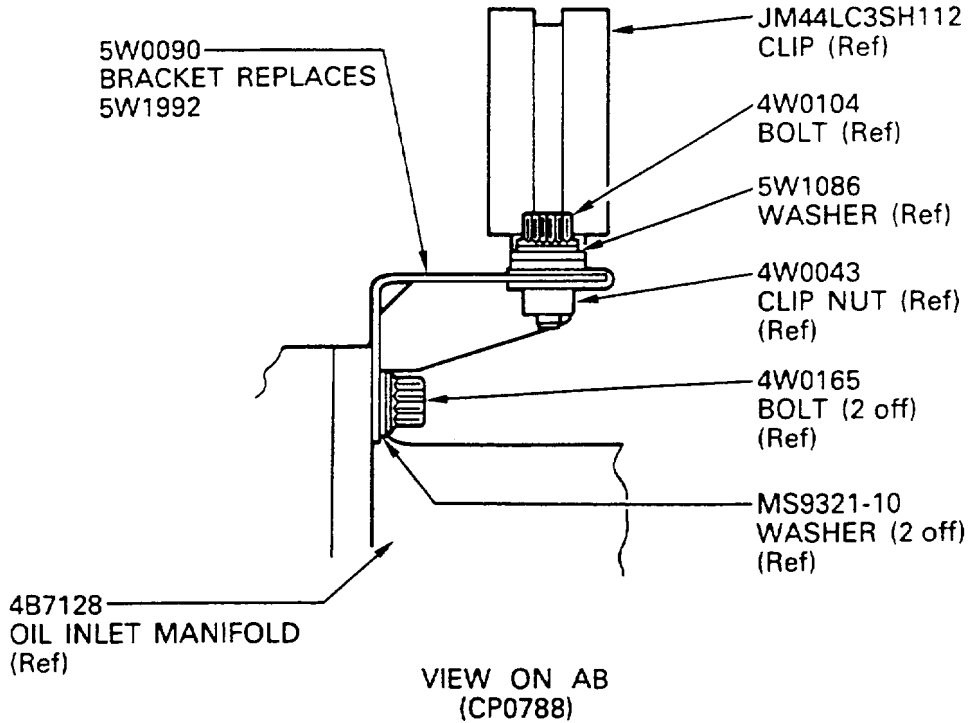
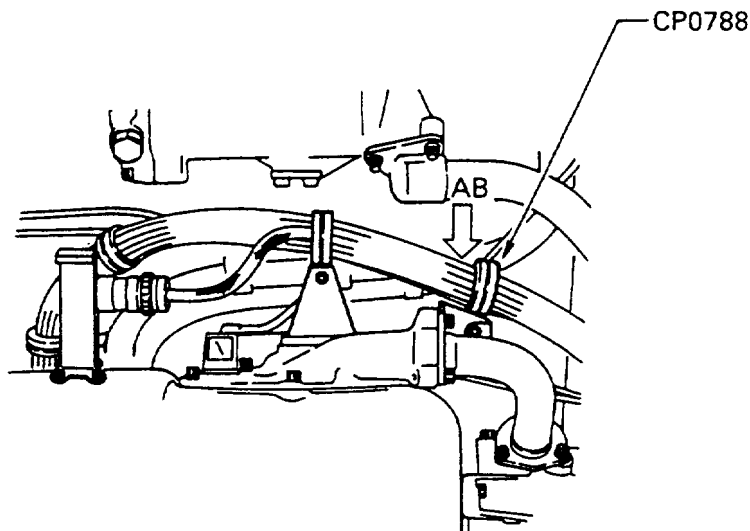
Replacement of the clipping bracket at CP0788
Fig.3

- (2) At CP0788, replace PN 5W1992, Clipping Bracket, on the Oil Inlet Manifold, with new PN 5W0090, Clipping Bracket as follows: (See Figures 1 and 3).

- (a) Remove PN 4W0104 Bolt, and PN 5W1086, Washer, which attach PN JM44LC3SH112, Clip to PN 5W1992, Clipping Bracket.
 - (b) Remove two PN 4W0165, Bolts and PN MS9321010, Washers which attach PN 5W1992, Clipping Bracket, to PN 4B7128, Oil Inlet Manifold flange.

- (c) Remove PN 5W1992, Clipping Bracket and remove PN 4W0043, Clipnut.
 - (d) Attach new PN 5W0090, Clipping Bracket, to PN 4B7128, Oil Inlet Manifold flange with two PN 4W0165, Bolts and PN MS9321-10, Washers. Torque the Bolts to 85 to 105 lbfin (10 to 12 Nm).

(e) Attach PN 4W0043, Clipnut to PN 5W0090, Clipping Bracket.

(f) Attach PN JM44LC3SH112, Clip to PN 5W0090, Clipping Bracket, with PN 4W0104, Bolt and PN 5W1086, Washer. Torque the Bolt to 36 to 45 lbf·in (4,00 to 5,00 Nm).
