OIL - OIL REPLACE THE CLIPPING BRACKET ON THE AIR COOLED OIL COOLER AT CP0533 -
CATEGORY CODE 3 - MOD.ENG-79-0005

- (1) Aircraft: Airbus A320
- (2) Engine: V2500-A1 Engines, Serial No.'s V0014 through V0039

V2500-ENG-79-0005

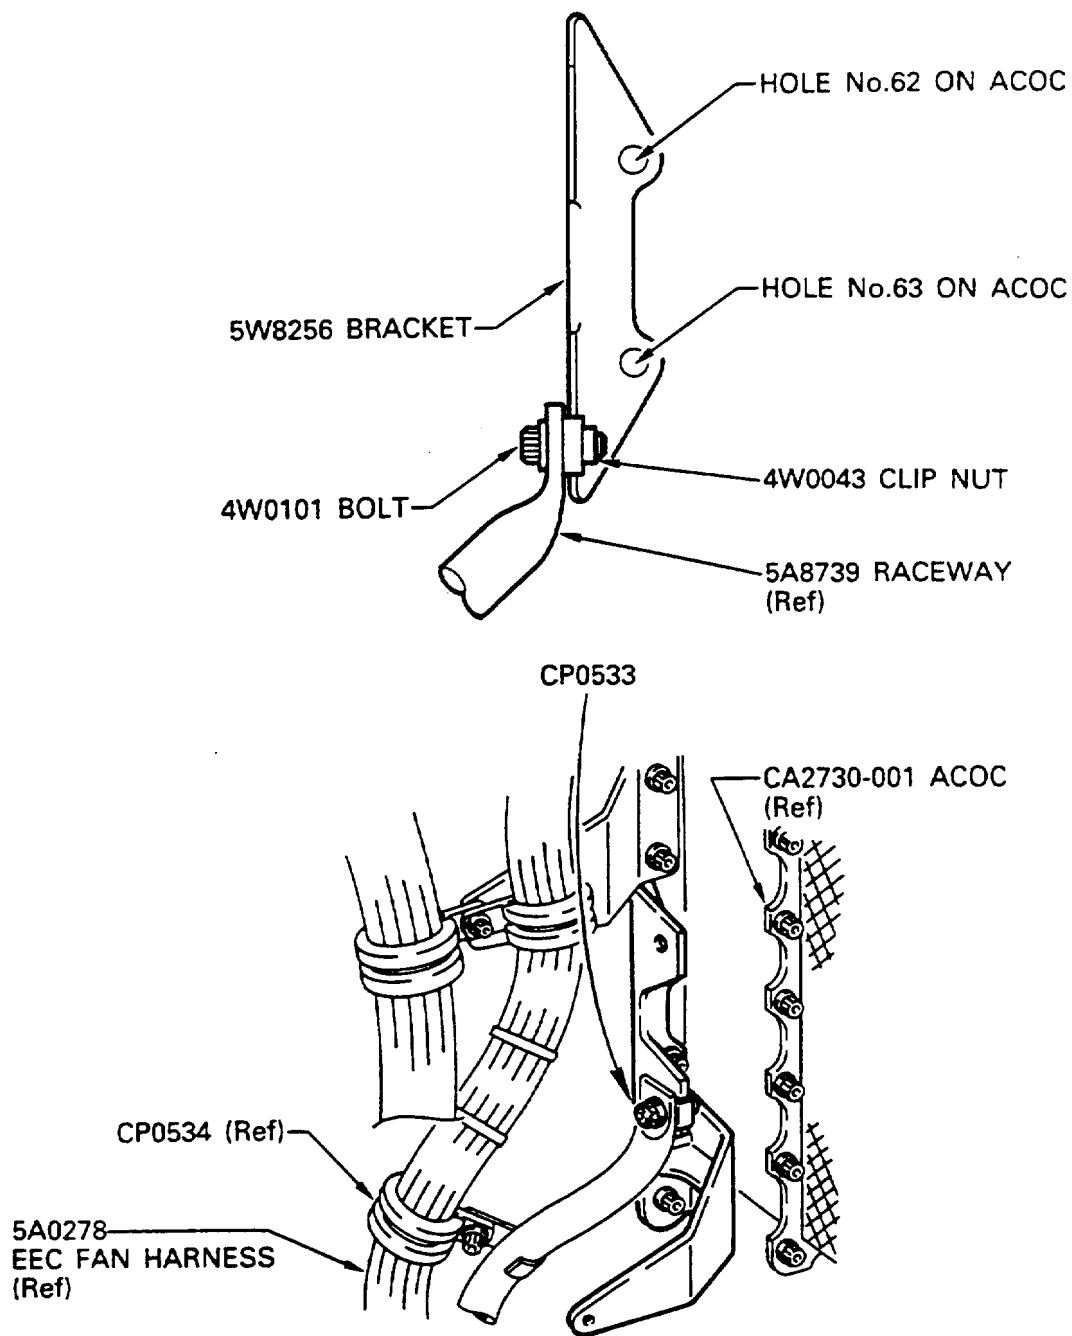
View on clipping bracket on the ACOC at CP0533 - Before alteration
Fig.2

Unacceptable vibration of the EEC Fan Harness and bend/twisting of the Raceway Lug may occur because of a resonance of the Clipping Bracket which holds the Harness at CP0534 through the Raceway attached to the Clipping Bracket on the Air Cooled Oil Cooler (ACOC) at CP0533.

The primary cause of the condition is considered that design of the Clipping Bracket does not adequately to prevent the resonance.

This condition has been noted during the shake test on a development engine. The unacceptable vibration occurred on the Harness at 60 Hz and the high lug stress on the Raceway at CP-533 was also observed.

(4) Remove PN 5W8256, Bracket from PN CA2730-001, ACOC (Ref.).	Refer to Figure 2.
(5) Remove PN 4W0043, Nut from PN 5W8256, Bracket.	Refer to Figure 2.
(6) Install PN 4W0043, Nut to New PN 5W0091, Bracket.	Refer to Figure 3.

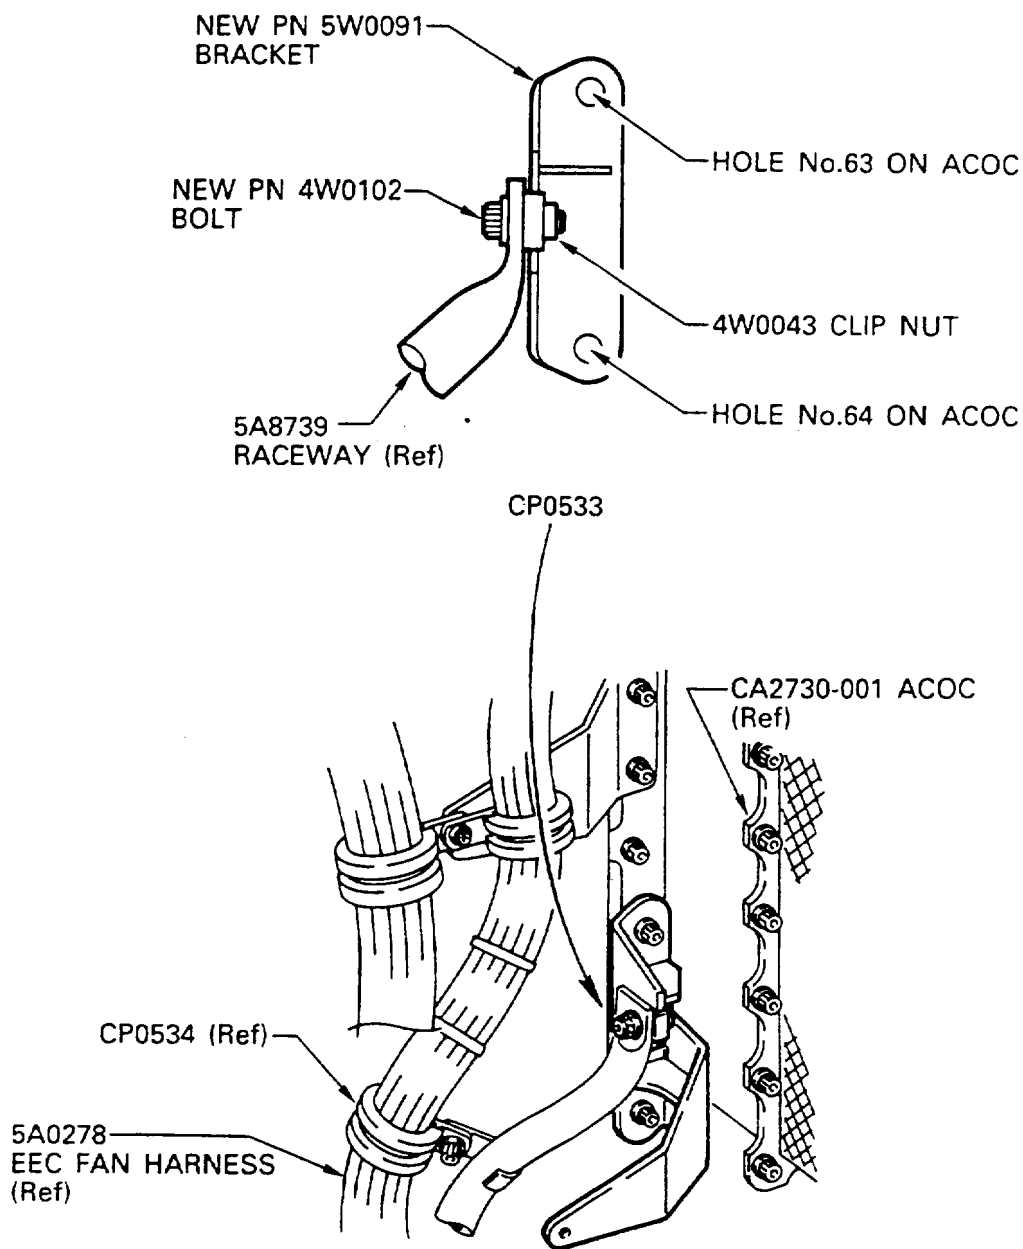
View on clipping bracket on the ACOC at CP0533 - After alteration
Fig.3

- (a) A gusset is welded to new Clipping Bracket, of which stock thickness is also changed from 0.047in. (1,2 mm) to 0.063in. (1,6 mm) to clear the resonance.
- (b) The new Clipping Bracket is relocated downward by one hole of the ACOC attaching bolt holes.
- (c) At CP0533, the Clip Bolt is changed to use a new longer Bolt to accomodate with the new thickner Bracket.
- (d) Figure/Item Number of new Bracket is changed from 79-21-42 01-086 to 79-21-42 01-070.

(7) Install New PN 5W0091, Bracket to PN CA2730-001, ACOC (Ref.) at the Hole No.'s 63 and 64.	Refer to Figure 3.
(8) Install PN AN960C416, Washers (3 off) and PN 4W0169, Bolts (3 off) to PN CA2730-001, ACOC (Ref.) at the Hole No.'s 62, 63 and 64.	Refer to Figure 1.

- (9) At CP0533, install New PN 4W0102, Bolt which attaches PN 5A8739, Raceway (Ref.) to New PN 5W0091, Bracket.

- (11) Tighten New PN 4W0102, Bolt to a torque of 36 - 45 lbfin (4,00 - 5,00 Nm) at CP0533.
