SERVICE BULLETIN

OIL - REWORK THE ACOC INLET DUCT ASSEMBLY BY INCORPORATING DRAIN HOLES TO PREVENT FLUID ENTRAPMENT - CATEGORY CODE 5 - MOD.ENG-79-0010

V2500-ENG-79-0010

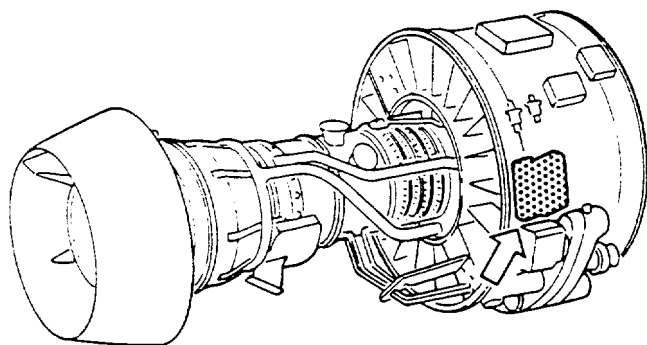
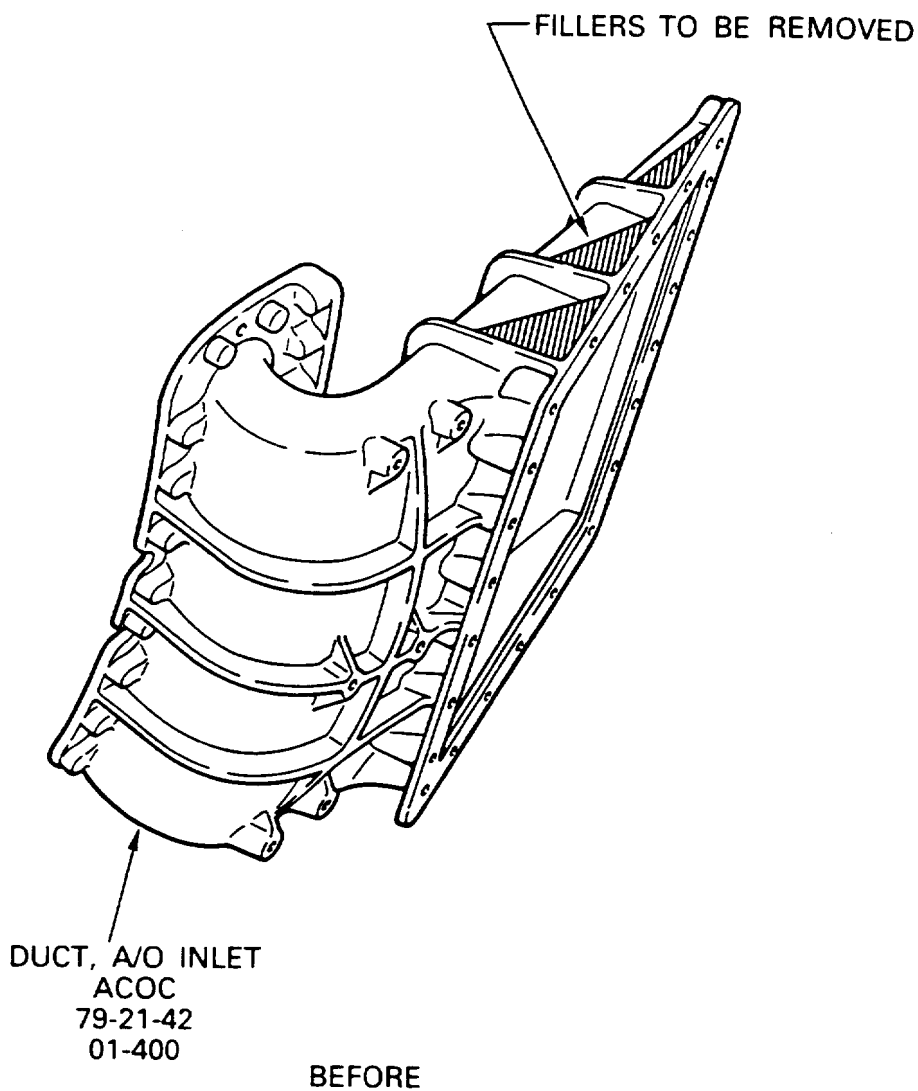
Before and After views of configuration changes
Fig.1 (Sheet 1 of 2)

The filters are removed and the drain holes are incorporated to prevent possible fluid traps on the top of the Duct, A/O Inlet ACOC. (See Figure 1).

Procedure	Supplementary Information
(a) Attach the masking tape to prevent surface damage around the filters.	Use CoMat 02-002 Masking Tape. See Figure 1, Sheet 1 of 2.

(b) Remove the filters carefully not to damage the surface of duct.	Use suitable chisel and cutter, RB012 Files, rotary or equivalent.
(c) Clean the surface that the fillers were removed.	Use suitable vacuum cleaner.
