OIL - REVISE NO.5 BEARING OIL SCAVENGE TUBE ASSEMBLY ATTACHING PARTS - CATEGORY CODE 6
- MOD.ENG-79-0011

V2500-ENG-79-0011

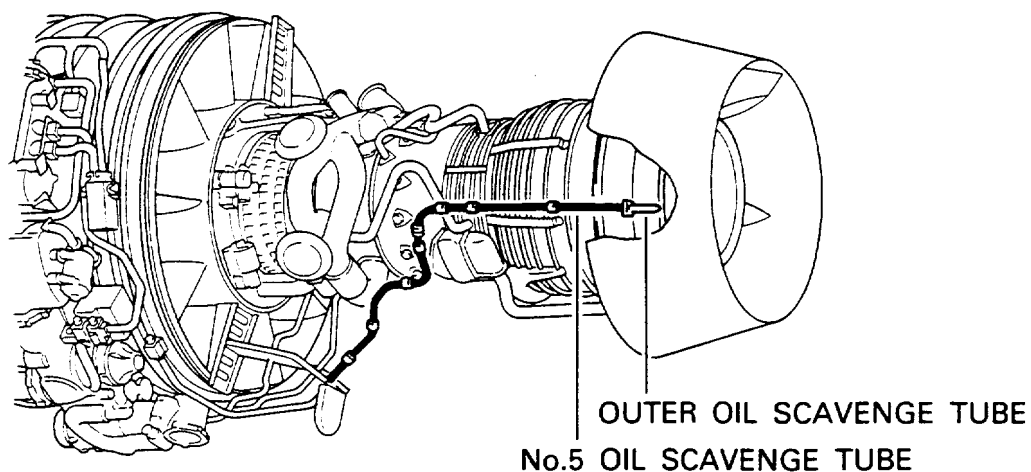
No.5 oil scavenge tube
Fig.1

No.5 OIL SCAVENGE TUBE
79-22-49
01-100

OUTER OIL SCAVENGE TUBE
72-50-53
01-480

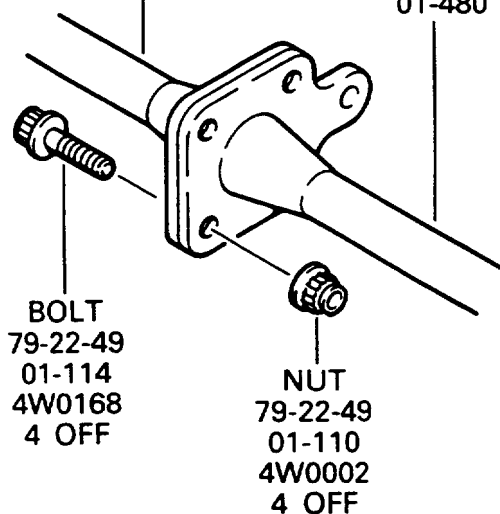
BEFORE SB

Insufficient clearance may exist when tightening No.5 scavenge tube nuts.

Difficulties have occurred when tightening nuts in the existing configuration.

(1) Remove Nuts and Bolts which connect No.5 Oil Scavenge Tube (79-22-49, 01-100) and Outer Oil Scavenge Tube (72-50-53, 01-480), Figure 1.

(a) Remove 4W0002 Nuts (4 off).

(b) Remove 4W0168 Bolts (4 off).

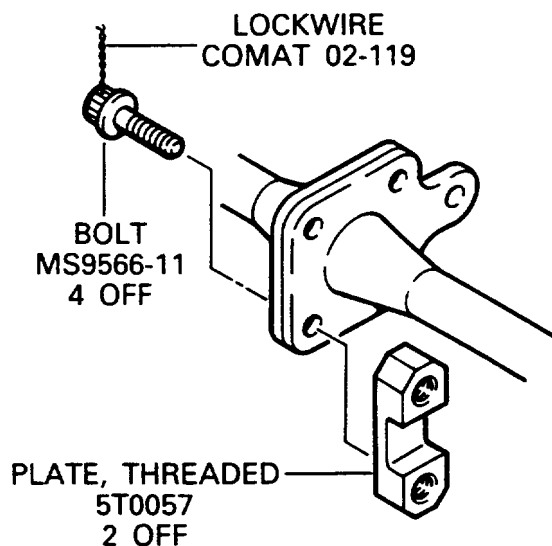
AFTER SB

- (1) Four nuts are replaced with two threaded plates.

(1) Install Threaded Plates and Bolts, Figure 1

(a) Install 5T0057 Threaded Plates (2 off) and MS9566-11 Bolts (4 off).
Torque Bolts to 75 to 85 lbfin (8,47 to 9,60 Nm).

(b) Safety with CoMat 02-110 lockwire.
