OIL - INCORPORATE NEW NO.5 BEARING OIL FEED TUBE SUPPORT BRACKET ATTACHING BOLTS -
CATEGORY CODE 4 - MOD.ENG-79-0012

V2500-ENG-79-0012

SERVICE BULLETIN

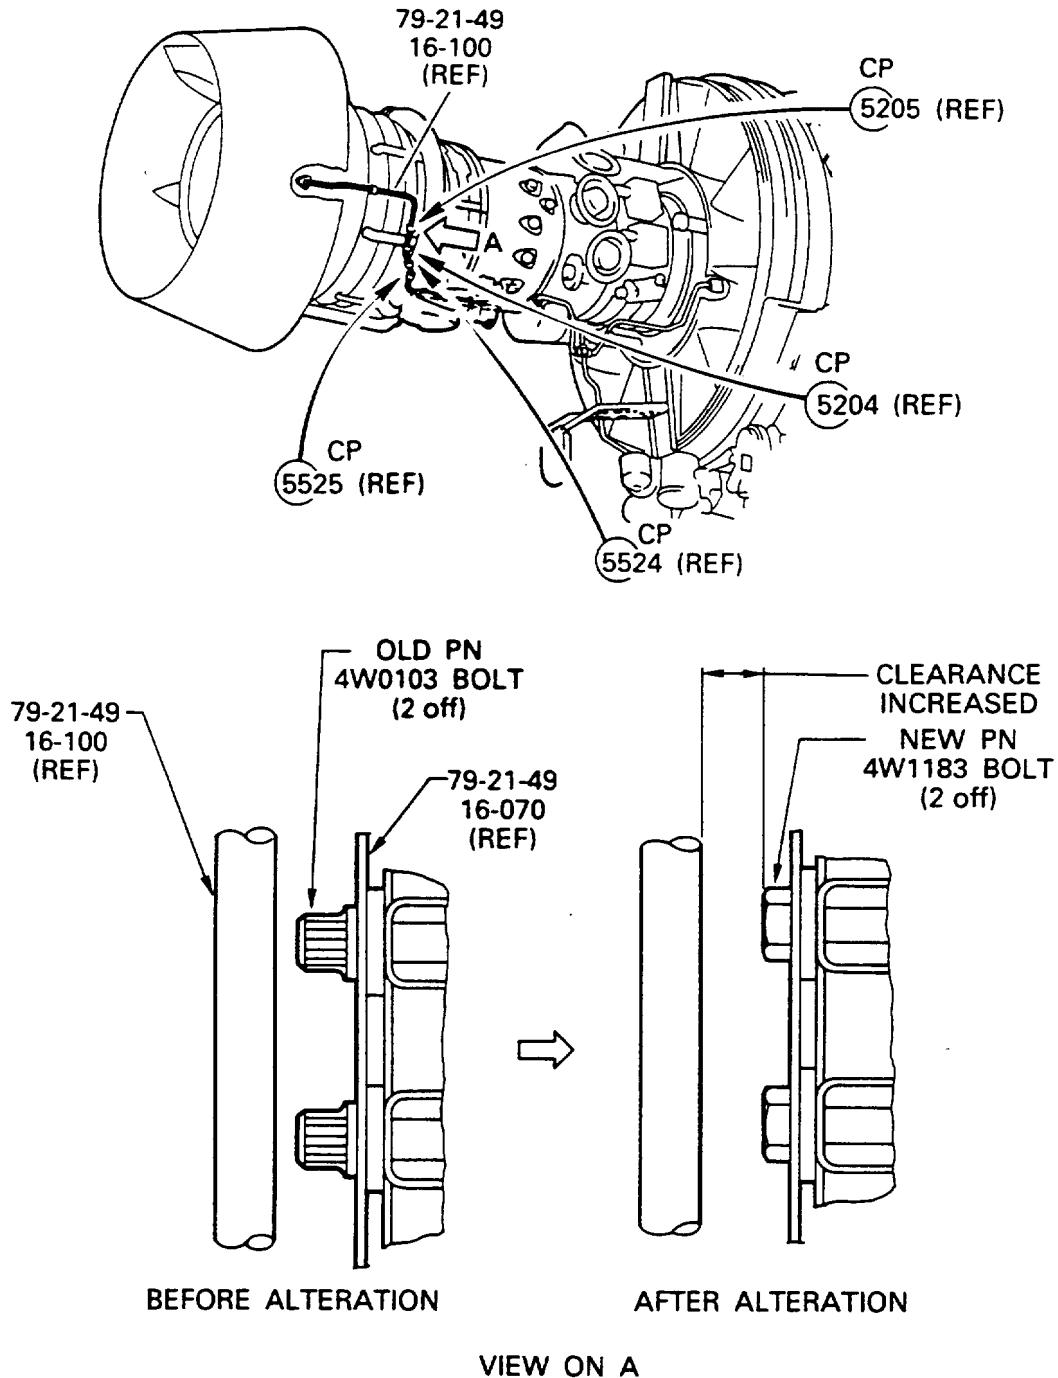
Replacement of attaching bolts
Fig.1

Insufficient clearance may exist between the No.5 bearing oil feed tube and the bolts attaching to the the bracket.

- (a) The new bolts of hexagon head type are introduced in lieu of the existing bolts of double hexagon head type.
- (b) This provides sufficient clearance, approximately 0.25in. (6,35 mm).

- (1) Remove 4W0103, Bolts (79-21-49, 16-072) (2 off) from the engine.
- (2) Install 4W1183, Bolts (79-21-49, 16-072) (2 off) in position of the engine and torque the bolts to 36 to 45 lbfin (4,00 to 5,00 Nm).

NOTE: Lubricate all threads and abutment faces of the bolts with CoMat 10-039 engine oil.
