SERVICE BULLETIN

ENGINE - OIL - INCORPORATE LONGER BOLTS TO ATTACH NO.4 BEARING COMPARTMENT SCAVENGE VALVE - CATEGORY CODE 5 - MOD.ENG-79-0018

V2500-ENG-79-0018

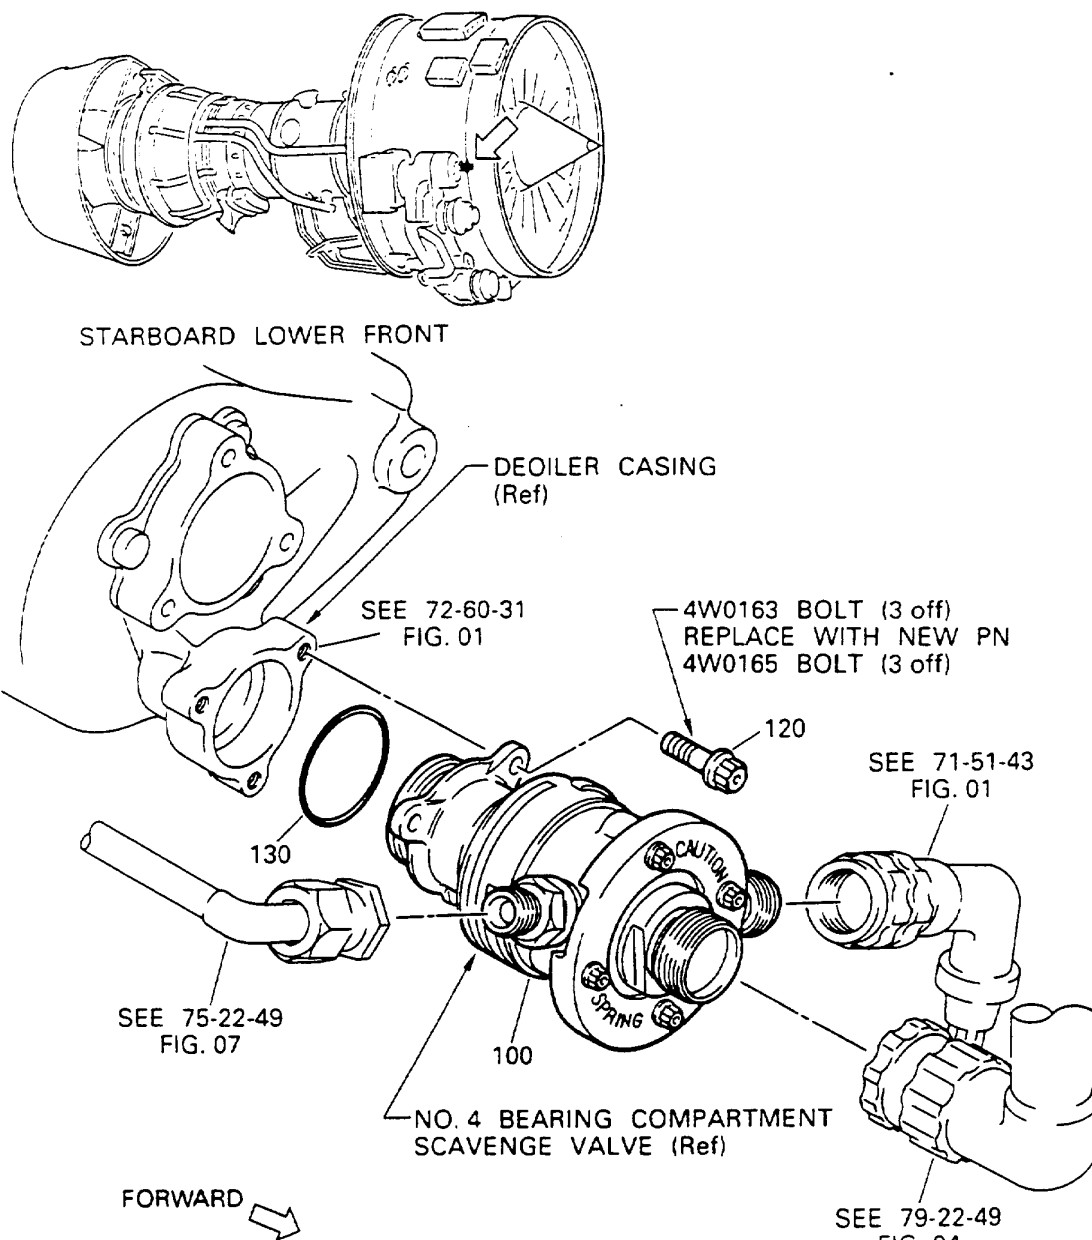
Replacement of the No.4 Bearing Compartment Scavenge Valve Attaching Bolts
Fig.1

The bolts which attach the No.4 Bearing Compartment Scavenge Valve may not completely engage the tapped holes in the Deoiler casing flange.

(a) The existing bolts which attach the No.4 Bearing Compartment Scavenge valve have been changed to longer bolts (See Figure 1).

- (1) Replace the three bolts which attach the No.4 Bearing Compartment Scavenge Valve, one by one with the following steps (a) to (c) (Refer to Figure 1 and 1.K.(2)).
 - (a) Remove 4W0163, Bolt, from the No.4 Bearing Compartment Scavenge Valve and the Deoiler Casing.
 - (b) Install new 4W0165, Bolt, to the No.4 Bearing Compartment Scavenge Valve and the Deoiler Casing.
 - (c) Torque the Bolt, to 85 - 105 lbfin (10,00 - 12,00 Nm).
