OIL - REPLACE THE FUEL COOLED OIL COOLER ATTACHING BOLTS - CATEGORY CODE 4 -
MOD.ENG-79-0019

V2500-ENG-79-0019

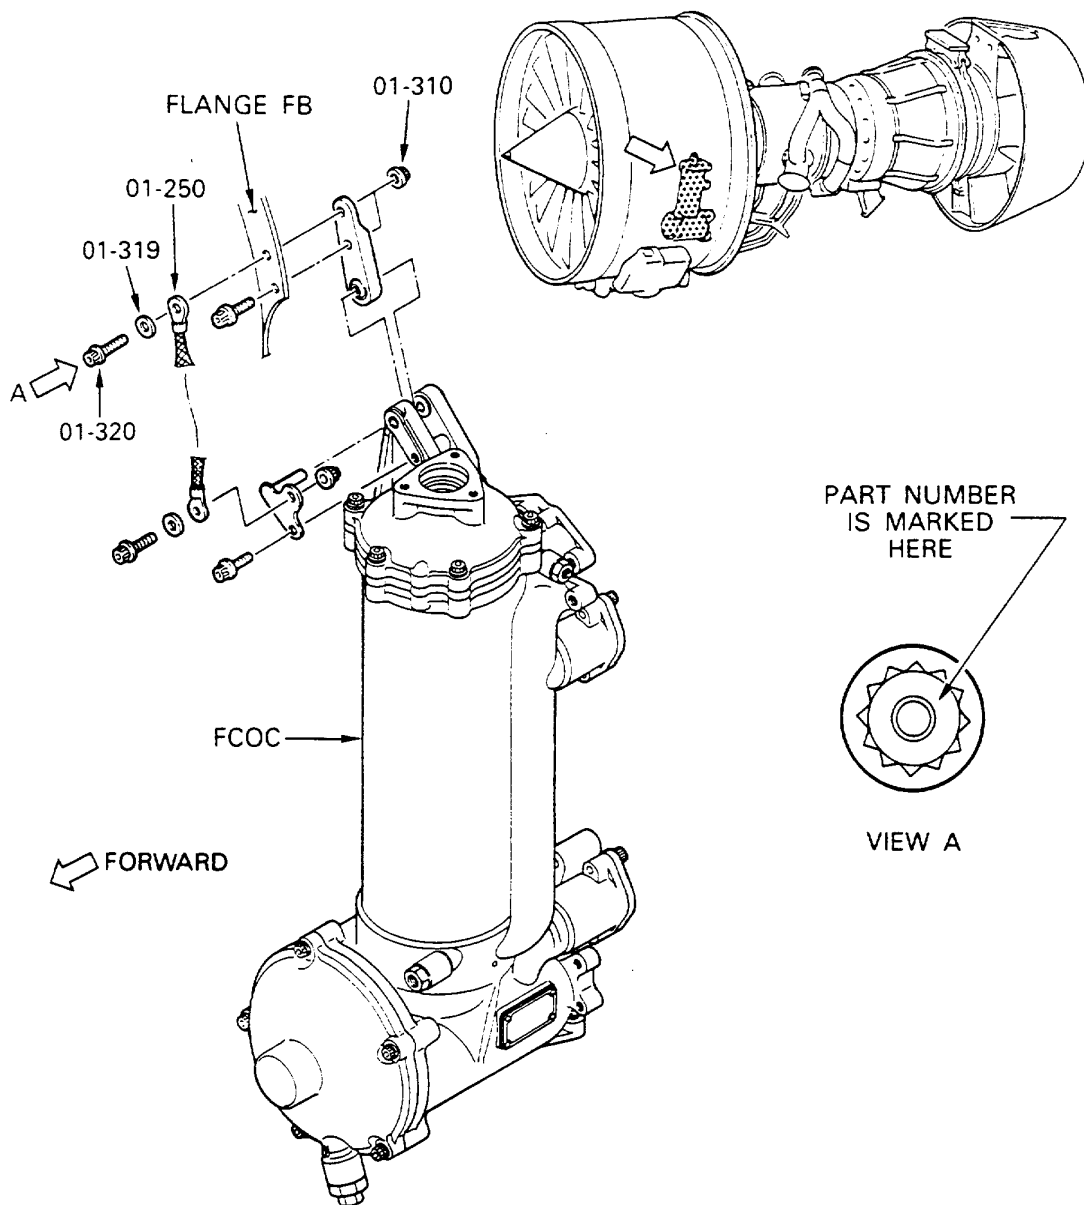
Fuel Cooled Oil Cooler
Fig.1

The existing Fuel Cooled Oil Cooler (FCOC) attaching bolt fitted at engine manufacture may have been the incorrect part number.

The incorrect FCOC attaching bolt AS21514 may have been installed rather than the correct attaching bolt AS22514 during engine manufacture.

- (1) Remove the two bolts (79-21-43, 01-320). Refer to Figure 1.
- (2) Replace the AS21514 Bolt with the AS22514 Bolt.

- (1) Install the AS22514 Bolt and torque the nut (79-21-43, 01-310) to between 85 and 95 lbfin (0,96 and 1,07 mdaN).
