SERVICE BULLETIN

OIL - FUEL COOLED OIL COOLER - INTRODUCTION OF LONGER UPPER BONDING STRAP - CATEGORY CODE 6 - MOD.ENG-79-0020

V2500-ENG-79-0020

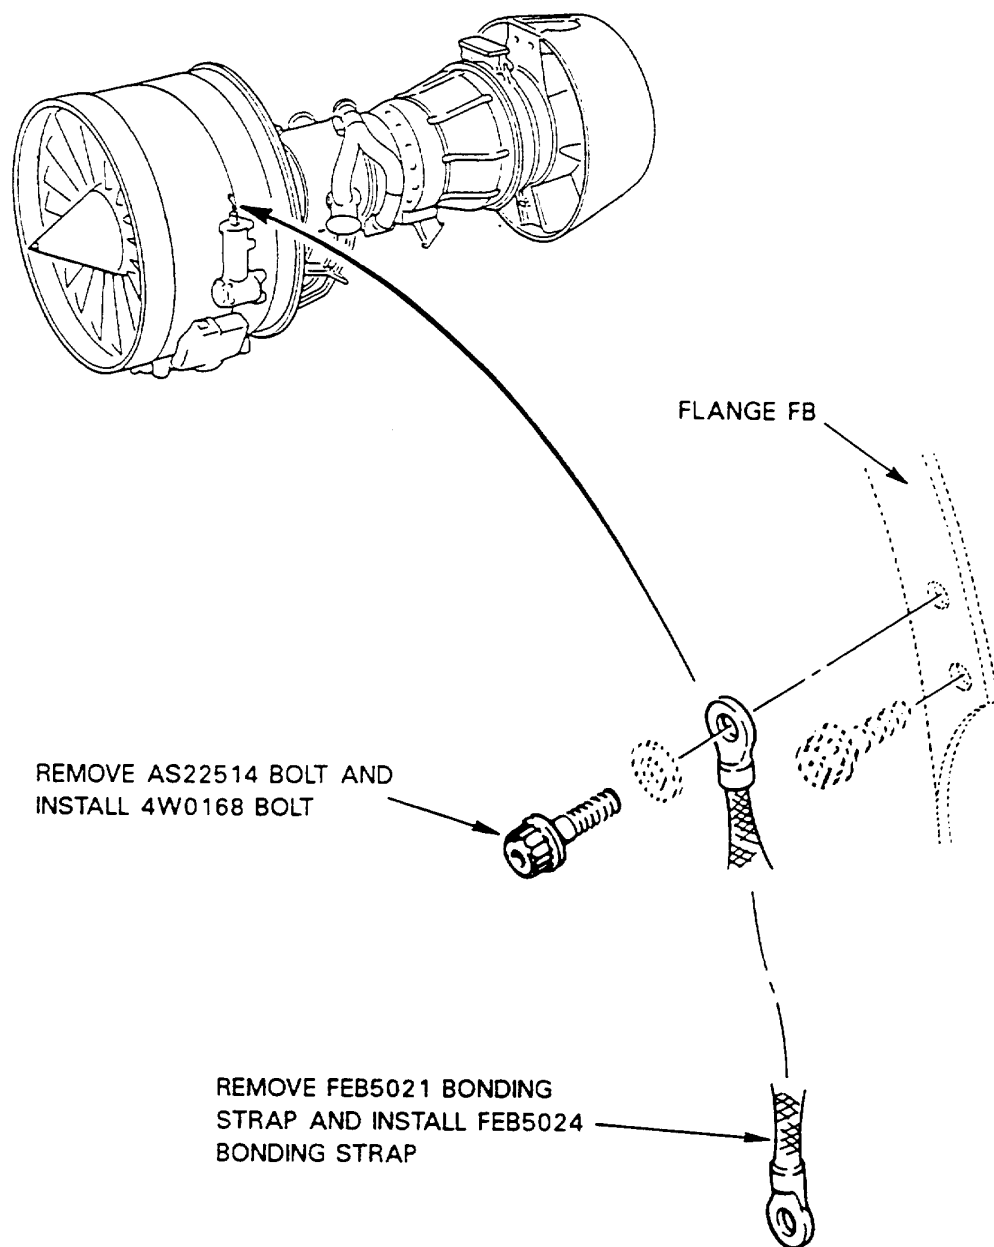
Location of bonding strap
Fig.1

The bonding strap between the top of the fuel cooled oil cooler (F.C.O.C.) and the fan case flanged FB may not to be the proper length and could therefore touch either the adjacent oil tubes or the bolt tail on flange FB, possibly resulting in fretage.
