SERVICE BULLETIN

OIL - REPLACE THE FUEL COOLED OIL COOLER (FCOC) MOUNT BRACKET - CATEGORY CODE 4 - MOD.ENG-79-0021

V2500-ENG-79-0021

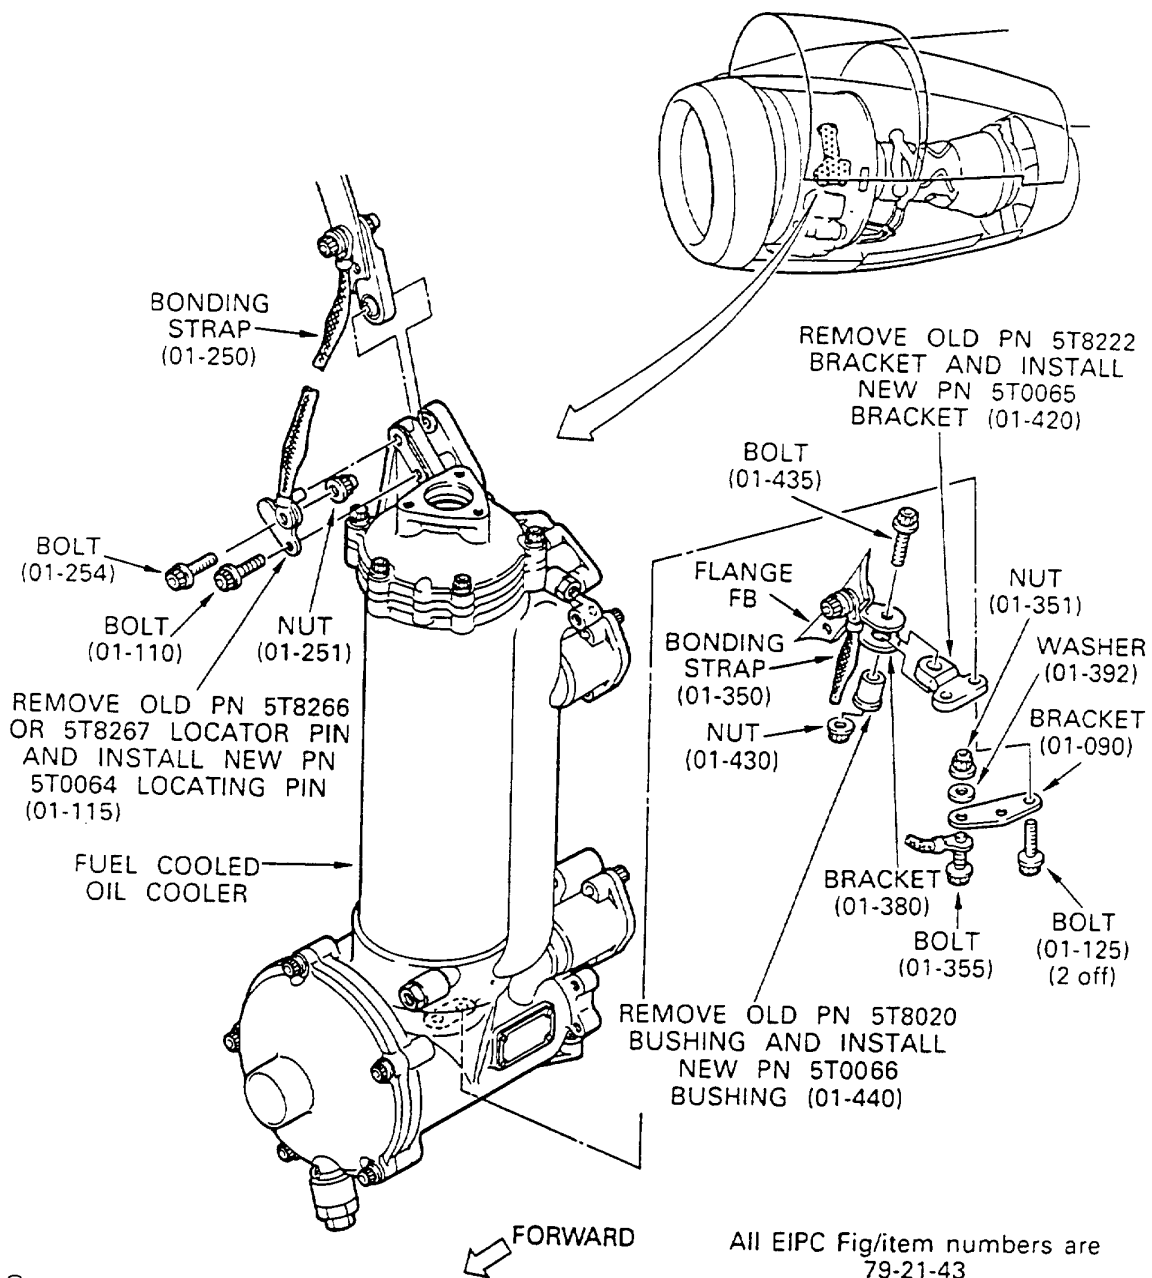
FCOC Mount Bracket, Pin and Bushing
Fig.1

Fretage of the Fuel Cooled Oil Cooler (FCOC) mount brackets could occur.

The FCOC mounting bracket and pin had been found to be worn at hard cyclic test engine.

- (1) Remove the two bolts (79-21-43, 01-125), the Bracket (79-21-43, 01-090) and the old 5T8222, Bracket (79-21-43, 01-420). Refer to Figure 1.
- (2) Replace the old 5T8267 or 5T8266, Pin, Locator (79-21-43, 01-115) with the new 5T0064 Pin, Locating. Refer to Figure 1.
- (3) Replace the old 5T8020, Bushing (79-21-43, 01-440) with the new 5T0066 Bushing. Refer to Figure 1.

- (1) Install the bracket (79-21-43, 01-090) and the new 5T0065 Bracket (79-21-43, 01-420) to the FCOC with the two Bolts (79-21-43, 01-125) and torque the bolts to between 85 and 105 lbfin (10 and 12 Nm).
