SERVICE BULLETIN

OIL - OIL TANK ASSEMBLY - ADD A BRACKET FOR SECURING THE DUST COVERS LANYARDS -
CATEGORY CODE 6 - MOD.ENG-79-0022

V2500-ENG-79-0022

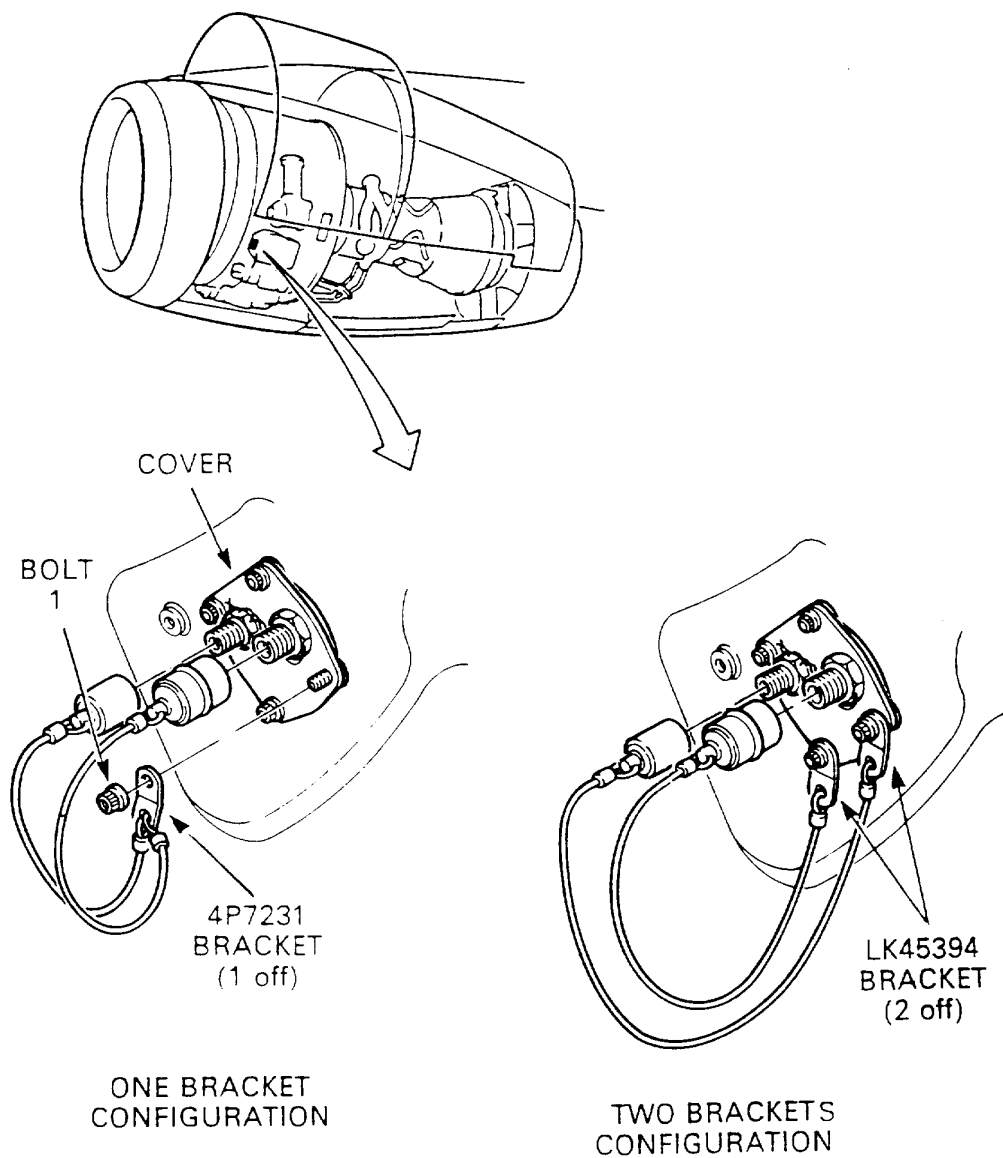
Brackets installation
Fig.1

The existing oil tank introduced by Service Bulletin V2500.ENG-79.0014 does not have a dedicated bracket to secure the dust covers lanyards.

- (1) Loose but not remove the four bolts that attach the cover to the oil tank. Refer to Figure 1
- (2) Remove PN 4W0163, Bolt (1) from the cover and retain the bolt.
- (3) Center PN 4W7231, Bracket on the cover bolt hole and install the old PN 4W0163, Bolt (1). Tighten the bolt by hand.
- (4) Torque the four bolts to 85 to 95 lbfin (9m,604 to 10,734 Nm) (See in Reference (3) Chapter/Section 70-41-00 Torque Tightening Technique)
- (5) Connect the two dust covers lanyards to the bracket.
