OIL - OIL TANK ASSEMBLY - PROVIDE AN OIL TANK OVERFILL WARNING PLATE - CATEGORY CODE 4
- MOD.ENG-79-0023

V2500-ENG-79-0023

SERVICE BULLETIN

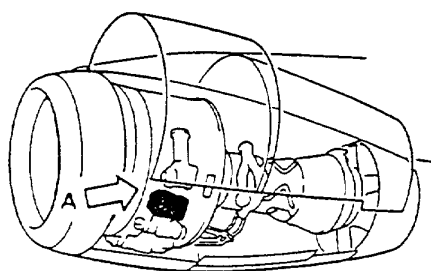
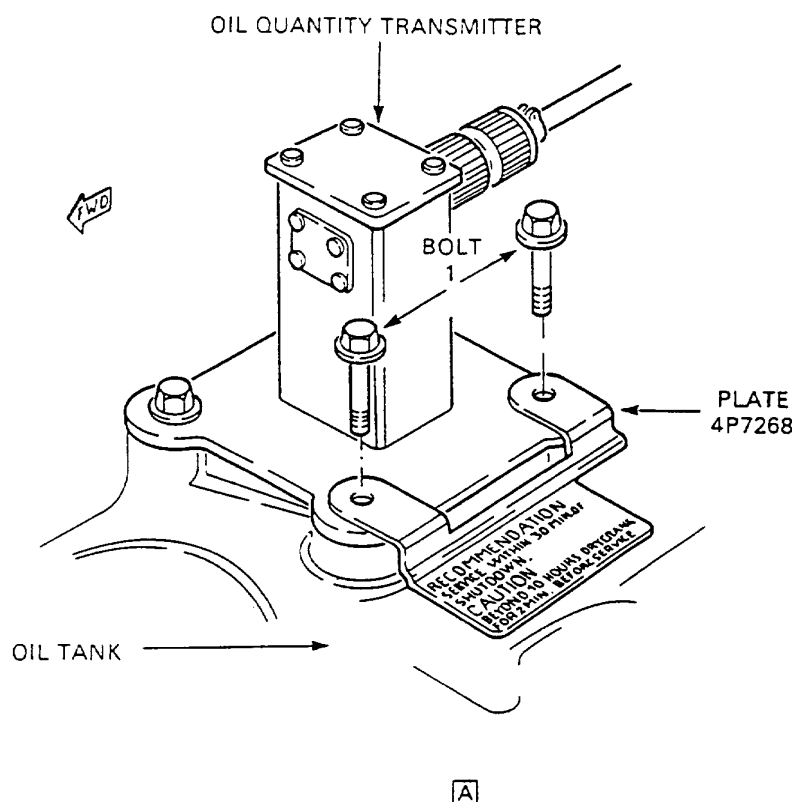
Oil Tank Overfill Warning Plate Fig.1

The existing oil tank does not have adequate precautions regarding the potential for oil tank overfilling.

In order to highlight the importance of a correct oil refilling a warning plate has been added on the oil tank. Refer to Fig.1.

- (2) Loosen the four bolts that attach the flange of the oil quantity transmitter to the oil tank. See Fig.1.
- (3) Remove the two front bolts (1).

- (1) Install the 4P7268 plate on the flange of the oil quantity transmitter. See Fig.1.
- (2) Install the two front bolts (1)
- (3) TORQUE the four bolts to 100 lbf_n (1,13 mdaN) (Ref TASK 70-23-11-911-010).
- (4) Close the fan cowl panels, refer to Aircraft Maintenance Manual, 71-13-00.
