ENGINE - POWERPLANT - OIL - MAGNETIC CHIP DETECTOR - INSPECTION FOR WEAR - CATEGORY
CODE 5 - MOD.ENG-79-0029

V2500-ENG-79-0029

SERVICE BULLETIN

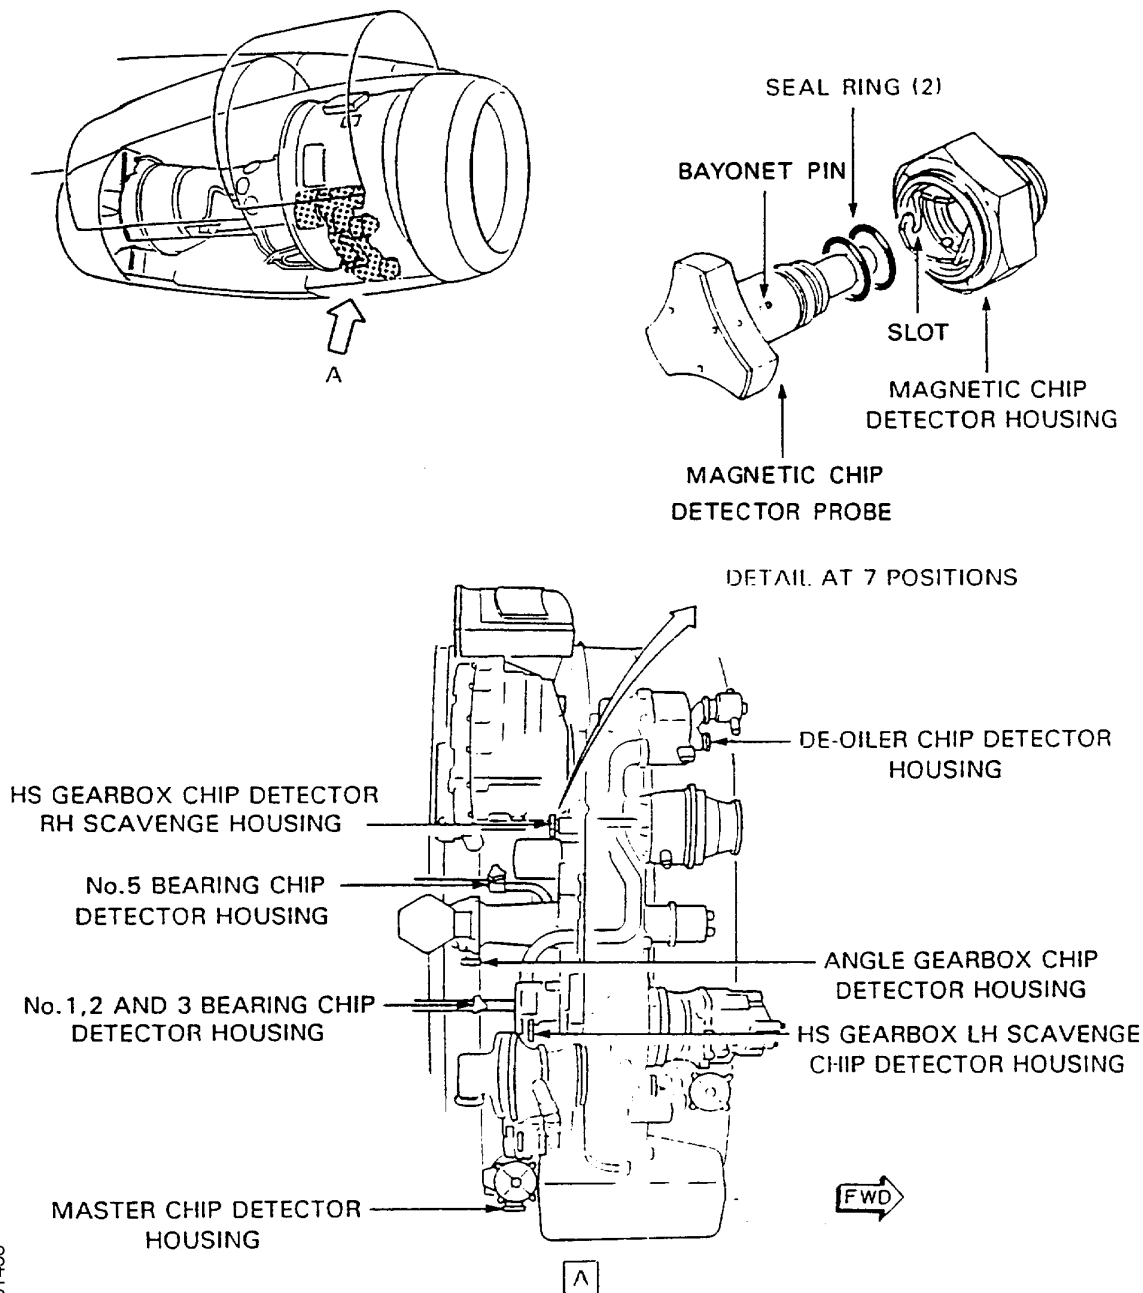
EXAMINATION OF MCD PROBE AND HOUSING
Fig.1

Some wear was discovered on the Magnetic Chip Detector (MCD) probe pins and housings during routine maintenance checks. The intent of this Service Bulletin is to ensure effective chip detector operation through regular inspections.

- (3) Inspect the Master MCD probe:
 - (a) If the diameter of the bayonet pins along the pin length is not less than 0.077 inch (1.97mm), the probe is acceptable. If the diameter is less than 0.077 inch (1.97mm), replace or repair the MCD probe. See Reference 1.E.(2) for repair.

- (b) If the pins are bent or loose, repair or replace the MCD probe. See Reference (2) for pin repair.
 - (c) If the pin(s) are broken, replace the probe.

- (4) Inspect the master MCD housing for wear on the slots. Use the T71884 Inspection tool:
 - (a) If the slots in the housing are not visible at the location indicated by the yellow arrows on the tool, the housing is acceptable.

- (b) If any/all of the slots are visible, replace the housing. Remove the master magnetic chip detector (MCD) housing as instructed in Reference (1) TASK 79-22-45-000-011. Refer to Figure 1.

- (7) Inspect the MCD probes and housing at the six remaining locations shown in Figure 1 per steps (2) through (6).
- (8) If, after inspecting probes and housings at any location and required replacement probes and/or housings are unavailable, proceed as follows:
