OIL - ENGINE- FANCASE - REPLACE IDG POWER CABLE SUPPORT BRACKETS - CATEGORY CODE 6 -  
MOD.ENG-79-0038

# V2500-ENG-79-0038

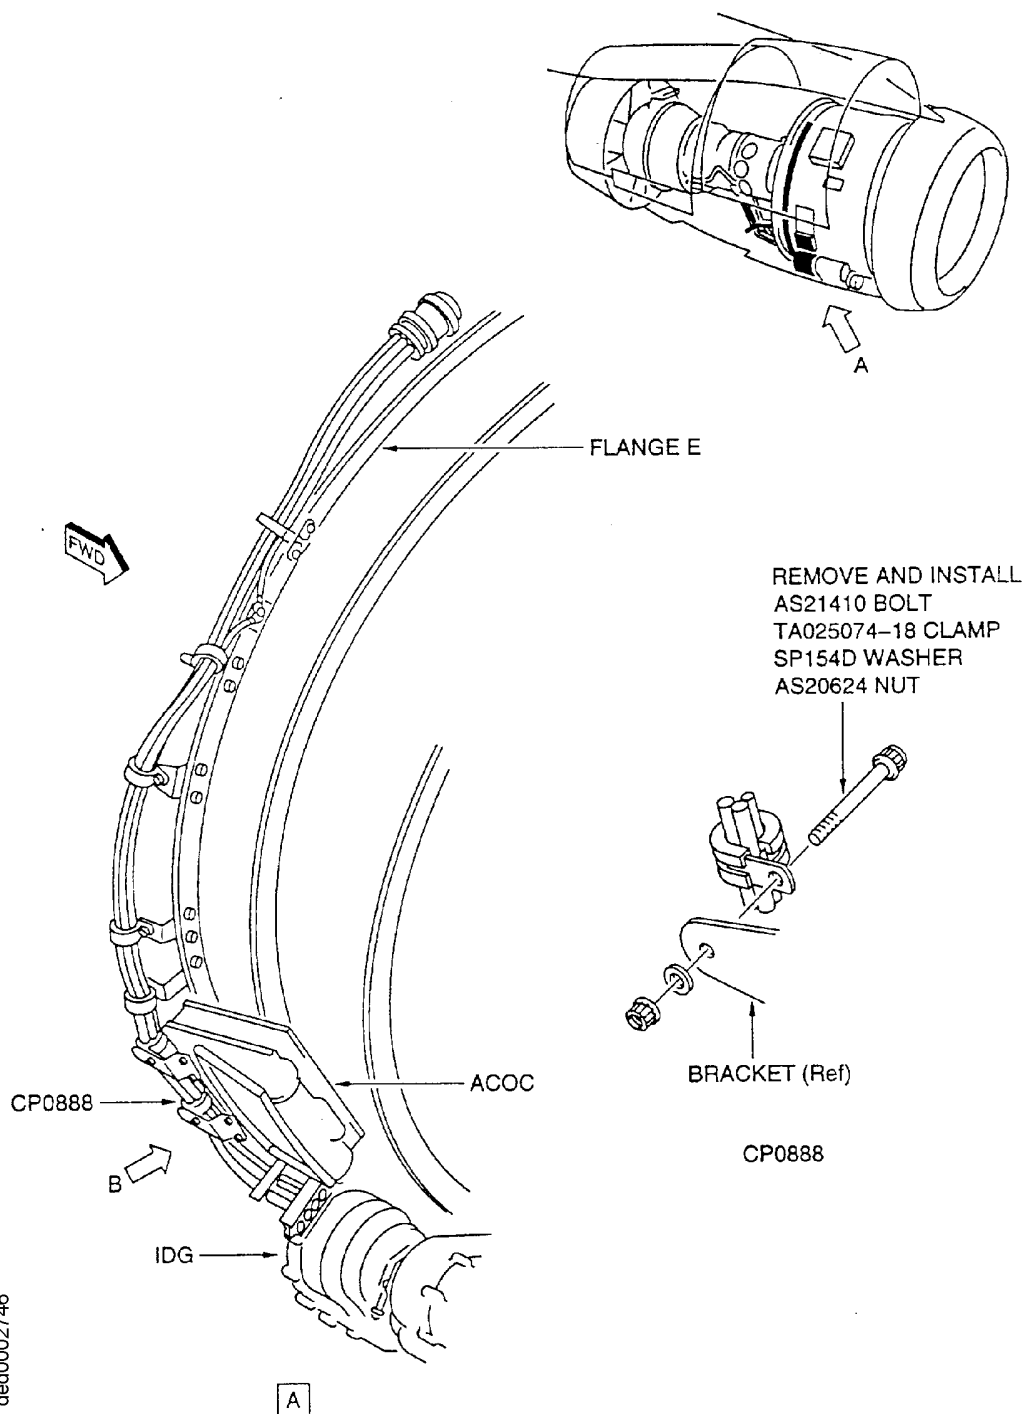
Installation of new IDG cable support brackets  
Fig.1 (Sheet 1)

Insufficient clearance may exist between the IDG power cable support bracket and the EEC harness.

- (1) Install the new 745-5951-501 Bracket as shown with two 4W0169 Bolts and two MS9321-10 Washers. (Refer to Figures 1 and 2). Torque the bolts to 85 to 105 lbf in (10 to 12 Nm).
- (2) Install the new 745-5980-501 Bracket as shown with a 4W0169 Bolt, MS9321-10 Washer, 4W0002 Nut, AS21408 Bolt and an AS20624 Nut. Torque the bolts to 36 to 45 lbf in (4 to 5 Nm).
- (3) Assemble clipping point CP0888 as shown with a AS20624 Nut, AS21410 Bolt, SP154D Washer and TA025074-18 clamp. Torque the nut to 20 to 25 lbf in (2 to 3 Nm).
