**International
Aero Engines**

SERVICE BULLETIN

ENGINE — POWERPLANT - INTRODUCTION OF A NEW MAGNETIC
CHIP DETECTOR

V2500-ENG-79-0042

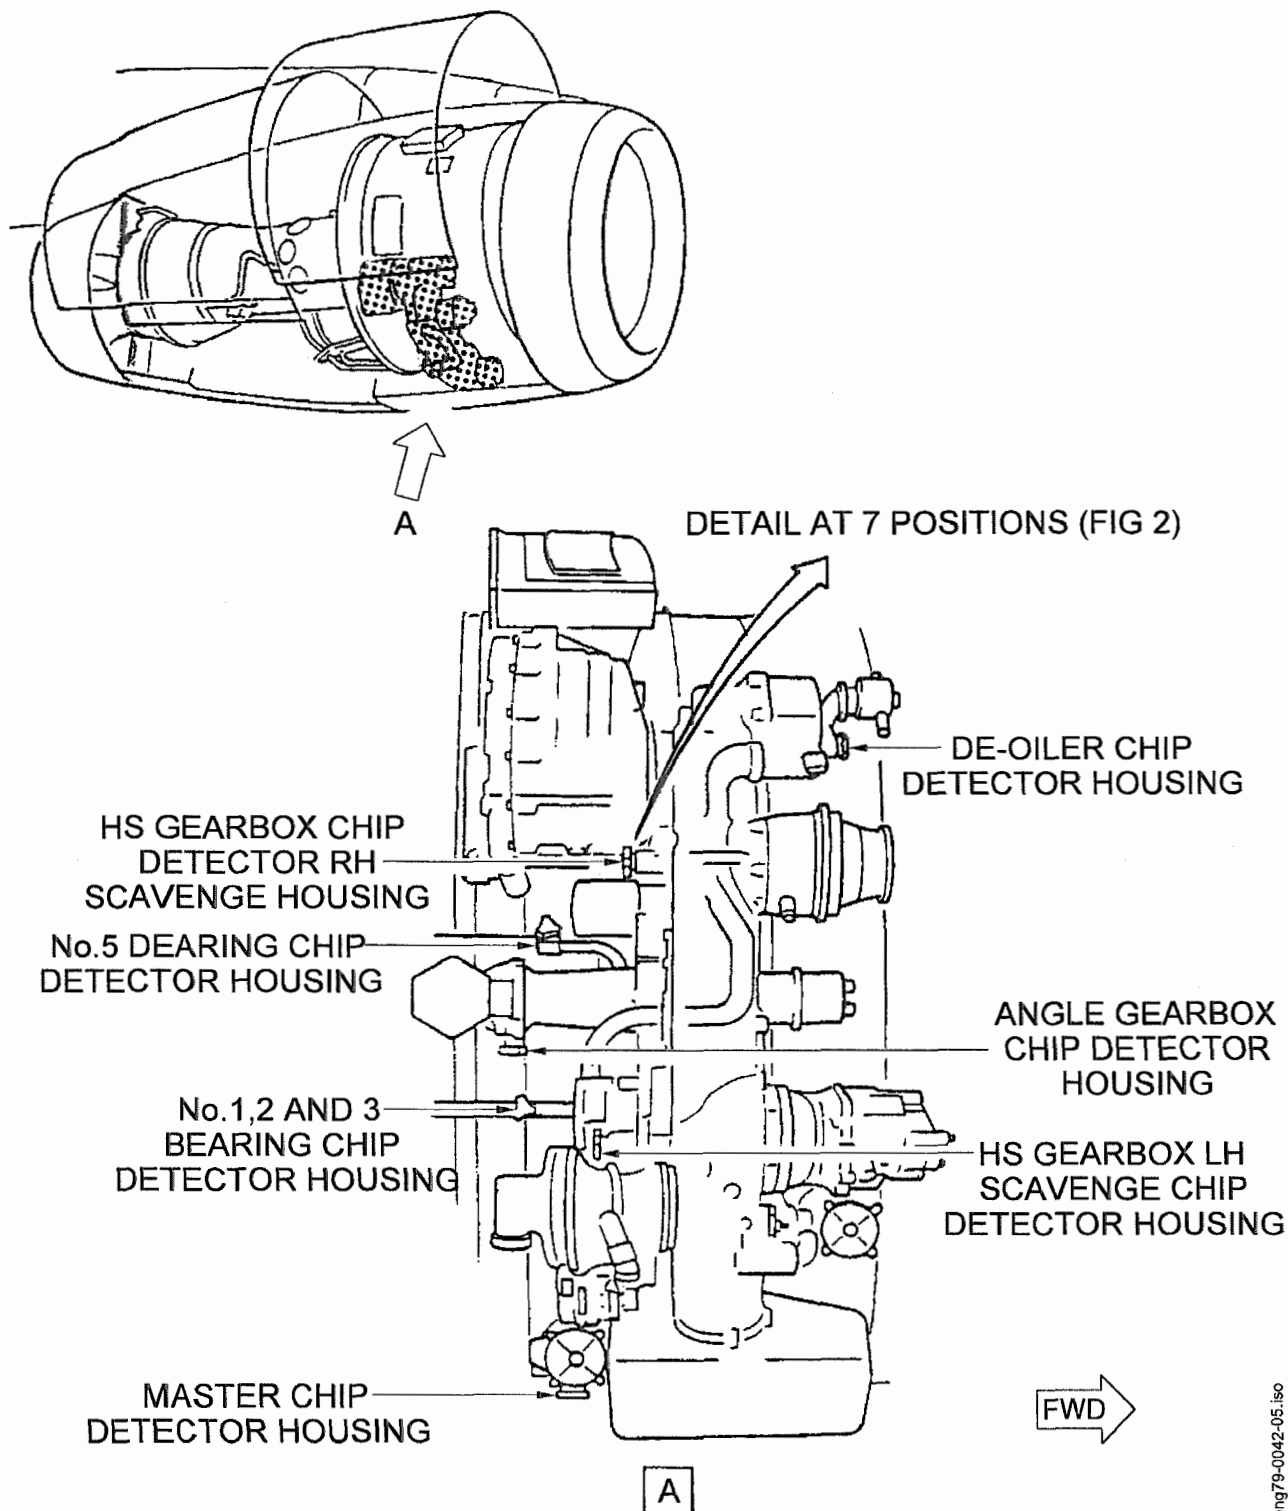
LOCATION OF MCD ASSEMBLIES
FIGURE 1

The current Magnetic Chip Detector Assembly has been experiencing a wear problem on the probe pins and housing slots. Consequently, a new magnetic chip detector was evaluated in-service under "Controlled Service Use" conditions (Ref: original issue of this Service Bulletin) and demonstrated satisfactory performance.

- (4) Repeat steps (1) thru (3) as necessary for the replacement of the MCD Assemblies at the locations listed below. Refer to Figure 1:
 - * HS Gearbox Chip Detector RH Scavenge Housing

- * No. 5 Bearing Chip Detector Housing
 - * No. 1,2 and 3 Bearing Chip Detector Housing
 - * De-oiler Chip Detector Housing
 - * Angle Gearbox Chip Detector Housing

- * HS Gearbox LH Scavenge Chip Detector Housing
- (5) Make sure there is sufficient oil in the system. Refer to the Aircraft Maintenance Manual, Task 12-13-79-610-011.
