International Aero Engines

SERVICE BULLETIN

<u>OIL - ENGINE - FANCASE - REPLACE IDG POWER CABLE SUPPORT BRACKETS - CATEGORY CODE 6 - MOD.ENG-79-0045</u>

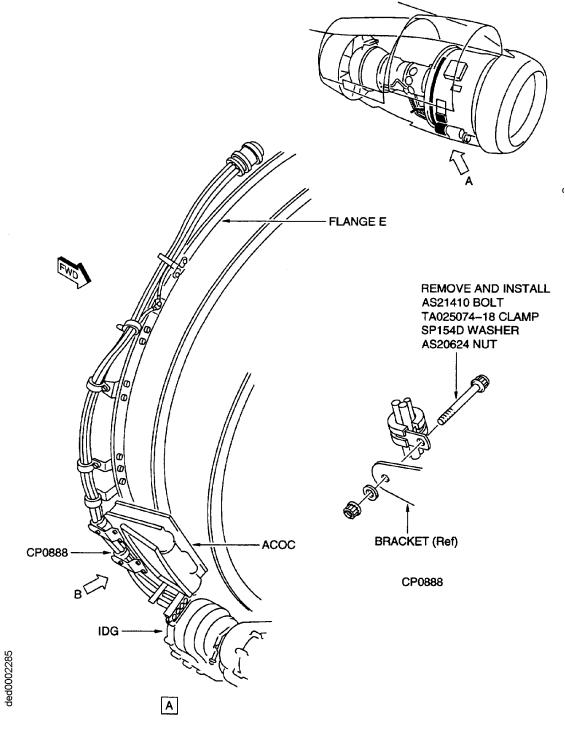
INSTALLATION OF IDG CABLE SUPPORT BRACKETS Fig.1 (SHEET 1)

Insufficient clearance may exist between the IDG power cable bracket and the EEC harness.

- (1) Install the new 745-5951-503 Bracket as shown with two 4W0169 Bolts and two MS9321-10 Washers. (Refer to Figures 1 and 2). Torque the bolts to 85 to 105 lb in (10 to 12 Nm).
- (2) Install the new 745-5980-503 Bracket as shown with a 4W0169 Bolt, MS9321-10 Washer, 4W0002 Nut, AS21408 Bolt and an AS20624 Nut. Torque the bolts to 36 to 45 lb in (4 to 5 Nm).
- (3) Assemble clipping point CP0888 as shown with an AS20624 Nut, AS21410 Bolt, SP154D Washer and TA025074-18 clamp. Torque the nut to 20 to 25 lb in (2 to 3 Nm).
