ENGINE - OIL - TO REMOVE THE INLET DUCT RIB OF THE ACOC INLET DUCT ASSEMBLY - CATEGORY
CODE 6 - MOD.ENG-79-0048

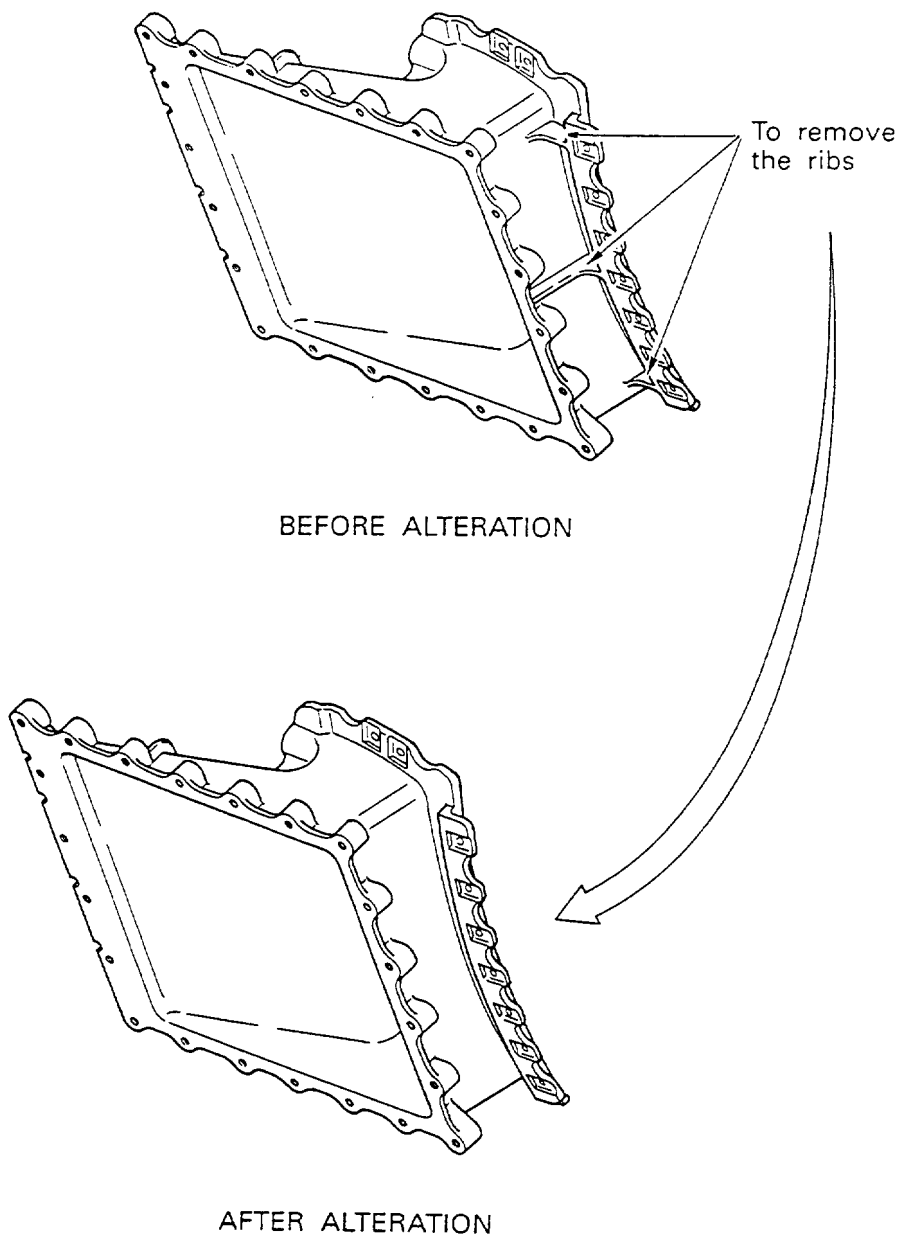
Before and After the Alteration of the ACOC Inlet Duct Assembly
Fig.1

- (1) Condition
High stress on lower/rear rib of ACOC Inlet Duct.
- (2) Background
This condition was observed during the flight test program.
- (3) Objective
To reduce stress area on the duct.
- (4) Substantiation
The configuration change shown in this Service Bulletin has been substantiated by analysis.
- (5) Effect of Bulletin on Workshop Procedures:

The ribs of ACOC Inlet Duct are removed to reduce high stress on the rib.

- (1) Affected part numbers of the ACOC Inlet Duct are follows:
 - (a) 5T0116 (79-21-42, 01-400)
 - (b) 5T0101 (79-21-42, 01-400)
- (2) Remove the rib of the ACOC Inlet Duct by grinder and files as Figures 1 and 2.
- (3) Reidentify the part number of the ACOC Inlet Duct from 5T0116 to 5T0134 adjacent to the existing part number by vibration peening. Delete the existing part number with a single solid line, Refer to 1.K.(3).
- (4) Reidentify the part number of the ACOC Inlet Duct from 5T0101 to 5T0138 adjacent to the existing part number by vibration peening by hand. Delete the existing part number with a single solid line, Refer to 1.K.(3).
- (5) Remove the burrs at new and deleted marking positions by CoMat 05-016 or 05-017 Garnet Paper.
- (6) To apply the CoMat 01-275 chromate conversion coating to ground face of the rib and non anodic portion by the brush, Refer to 1.K.(4).
