V2500-D5 SERIES PROPULSION SYSTEMS SERVICE BULLETIN

This document transmits Revision 1 to Service Bulletin EV2500-79-0062

V2500-ENG-79-0062

AIR - BEARING COMPARTMENT COOLING AND SEALING TUBES - INTRODUCTION OF A REVISED
BIFURCATION TO NO. 4 BEARING SCAVENGE VALVE AIR TUBE ASSEMBLY

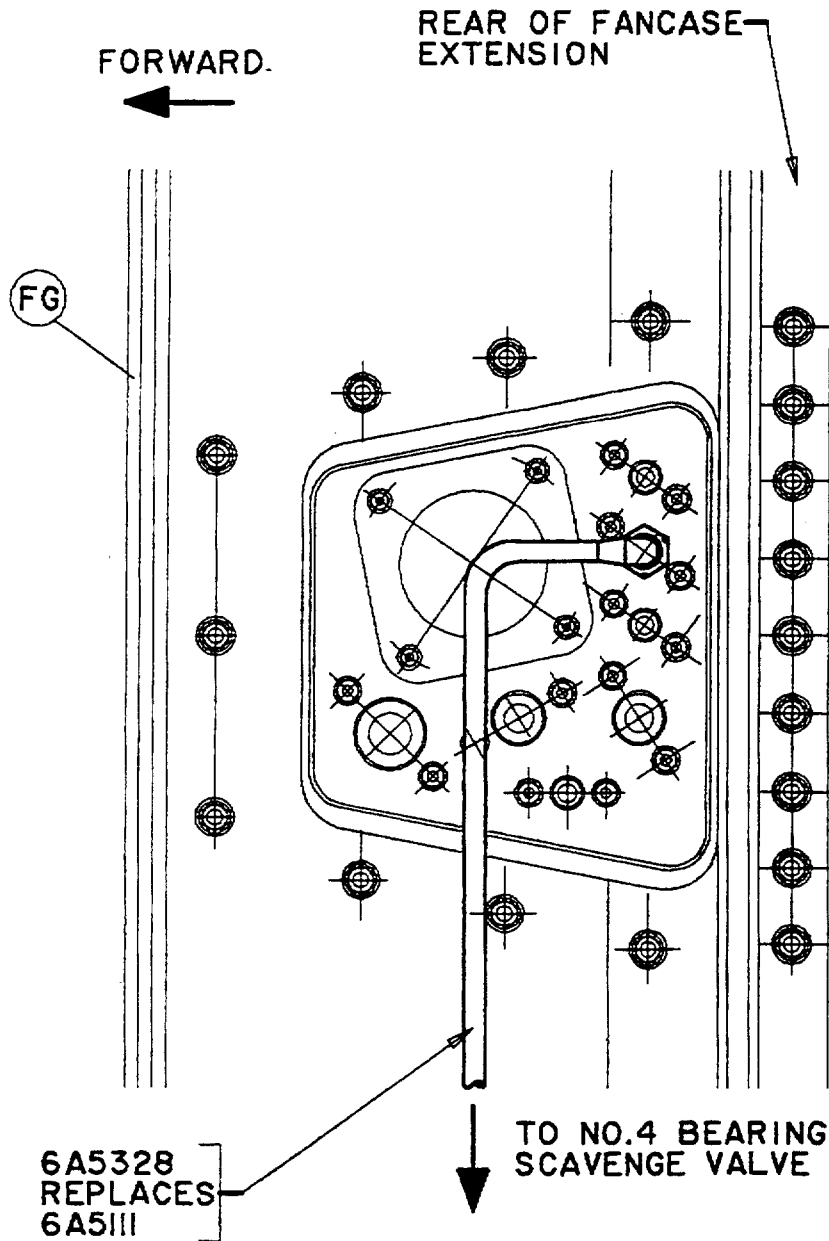
Before and after alteration
Fig 2

There is limited clearance between the air tube from the LH bifurcation box to the No. 4 bearing scavenge valve and a thrust reverser actuation bracket.

A new air tube assembly from the LH bifurcation box to the No.4 bearing scavenge valve. The tube features a 90 degree elbow at the bifurcation box end to provide additional clearance with the thrust reverser actuation fitting.

ENLARGED VIEW
SHOWING LEFT HAND BIFURCATION
