**OIL - MAGNETIC CHIP DETECTOR - INTRODUCTION OF A REVISED MAGNETIC CHIP
DETECTOR SUPPLIED BY VICKERS-TEDECO DIVISION**

V2525-D5

V2528-D5

V2500-ENG-79-0067

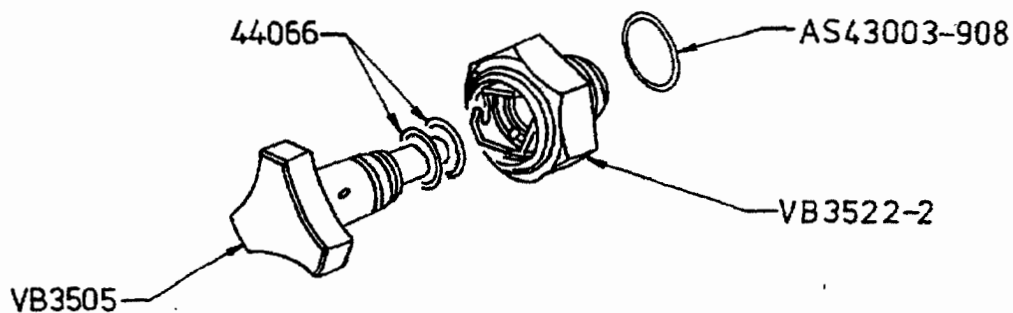
PRIOR TO ALTERATION

Excessive wear of the locking pin on the Magnetic Chip Detectors (MCD's) can occur.

The problem is caused by the weight and centre of gravity of the pin which affects the vibration characteristics and the magnitude of the forces on the locking pins. In addition, maintenance personnel have mistaken the MCD to be a screw-in type and have attempted to screw the MCD probe out of the housing.

Installation of magnetic chip detectors - Before and after alteration
Figure 1

- (1) This Service Bulletin introduces an MCD supplied by Vickers-Tedeco Division (VTD), to replace the Muirhead Vactric Components Ltd standard MCD. The VTD MCD is supplied as a complete assembly. The changes introduced are as follows:

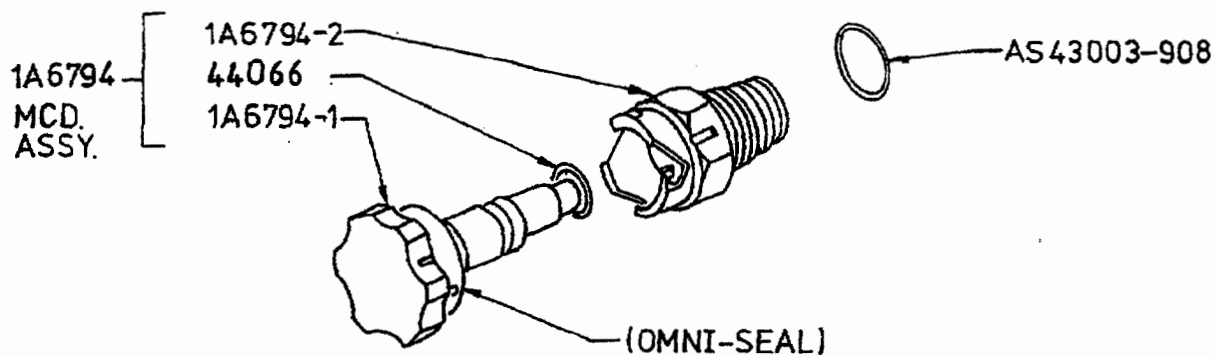
AFTER ALTERATION

- (d) To visually identify the MCD as a bayonet type design, the bayonet groove has been moved from the inside of the housing to the outside.

- (e) The position marks have been changed to make them easier to see.

- (f) The housing has been strengthened and an additional O-Ring has been introduced in the self-closing valve.
