SERVICE BULLETIN

OIL - PRESSURE OIL TUBES - ENGINE - INTRODUCTION OF REVISED OIL FEED SYSTEM RESTRICTORS

V2500-A1

Apr. 16/99 Revision 1 Jan.28/00 V2500-ENG-79-0070

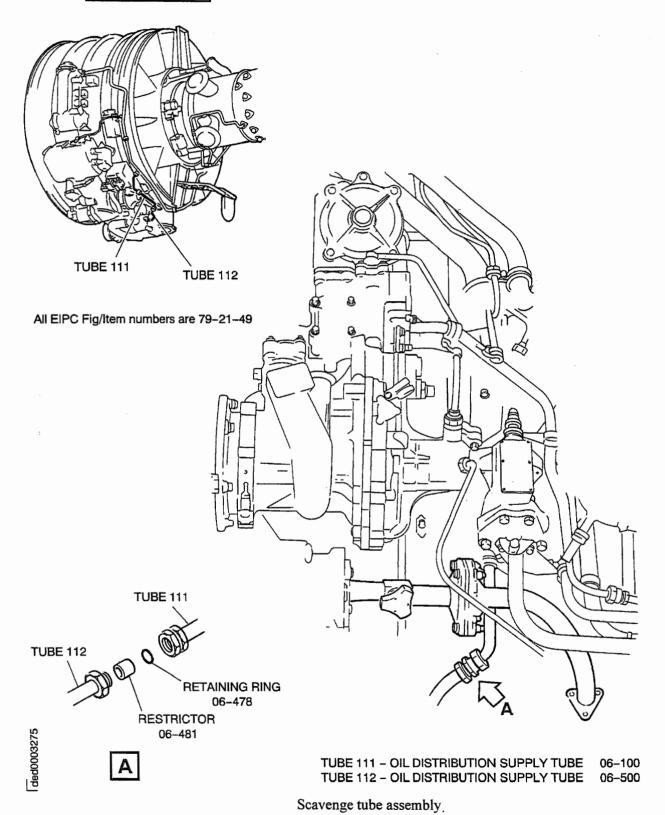
Figure 1

- (1) The filter assembly for the oil-feed tube assembly of the No.4 bearing has been revised, the orifice of the restrictor is reduced.
- (2) The restrictor between the oil-feed tube assembly of the No.5 bearing and the oil-feed tube assembly to the 4-Way connector has been revised, the orifice of the restrictor is reduced.
- (3) The restrictor between the disconnect to 5-Way oil tube assembly and the oil-feed to gearbox tube assembly has been revised, the orifice of the restrictor is reduced.

2.	Accomplishment Instructions							
R	A. Pre	e-requisite Instructions						
R R	WARN	ING: ALL ELECTRICAL POWER SUPPLY FROM THE ENGINE MUST BE DISCONNECTED						
R	(1)	Disconnect the power supply from the engine by opening all applicable circuit breakers.						
R R	(2)	Open the fan cowl panels to gain access to the gearbox refer to Aircraft Maintenance Manual, 71-13-00.						
R (3) Open the Thrust Reverser Halves to gain access to No.4 and Refer to Aircraft Maintenance Manual, 78-32-00.		Open the Thrust Reverser Halves to gain access to No.4 and No.5 bearing oil feed tubes Refer to Aircraft Maintenance Manual, 78-32-00.						
R R	WARNI	NG: DO NOT GET ENGINE OIL ON YOUR SKIN FOR LONG TIME. THE OIL IS POISONOUS AND CAN GO THROUGH YOUR SKIN AND IN TO YOUR BODY						
R	NOTE:	Position a container to catch the oil spill during the removal of the tubes and accessories.						
R (4) Disconnect the tube 112 from the tube 111 and remove the restrictor (Pre SB remove and discard the retaining ring Ref Figure 1.

R	(h) Remove the filter (Pre SB) from the tube 21.							
R	B. Rework Instructions							
R	None							
R	C. Assembly Instructions							
R R								
R R	(1)	Install the restrictor (Post SB) (06-481) and a new (06-478) retaining ring 1 off in the tube 112 Ref Figure 1.						
R R	(2)	Connect the tube 112 to the tube 111. Torque the tube connector to 283 to 310 lbfin (32 to 35 Nm). Safety with CoMat 02-126 lockwire.						
R R	(3)	Install the restrictor (Post SB) (15-491) and a new (15-488) retaining ring 1 off in the tube 17 Ref Figure 2						
R R	(4)	Connect the tube 17 to the tube 24. Torque the tube connector to 283 to 310 lbfin (32 to 35 Nm). Safety with CoMat 02-126 lockwire.						
R	(5)	Install the tube 21 Ref Figure 3						
R		(a) Attach the tube 21 to the diffuser case adapter. Attach the tube 21 to the diffuser case adapter.						
R		(b) Install the (Post SB) filter into the tube 21						
R		(c) Install a new seal ring into the tube 21
