International Aero Engines SERVICE BULLETIN

Subject: Transmittal of Revision 1 to Service Bulletin
No. V2500-ENG-79-0073

ENGINE - OIL - INTRODUCTION OF OIL RESTRICTOR OF FBC OIL LINE
WITH REVISED THROAT SIZE

V2500-ENG-79-0073

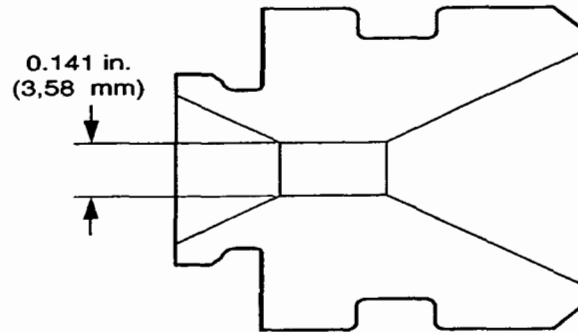
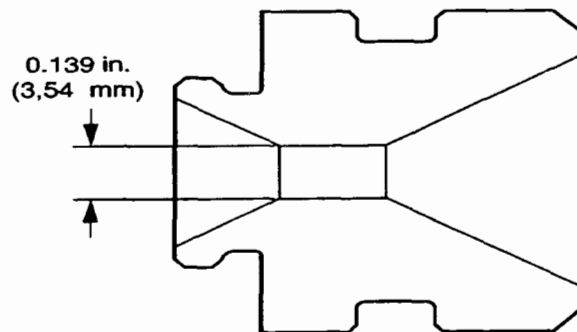
Modification of the oil restrictor
Figure 3

(a) The throat diameter of oil restrictor which is installed in the main oil distributor have changed from 0.141 inch (3,58 mm) to 0.139 inch (3,54 mm).

- (1) Remove the oil restrictor, (5A0261, 1 off) from the main oil distributor. For the correct procedures, refer to the Engine Manual (EM), Chapter/Section, 72-32-00, Disassembly-12).
- (2) Install the new oil restrictor, (5A1451, 1 off) into the main oil distributor. For the correct procedures, refer to the Engine Manual (EM), Chapter/Section, 72-32-00, Assembly-04).
