**V2500-A1/A5 SERIES PROPULSION SYSTEMS SERVICE BULLETIN**

**V2500-ENG-79-0080**  
Transmittal - Page 1 of 2

OIL - AIR COOLED OIL COOLER MODULATING VALVE - INTRODUCTION OF AN AIR MODULATING VALVE WITH REVISED ACTUATOR END CAP RETAINING WASHERS

FLIGHT CONTROLS - AIR MODULATING VALVE TY1558 - THICKER WASHER ADDED  
MODIFICATION L1558-10

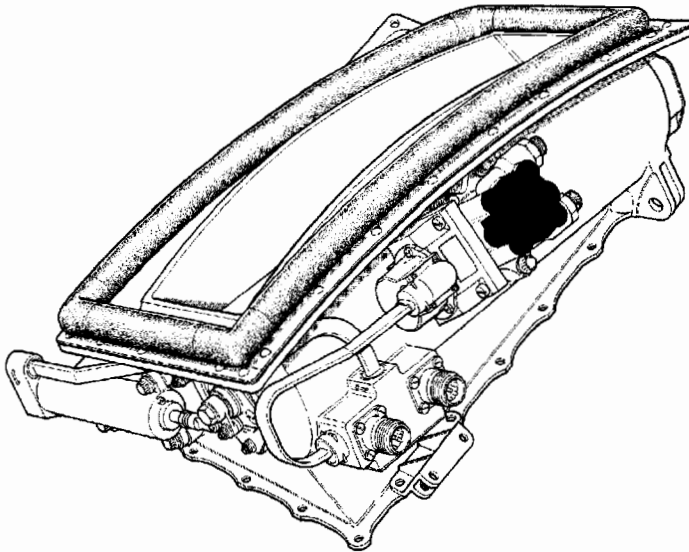
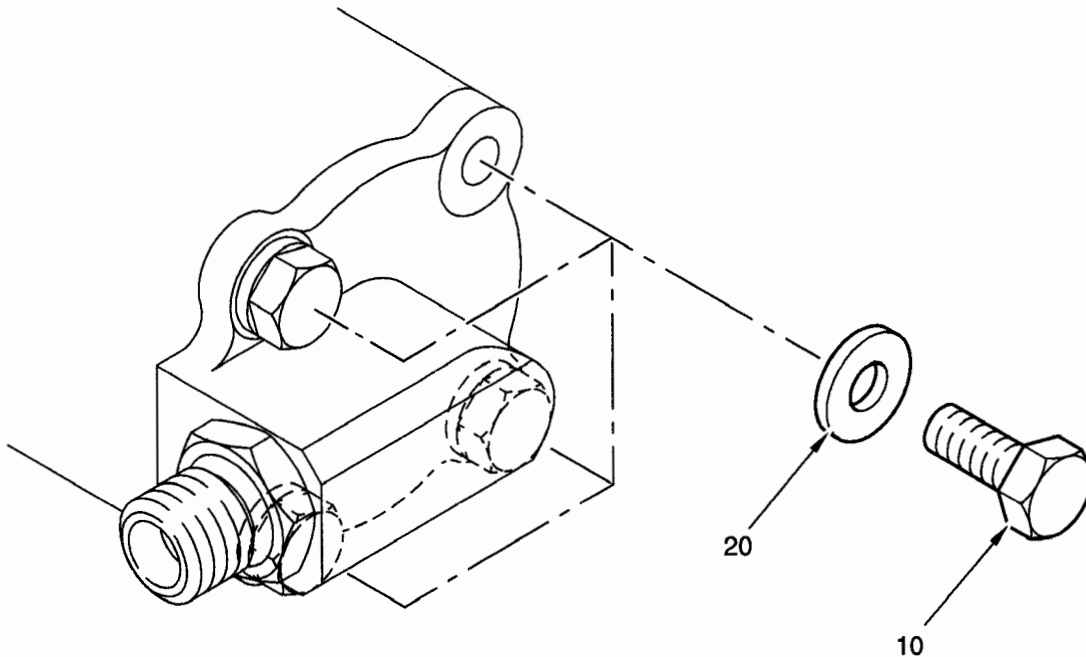
Attaching Bolt and Washer  
Figure 2

The problem has been attributed to the tolerance stack up of the bolt, washer, bore and end cap. This can allow a gap to develop between the under side of the bolt head and the end cap. Over torque tightening of the retaining bolts may be a contributory factor.

(c) Remove and retain the bolt (10, Fig 2) from the Actuator End Cap.

(d) Remove and discard the washer (20, Fig 2) from the Actuator End Cap.

(e) Install the new washer (20, Fig 2) on the Actuator End Cap.

(f) Re-install the bolt (10, Fig 2) into the Actuator End Cap.

(g) Torque tighten the bolt (10, Fig 2) between 2,82 and 3,39 Nm (24.96 and 30.00 lbf in).
