**International Aero Engines
NON-MODIFICATION
SERVICE BULLETIN**

**ENGINE – EXTERNALS – INSPECTION OF OIL SCAVANGE TUBE AND CLIPPING POINT – NON-
MODIFICATION SERVICE BULLETIN**

V2500-D5 SERIES PROPULSION SYSTEMS NON-MODIFICATION SERVICE BULLETIN

V2500-ENG-79-0091

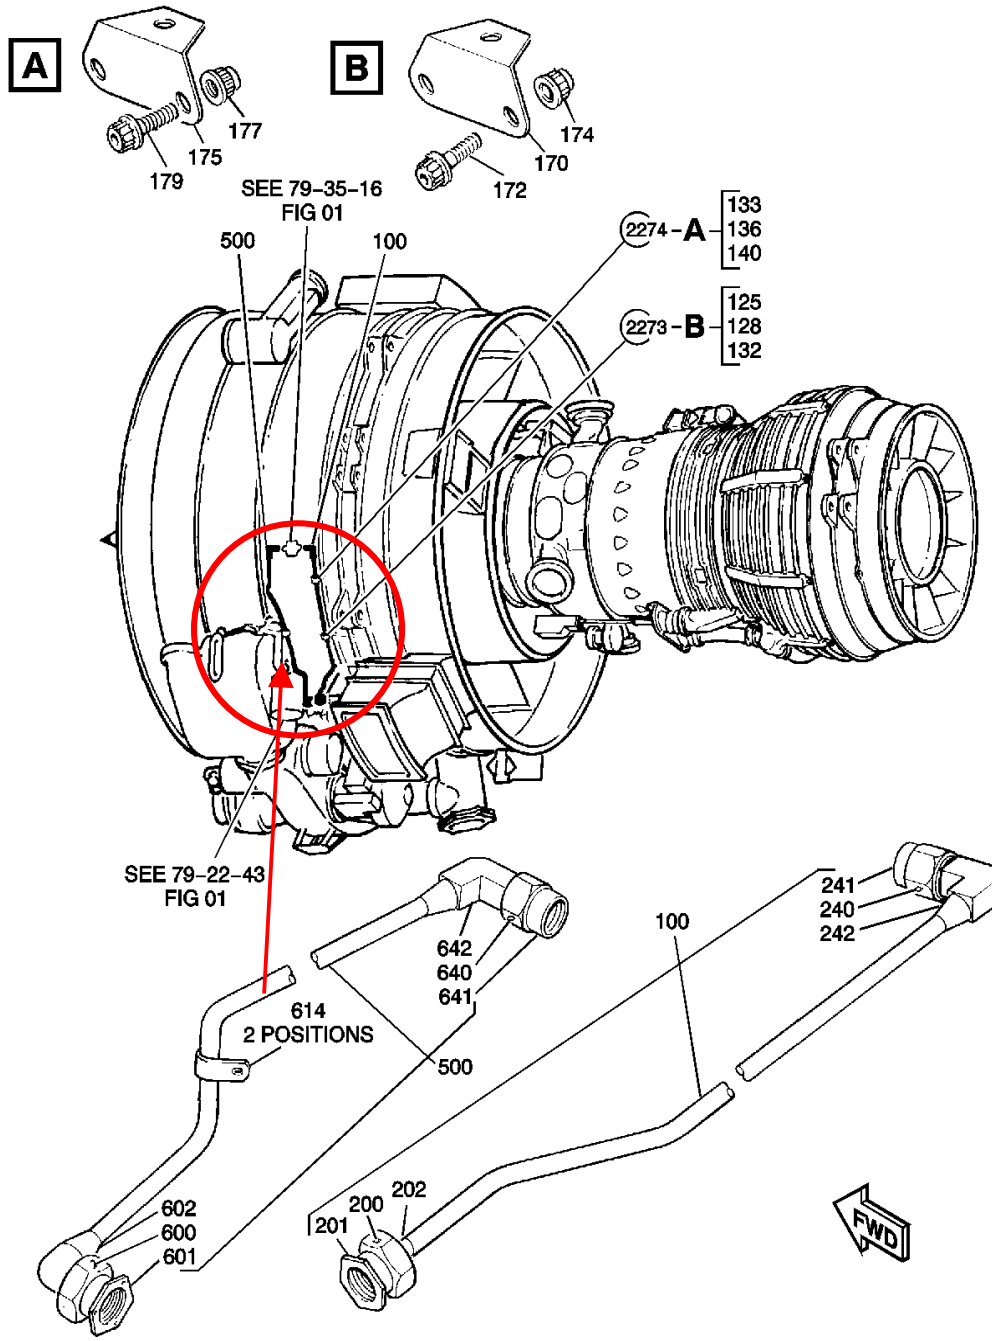
Figure 1

- (1) Locate oil tube 6A5082 on the engine, see Figure 1. Visually examine tube 6A5082 for deformation. Pay special attention to the straight sections supported by the lugs, highlighted by the two dotted lines in Figure 2. Use a straight edge, see Figure 3. These figures are for reference only.

Location of oil scavenge tube and clipping points on the engine.

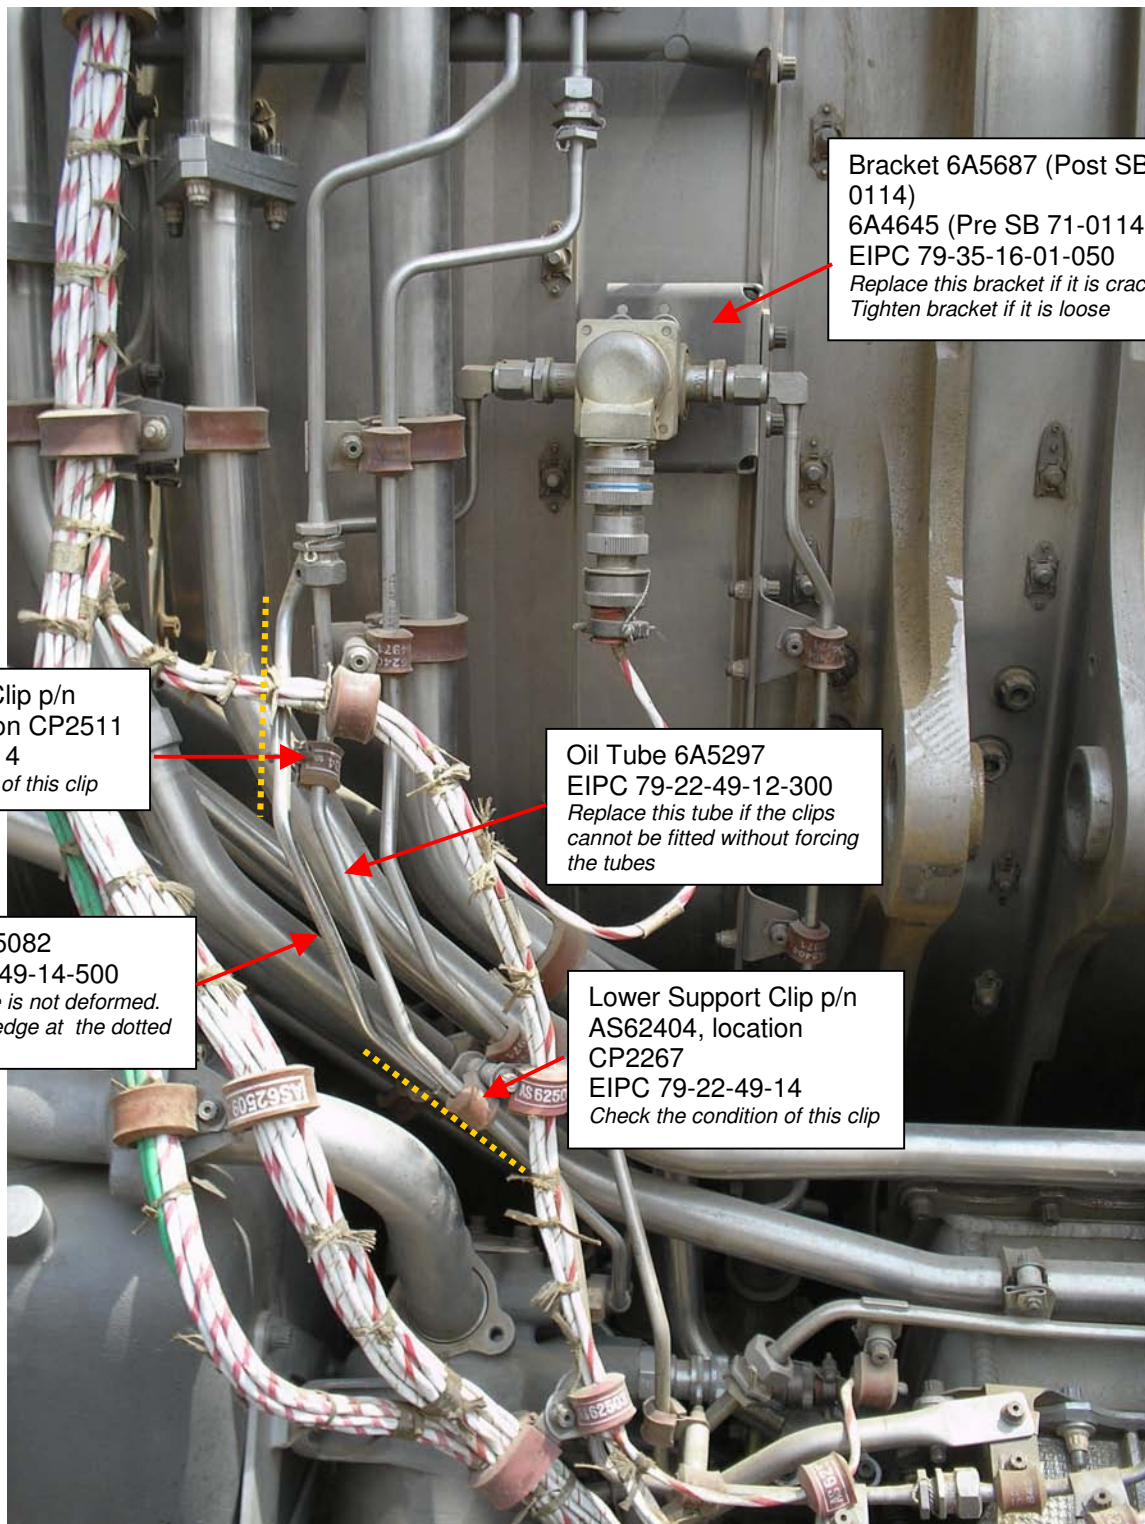
Modal vibration tests have also been carried out on IAE's mock-up engine in Derby. The results of these tests have shown that when the tube upper support clip at CP2511 is either missing or broken, a vibration mode is excited in oil tube p/n 6A5082 that is not normally present with the clip correctly configured.

With the upper support clip CP2511 missing or broken, the coincident frequency is contributory to the fracture of oil tube P/N 6A5082.

- (2) Visually inspect clip P/N AS62404 at the upper clip point at CP2511 and the lower clip point CP2267. Refer to Figure 2. This figure is for reference only.

Figure 2. Location of tubes and clipping points

| (a) Tube is deformed | Replace the tube within 50 flight cycles. Ensure no pre-loading, stress or deformation occurs during installation. |

| (a) Clip rubber is worn or damaged | Replace the clip. |
| (b) Clip is fractured, missing or loose | Replace the clip immediately.

Replace the oil pressure tube 6A5082 within 50 flight cycles.

Check bracket 6A5687 (post SB 71-0114) Tighten bracket if it is loose. Replace within 50 flight cycles if it is cracked. |

| (c) Clip cannot be fitted without pre-loading tube 6A5082 | Replace tube 6A5082 and 6A5297 within 50 flight cycles. |

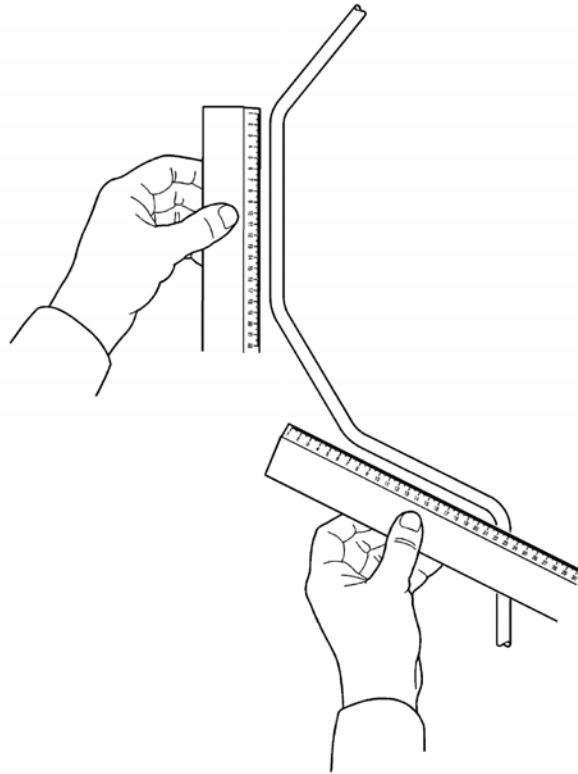
Figure 3. Check the tube straight sections using a straight edge
