V2500-A1/A5 SERIES PROPULSION SYSTEMS SERVICE BULLETIN

ENGINE – EXHAUST GAS TEMPERATURE (EGT) HARNESS CLIPPING MODIFICATION TO PREVENT
CHAFING ON FUEL MANIFOLD TUBE

V2500-ENG-79-0098

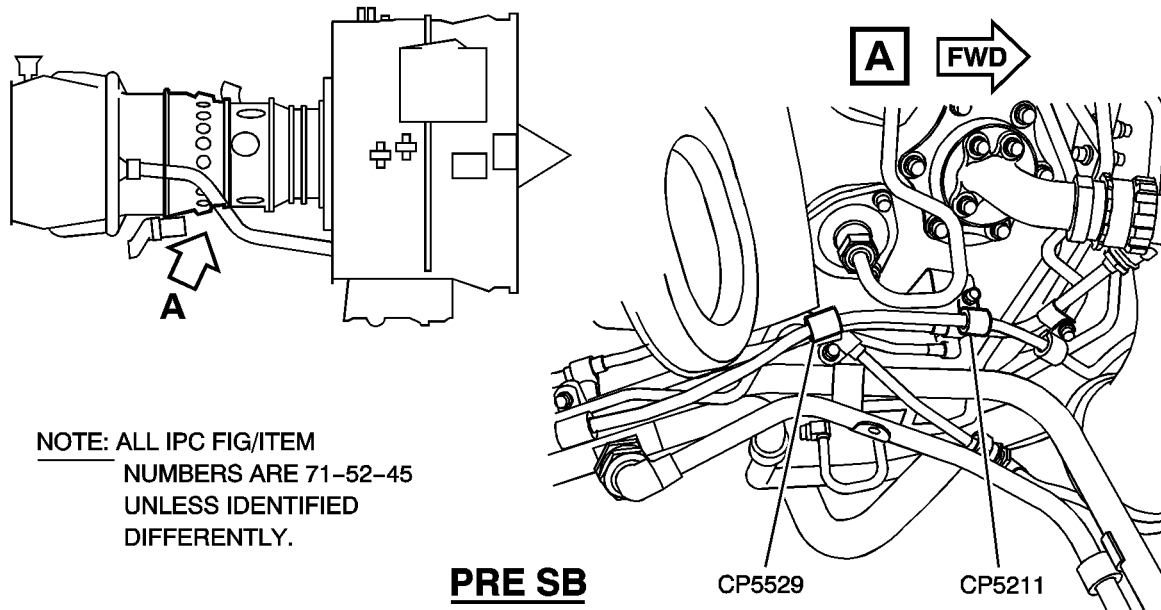
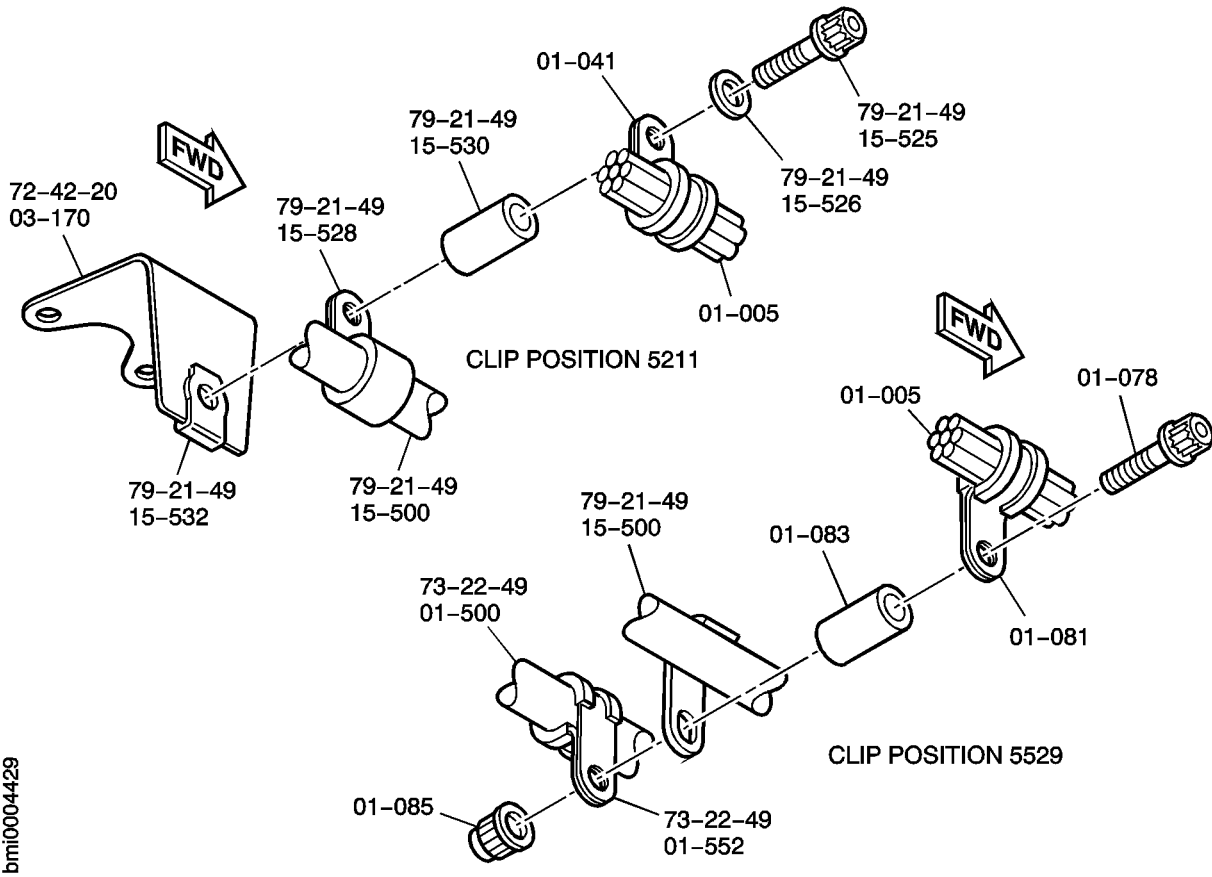
Locations of Clip Positions CP5211 and CP5529
Figure 1 Sheet 1

Local damage to the fuel manifold tube can occur, by chafing of the Exhaust Gas Temperature (EGT) harness against the fuel manifold tube. This can be caused by not enough clearance between the parts.

This Service Bulletin modifies the clip positions CP5211 and CP5529 to improve the route of the Exhaust Gas Temperature (EGT) harness.

- (a) Remove the old bolt (79-21-49, 15-525), P/N 4W0119, the washer (79-21-49, 15-526) and the old spacer (79-21-49, 15-530), P/N UP10482 or 5W1033 that attach the clip (71-52-45, 01-041) and the clip (79-21-49, 15-528) to the bracket (72-42-20, 03-170).
- (b) Install the new bolt (79-21-49, 15-525), P/N 4W0116, the washer (79-21-49, 15-526) and the new spacer (79-21-49, 15-530), P/N UP10481 that attach the clip (71-52-45, 01-041) and the clip (79-21-49, 15-528) to the bracket (72-42-20, 03-170).

- (4) At the clip position CP5529:
 - (a) Remove the nut (71-52-45, 01-085), the bolt (71-52-45, 01-078), and the spacer (71-52-45, 01-083) that attach the clip (71-52-45, 01-081) and the clip (73-22-49, 01-552) to the tube (79-21-49, 15-500).

- (b) Remove the clip (71-52-45, 01-081) from the EGT harness (71-52-45, 01-005).
 - (c) Turn the clip (71-52-45, 01-081) through 180 degrees in the same plane and install it on the EGT harness (71-52-45, 01-005).

- (d) Install the bolt (71-52-45, 01-078), the spacer (71-52-45, 01-083) and the nut (71-52-45, 01-085) that attach the clip (71-52-45, 01-081) and the clip (73-22-49, 01-552) to the tube (79-21-49, 15-500).

- (5) Make a check that the EGT harness (71-52-45, 01-005) has the minimum clearance of 0.2 in. (5 mm) between the EGT harness and the fuel manifold tube and the other parts.

- (6) Torque the bolt (79-21-49, 15-525) (CP5211) and the nut (71-52-45, 01-085) (CP5529) to 36-45 lbf in. (4-5 Nm).
- (7) Make sure that the work area is clean and clear of tools, equipment and other unwanted materials.

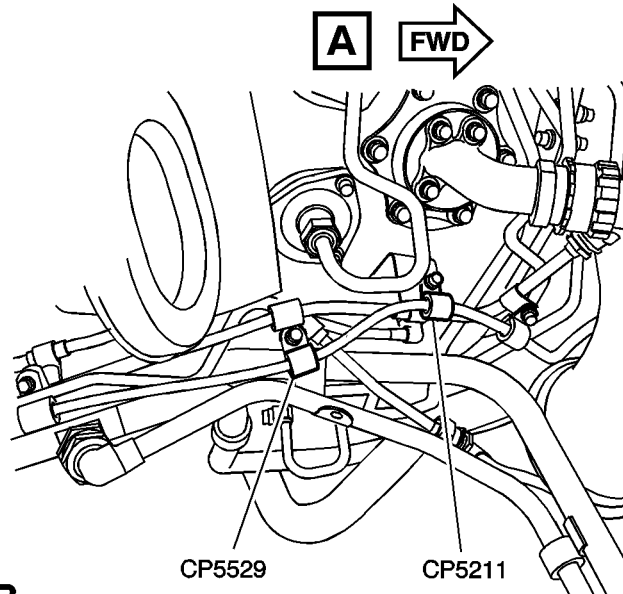
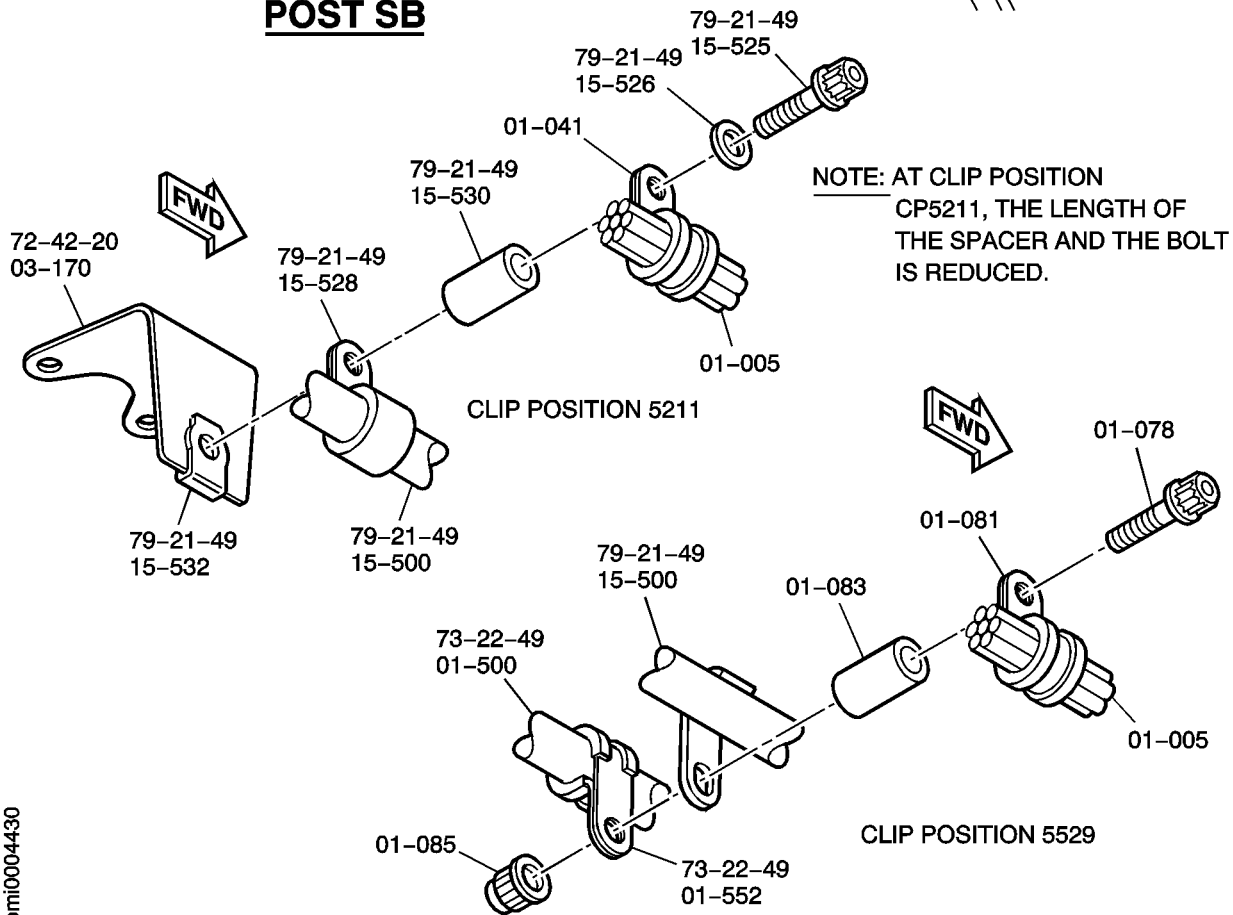
Locations of Clip Positions CP5211 and CP5529
Figure 1 Sheet 2

- (1) On clip position CP5211, the length of the spacer and the length of the bolt is reduced.
- (2) On clip position CP5529, the clip attached to the EGT harness is rotated through 180 degrees around the axis of the bolt. There are no hardware changes to this clip position.
