International Aero Engines

SERVICE BULLETIN

STARTING - INTRODUCTION OF A STARTER INCORPORATING IMPROVED CLAMPING OF THE TURBINE ASSEMBLY (L7), INCREASED OIL FLOW (L9) AND ADDITIONAL OVERFLOW TUBE (L10) - CATEGORY CODE 6 - MOD.ENG-80-0005

V2500-ENG-80-0005

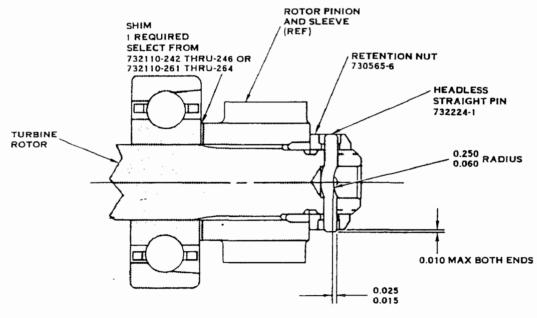
Pin Installation Deformation Dimensions Figure 1

This product improvement bulletin improves retention nut clamping force on the turbine rotor stack-up.

- (3) Assemble rotor balancing assembly in accordance with existing component maintenance manual and the following additional instructions.
 - (a) Install one new solid shim, PN 732110-264 on turbine rotor as shown in Figure 1.

⁽f) Install new headless straight pin, PN 732224-1. Crimp as shown in Figure 1.

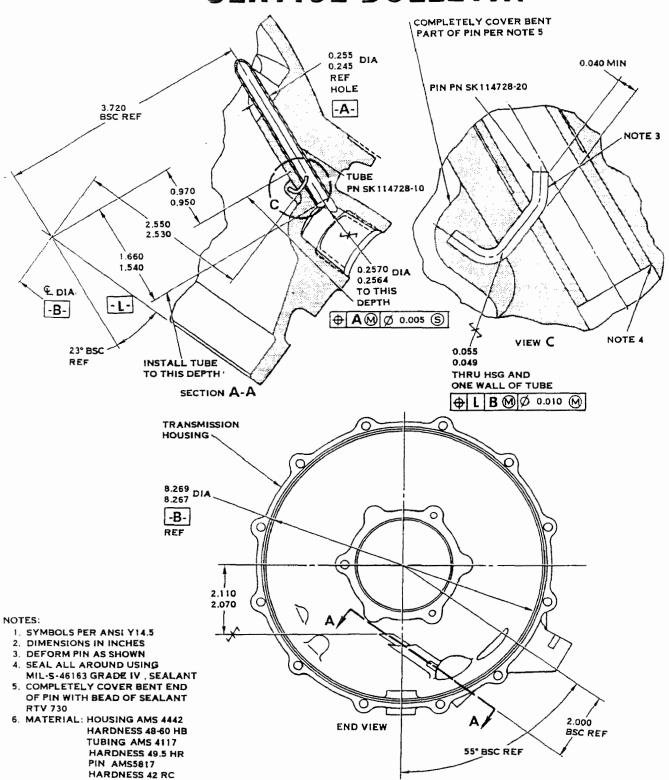
Modification of Transmission Housing Figure 1

This product improvement bulletin ensures that lubricating oil will flow from the starter's oil overflow port when a level of 12 ounces of oil has been reached during the starter oil servicing procedure, with the overflow port uncapped.

- A. Modify pneumatic starters as follows:
 - (1) Modify transmission housing PN 738274-100 to PN 738274-101 as follows:
 - (a) Machine existing 0.245 to 0.255 inch diameter hole in transmission housing to 0.2564 to 0.2570 inch diameter to depth shown in section A-A, Figure 1.

- (d) Heat transmission housing to 275 to 325 °F and maintain for 1 to 2 hours or chill tubing PN SK114728-10 to -275 to -325 °F.
 - (e) Install tubing into housing until slotted end is at 1.540 to 1.660 inch depth shown in section A-A, Figure 1.

- (g) Prime all around end of tubing where it protrudes through the transmission housing using Primer MIL-S-22473, Grade N, per view C, Figure 1.
 - <u>WARNING</u>: WEAR PROTECTIVE GLOVES WHEN HANDLING HEATED PARTS TO AVOID SEVERE BURNS.

- (h) Apply sealant, MIL-S-46163, Type III, Grade R, all around end of tubing where it protrudes through the transmission housing, view C, Figure 1. Cure at 202 to 222 °F for sufficient time to ensure bondline is at cure temperature for a minimum of 60 minutes. Allow housing to return to room temperature.

- (i) Machine 0.049 to 0.055 inch diameter hole through transmission housing and one wall of tubing, per section A-A and view C. Figure 1.
- (j) Break edges 0.025 inch maximum on ID and OD of machined hole.

- (k) Coat rework surface with dichromate per AMS2475.
- (1) Insert pin PN SK114728-20 as shown in view E, Figure 1 and deform end protruding into tube minimum of 0.040 inch.

- (o) Apply a bead of sealant RTV 730 to completely cover bent end of pin protruding from housing per view C, Figure 1. Air cure at room temperature for minimum of 72 hours.

- (p) Machine end of tubing to 2.070 to 2.110 inch dimension shown in end view, Figure 1.
- (q) Break edges 0.025 inch maximum on ID and OD of machined end of tubing.
