SERVICE BULLETIN

STARTING - PNEUMATIC STARTER - INTRODUCTION OF A STARTER FEATURING A SYNCHRONOUS
ENGAGEMENT CLUTCH AND AN OIL PRESSURE FILL FACILITY - CATEGORY CODE 4 -
MOD.ENG-80-0009

V2500-ENG-80-0009

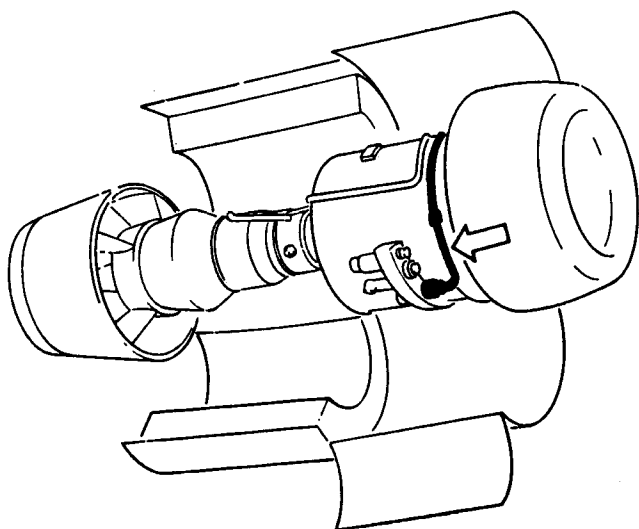
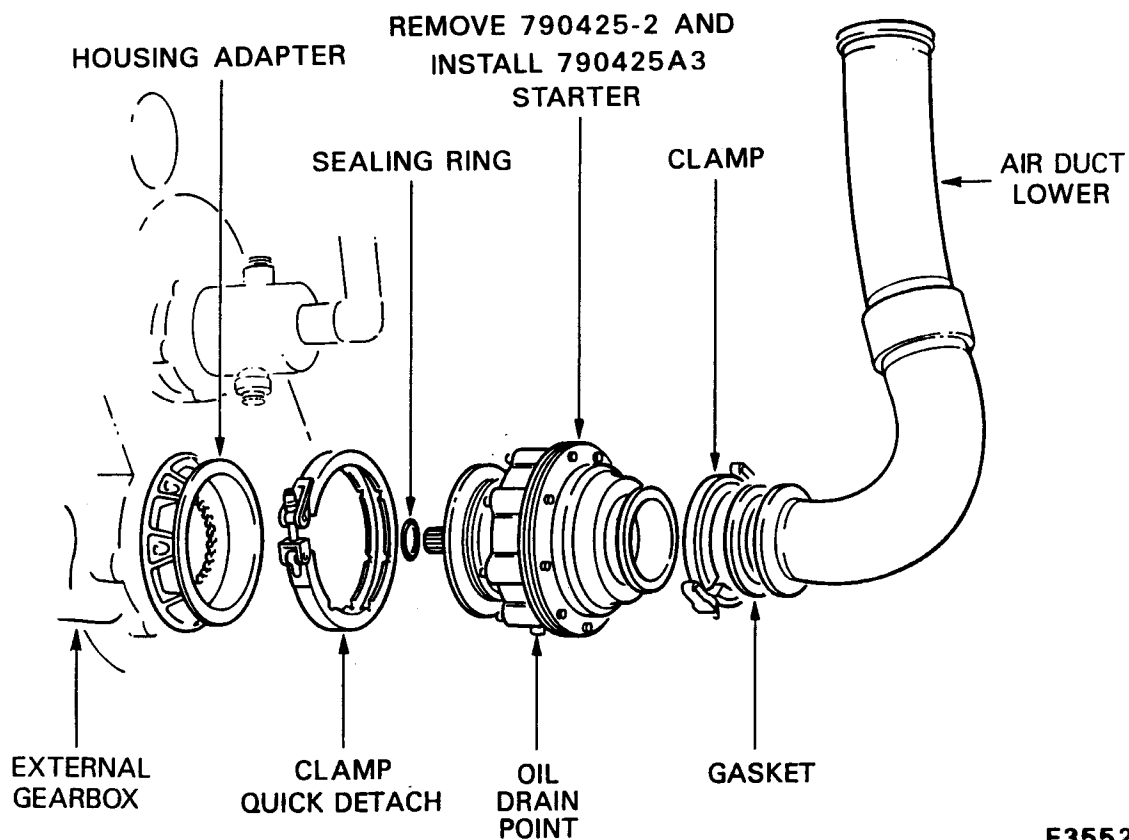
Location of pneumatic starter
Fig.1

Several incidents have occurred where starter output drive shafts have sheared in service due to the excessive torque produced when starter re-engagement is performed at high subidle speeds.

The existing pawl and ratchet type clutch is susceptible to damage when the starter is re-engaged outside of its operating limitations. Re-engagement at high speeds results in damage to the starter clutch mechanism and shearing of the output shaft. An operator has requested that starters be supplied with an oil pressure fill facility.

- (1) Remove the 790425-2 starter. Refer to Figure 1.
- (2) Disconnect the air duct from the starter. Disconnect the clamp and swivel the duct and remove the gasket. Retain the gasket.
- (3) Disconnect the quick detach clamp from the adaptor housing. Move the starter forward to disengage the adapter splines and the starter splines. Remove the starter.
- (4) Remove the sealing ring from the starter drive shaft. Discard the sealing ring.
- (5) Install caps to all openings.

- (1) Install the 790425A3 starter. Refer to Figure 1.
- (2) Remove caps from all openings.
- (3) Lubricate the new 69490D216 sealing ring with clean V10-077 engine oil.
- (4) Install the sealing ring on the 790425A3 starter drive shaft.
- (5) Make sure that the oil drain point is at the lowest position. Align the master spline on the starter and the adapter housing. Install the starter in the adapter housing.

- (6) Install the quick detach clamp. Torque the clamp to 60 to 65 inch-pounds (6.78 to 7.34 Nm).
- (7) Install existing gasket on to the air duct. Put the duct in position and install the clamp. Torque the clamp to between 115 to 120 inch-pounds (13.0 to 13.56 Nm).
- (8) Add oil to the starter (See 12-12-80) MD90 Aircraft Maintenance Manual.
