STARTING - PNEUMATIC STARTER VALVE - INTRODUCTION OF REVISED EXTERNAL WIRING -  
CATEGORY CODE 7 - MOD.ENG-80-0011

**V2500-ENG-80-0011**

## STARTING - STARTER CONTROL VALVE - INCORPORATION OF A NEW SOLENOID

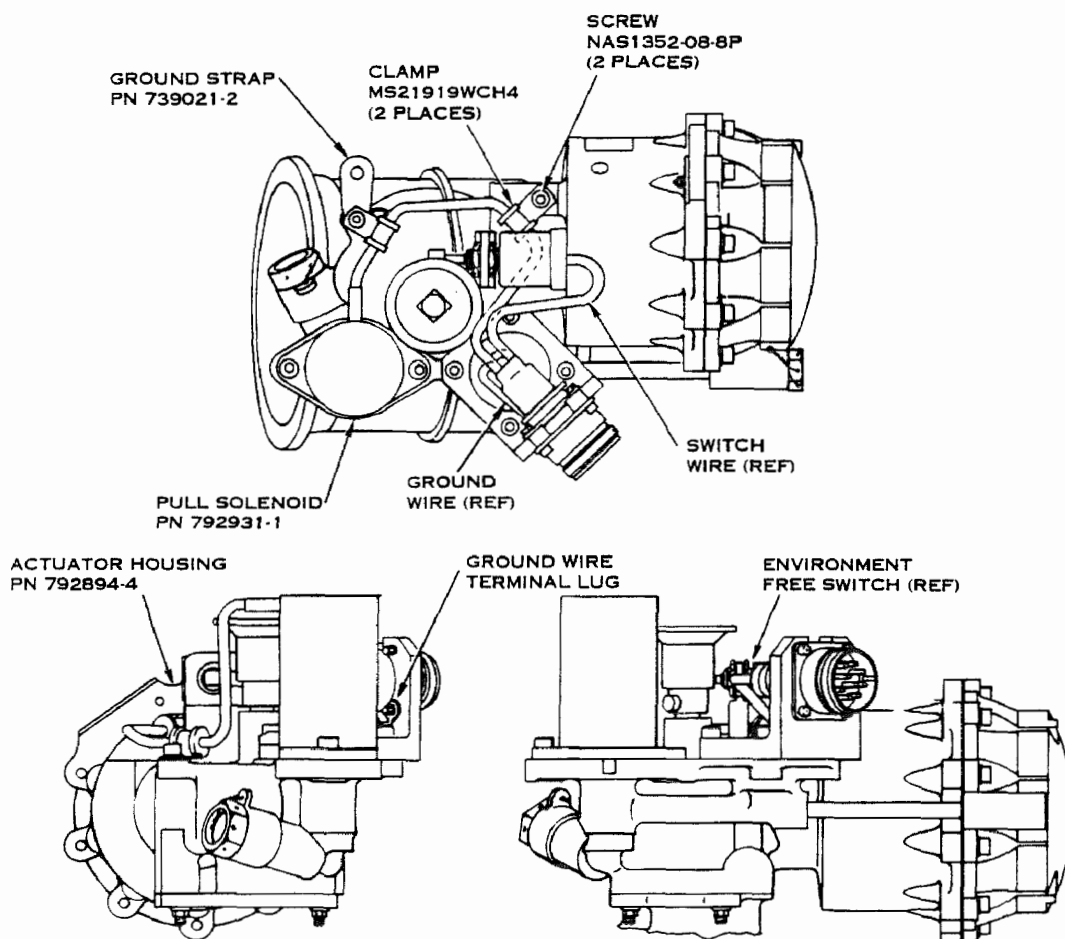
11-27555

The clearance between the external wiring and the body of the pneumatic starter valve may not be sufficient.

**Starter Control Valve - External View - Before Modification  
Figure 1**

**A. Modify starter control valve, Figure 1, as follows:**

- (1) Replace pull solenoid PN 792931-1 with pull solenoid PN 792931-2.

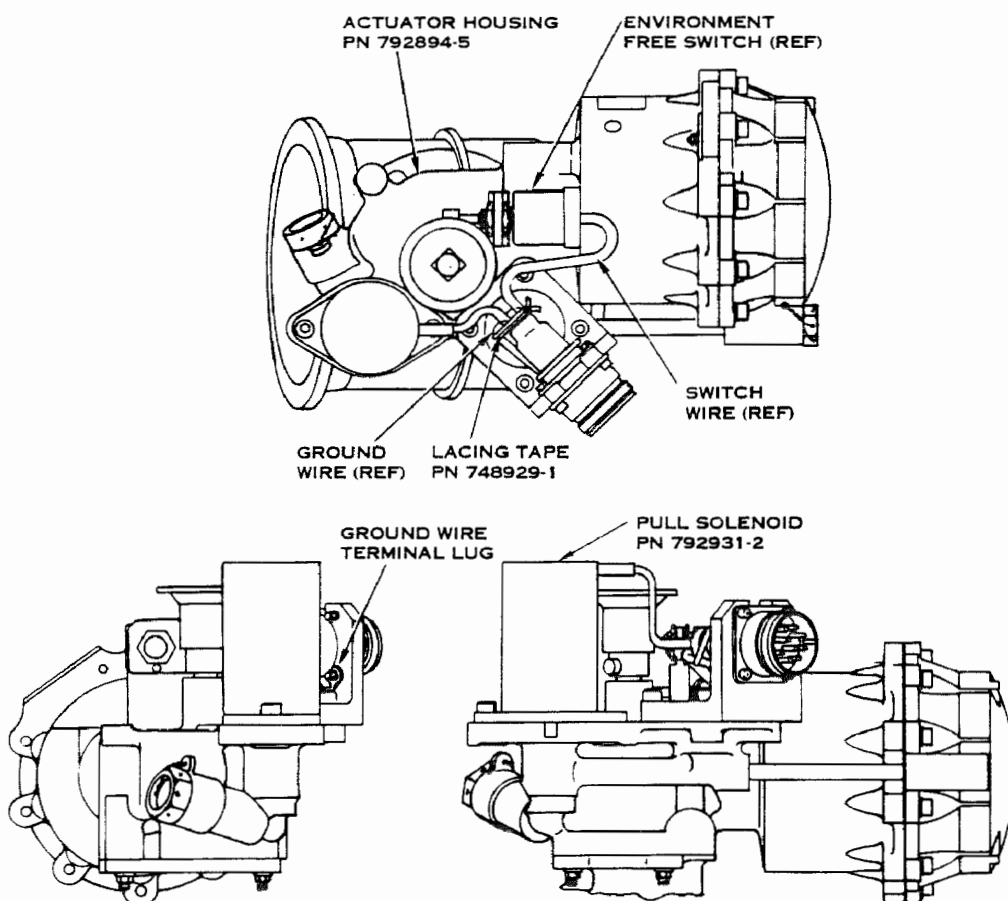
11-27556

**Starter Control Valve - External View - After Modification  
Figure 2**

- (2) Replace actuator housing PN 792894-4 with actuator housing PN 792894-5.

- (3) Remove and discard two clamps PN MS21919WCH4, two screws PN NAS1352-08-8P and ground strap PN 739021-2.
- (4) Assemble starter control valve in accordance with existing component maintenance manual instructions except as follows:
- (a) Install new pull solenoid PN 792931-2 on existing actuator housing PN 792894-4 or new housing PN 792894-5 and route solenoid wire to electrical connector as shown in Figure 2.
  - (b) Install ground wire and splice to new pull solenoid PN 792931-2 in accordance with REPAIR 5-1 of component maintenance manual.
  - (c) Secure ground wire of pull solenoid and environment free switch to electrical connector with lacing tape PN 748929-1. Wrap lacing tape around ground wires and connector two times and tie a square knot as shown in Figure 2.
  - (d) Trim lacing tape from knot approximately 0.500 inch. Fraying at ends permissible.
