SERVICE BULLETIN

STARTING - PNEUMATIC STARTER - INTRODUCTION OF STARTER WITH REVISED CARBON SEAL
RETENTION - SUMITOMO SB 80-2514 - CATEGORY CODE 7 - MOD.ENG-80-0013

PNEUMATIC STARTER - REPLACEMENT OF THE ROTOR SEAL ASSEMBLY

Subject: Starter Control Valve Screening

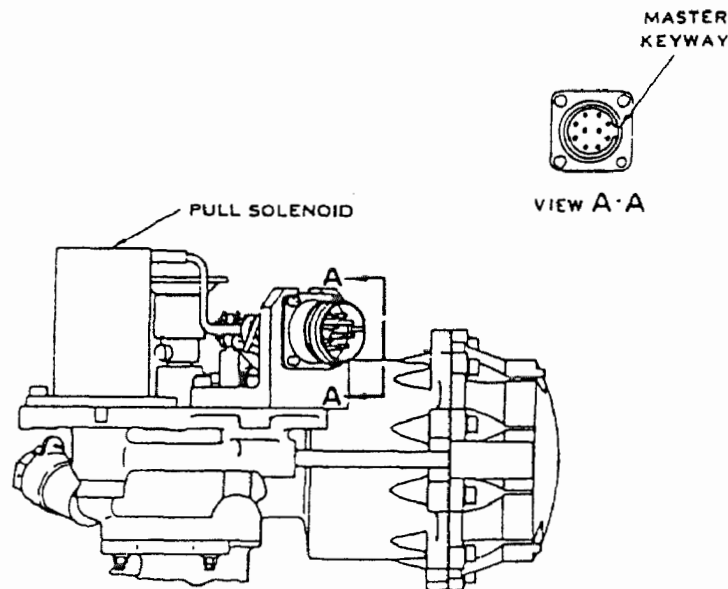
Electrical Solenoid and Connector

Remove the electrical connector from the start valve. Using those equipment specified below apply 9.25 – 9.5 Vdc across contacts 1 and 2 of the connector (160) and check the solenoid actuation. The figure of the contacts is also shown below for reference. The contact size number is #16, .0625 inch diameter (1.5875 mm).

If the valve solenoid actuation is satisfactory, no further work is necessary. Return the engine to normal condition.
Replace the connector to the start valve

If the check on the valve does not indicate satisfactory operation of the solenoid, remove valve from the engine for the next step if time permits, or schedule valve removal for the next step at the next convenient opportunity.

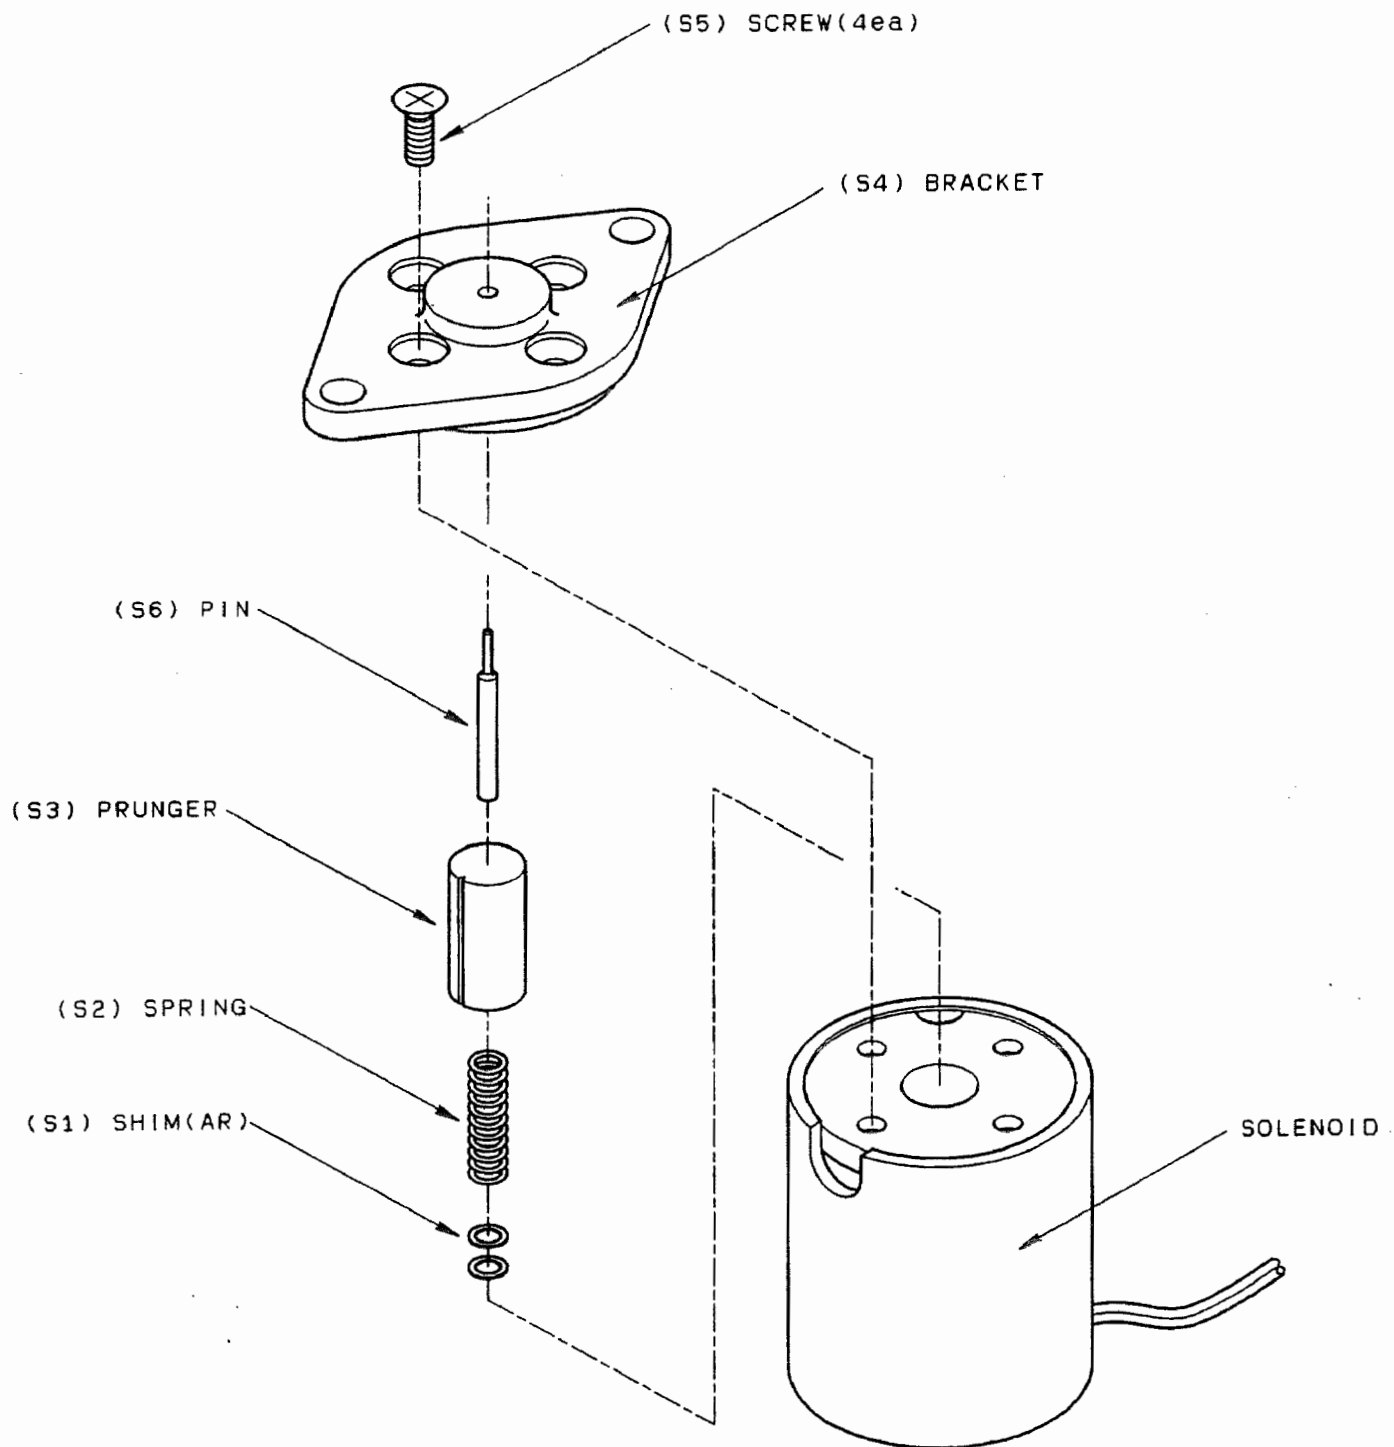
Solenoid Assembly
Figure A

The cause of the solenoid operational voltage out of limit condition has been attributed to increased friction occurring between the solenoid plunger and bore. Investigation of returned units has shown that this was related to a locally rough surface finish that existed on some solenoid plungers.

During operation on installed engines the nickel plating on these components was reduced to powder. The effect of the locally rough surface finish and the trapped nickel powder caused an increase in friction between the plunger and bore of the solenoid.

Remove the pin (S6) from the bracket (S4) bore of the solenoid. After loosening the four screws (S5), remove the bracket (S4). Remove the plunger (S3), the spring (S2) and the shims (S1) from inside of the core of solenoid.

Wipe external surface of the pin (S6) and the plunger (S3) and internal surface of the solenoid with a soft cloth wet with methyl ethyl ketone, TT-M-261, or methyl alcohol AMS3004. Dry clean surfaces with a clean lintless wiper.

Install the shim (S1), the spring (S2) and the plunger (S3) into the solenoid bore. Attach the bracket (S4) to the solenoid with the four screws (S5). Tighten all the screws (S5) to a torque of 3.2 to 4.7 pound-inches (.36 to .54 Newton-Meters). Insert the pin (S6) into the bore of the bracket (S4).
