V2500-A1/A5/D5 SERIES PROPULSION SYSTEMS SERVICE BULLETIN

V2500-ENG-80-0014

STARTING - PNEUMATIC STARTER - INTRODUCTION OF REVISED STARTER WITH MODIFIED TURBINE
RETENTION NUT PRE-LOAD

PNEUMATIC STARTER - REPLACEMENT OF THE TURBINE ROTOR RETENTION NUT AND REWORK OF THE PINION GEAR

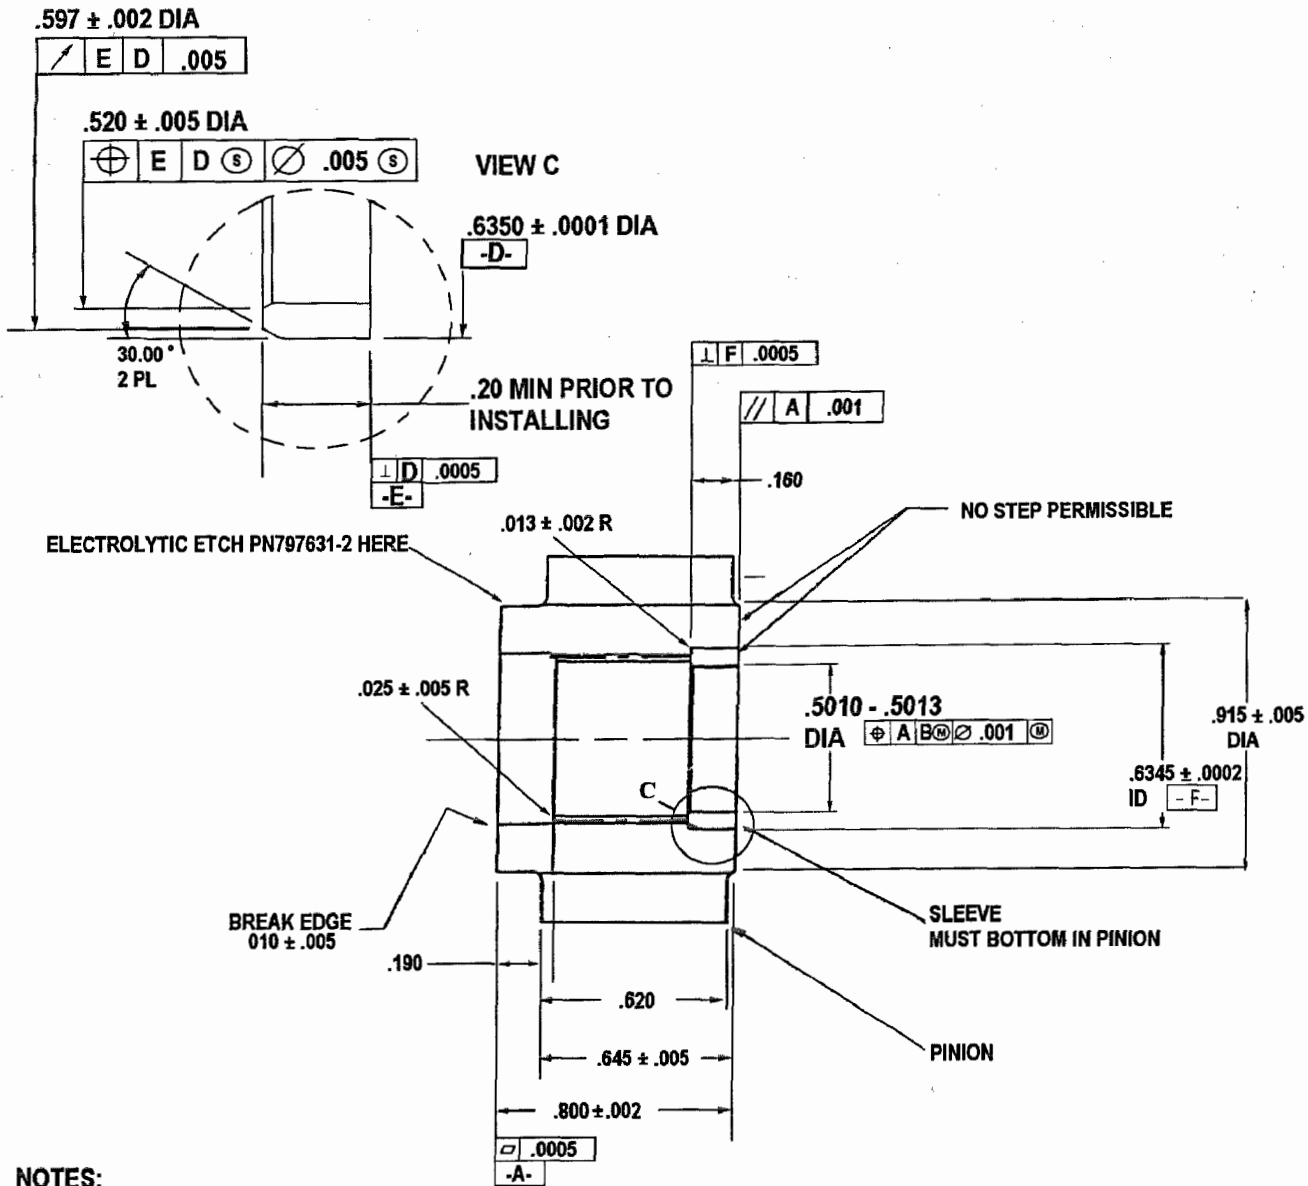
Figure 1. Rework of the Rotor Pinion

- (c) The pinion gear is reworked to replace the sleeve that the retention nut thrust face seats against. The new sleeve has an increased end surface area to provide a better distribution of preload. This will eliminate the possibility for a step that may exist on the surface where the retention nut seats.

(1) Machine the pinion to the requirements shown in Figure 1.

2. SLEEVE MAT'L: AMS6415 OR MIL-S-5000; HARDNESS 36-40HRC;
HEAT TREAT PER MIL-H-6875

- (2) Install the sleeve PN 797631-21 in the pinion. Press the sleeve into place using 1000 ± 100 lbs. axial force and make sure that it bottoms in the pinion gear.
- (3) Finish machine the pinion and sleeve to the requirements shown in Figure 1. No steps are permissible.
- (4) Reidentify the rotor pinion PN 797631-1 to PN 797631-2 as given below:

- 1 Electrolytic etch the PN "797631-2" onto the surface as shown in Figure 1.
