V2500-A1/A5/D5 PROPULSION SYSTEMS SERVICE BULLETIN

V2500-ENG-80-0015

STARTING – PNEUMATIC STARTER – INTRODUCTION OF A REVISED PNEUMATIC STARTER WITH A
MODIFIED SYNCHRONOUS ENGAGEMENT CLUTCH ASSEMBLY

HAMILTON SUNDSTRAND 80-2515 STARTING - PNEUMATIC STARTER - INSPECTION OF THE SYNCHRONOUS ENGAGEMENT CLUTCH AND REPLACEMENT OF THE WAVE SPRINGS

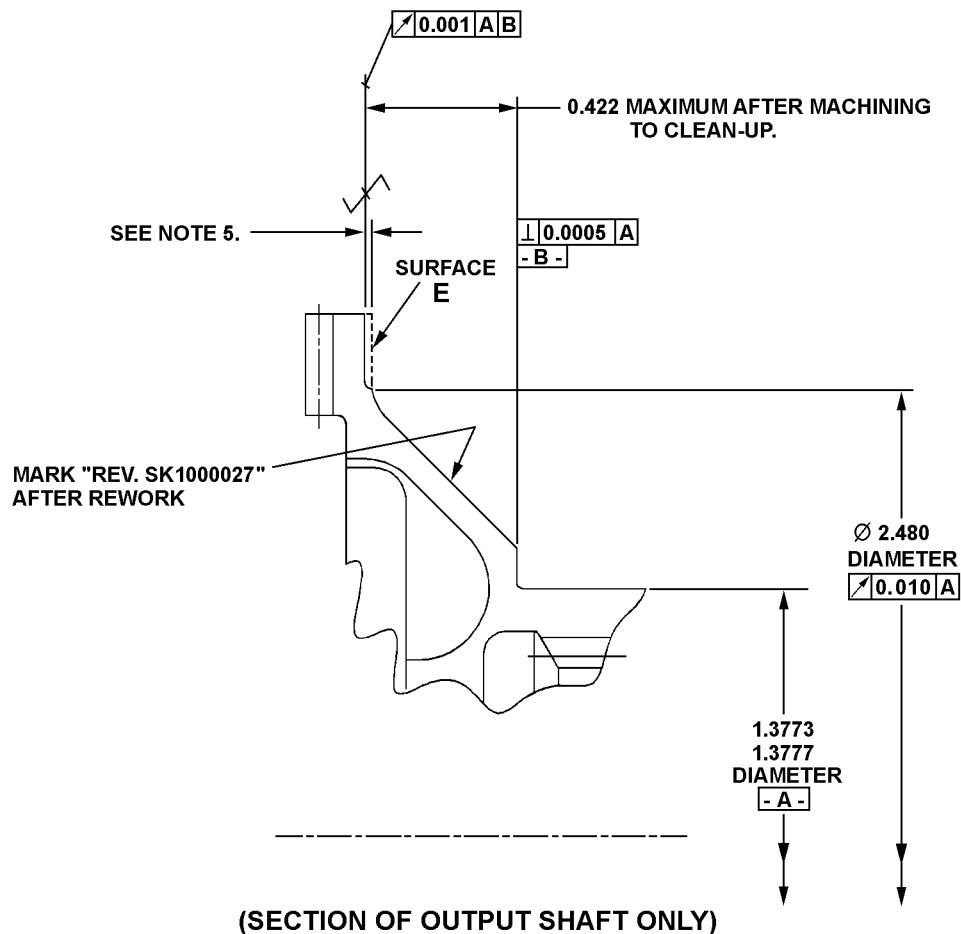
Figure 1. Output Shaft inspection and Rework

- (6) Inspect output shaft for wear on surface E per **Figure 1**. If worn, machine to clean up within limits shown in **Figure 1**.

NOTE: If the wear can not be removed by machining within the limits shown in figure one the shaft must be replaced.

- (a) If the part is reworked, vibrapreen SK1000027 following PN 813398-1.

1. SYMBOLS AGREE WITH ANSI Y14.5.
2. DIMENSIONS IN INCHES.
3. MATERIAL PER ASTM A535
4. HARDNESS 34 - 44 RC
5. MINIMIZE STOCK REMOVAL WHEN YOU MACHINE TO CLEAN-UP. DO NOT REMOVE MORE THAN 0.010 INCH MAXIMUM.

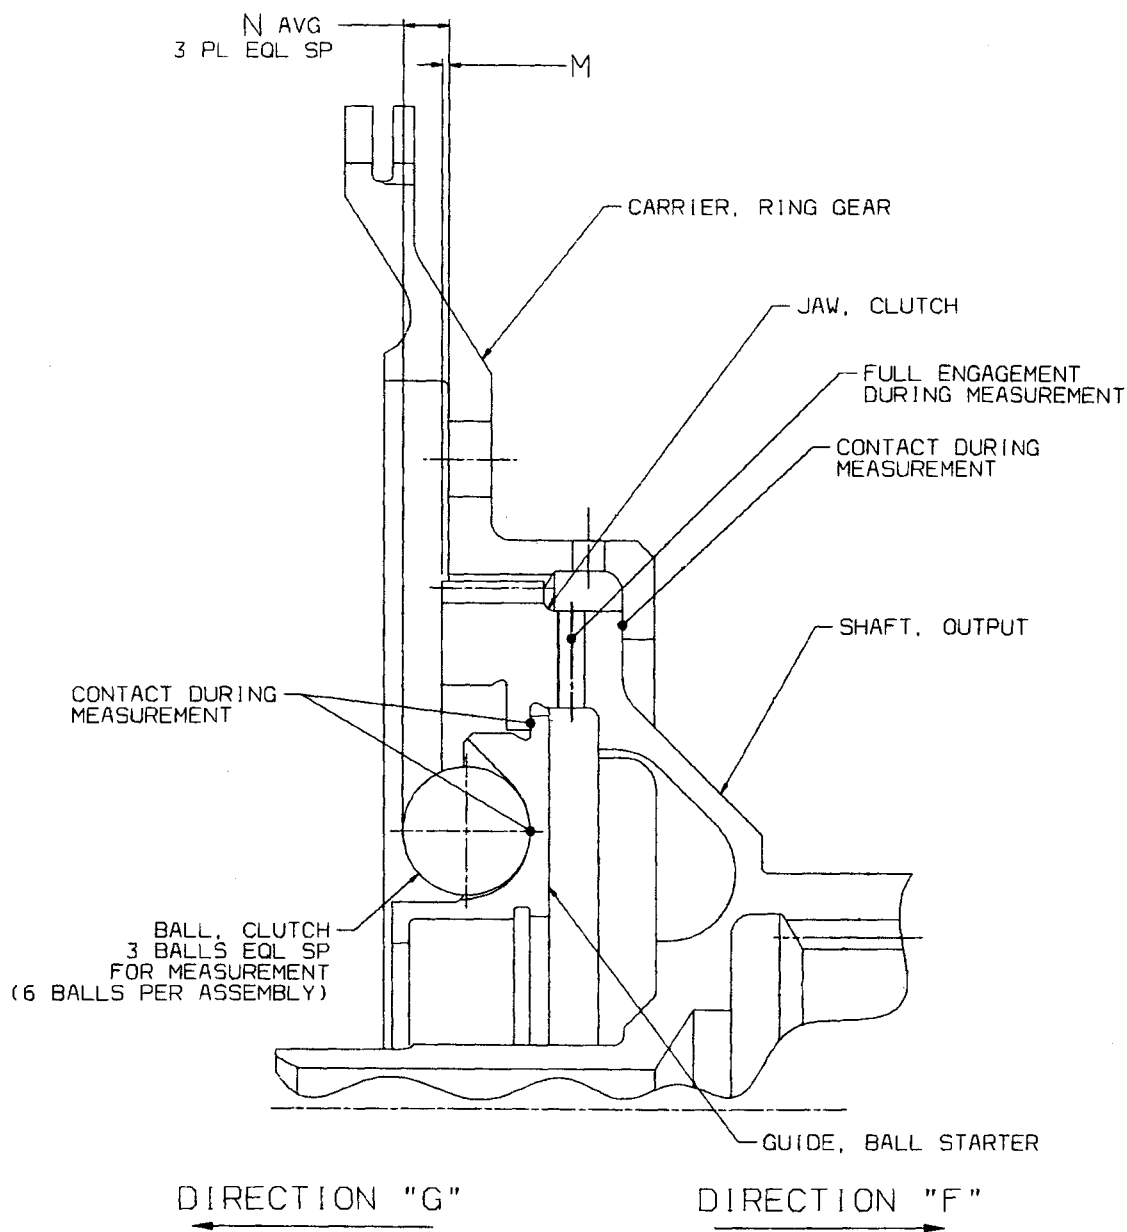
Figure 3. Measurement of Dimensions M and N

(8) Inspect and record dimensions M and N per **Figure 3**.

- (m) Add dimension H average from step 7 to dimension N average. If the sum of H plus N is equal to or greater than 0.185 inch, proceed with the following steps. If it is less than 0.185 inch, the clutch assembly must be replaced.

- (a) Put the output shaft in ring gear carrier.
- (b) Put clutch jaw PN 813393-1 in ring gear carrier. Load the output shaft and jaw against the ring gear carrier in direction F.
- (c) Measure and record dimension M.
- (d) Take the clutch jaw PN 813393-1 out of the ring gear carrier.
- (e) Put measurement spacer tool PN 63001012 shown in **Figure 10** on the output shaft over the three ball pockets.
