V2500-A1/A5/D5 SERIES PROPULSION SYSTEMS SERVICE BULLETIN

V2500-ENG-80-0020

STARTING – PNEUMATIC STARTER – INTRODUCTION OF A PNEUMATIC STARTER WITH A VENTED
INLET HOUSING

STARTING - PNEUMATIC STARTER - VENTED INLET HOUSING

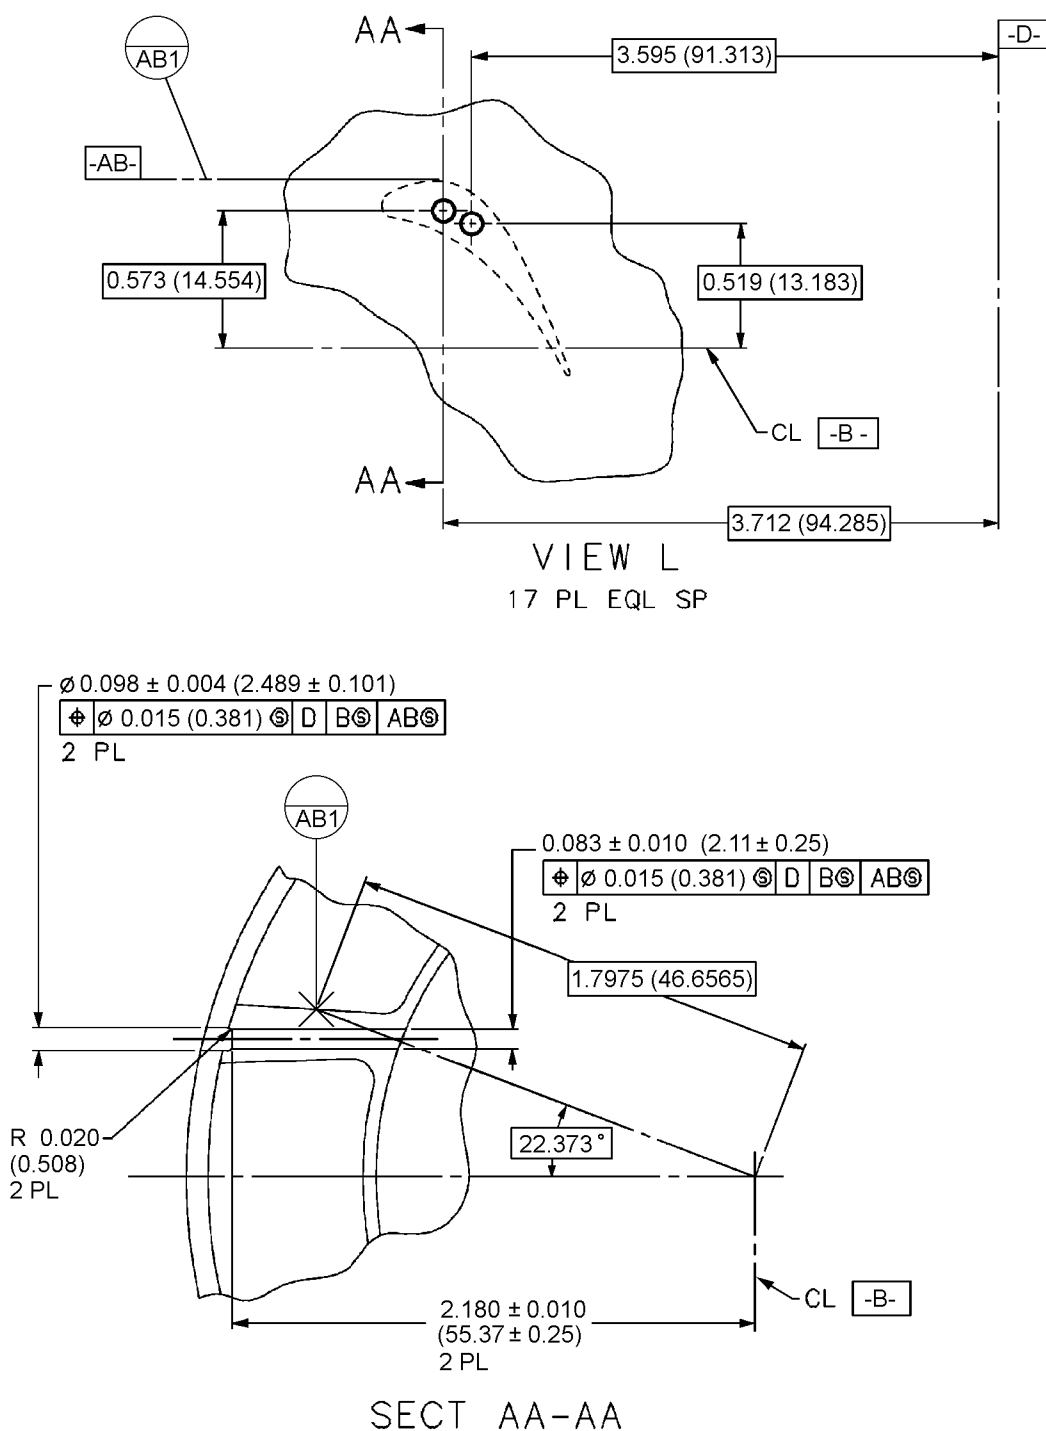
Figure 2. Modify the Inlet Housing (Part 2)

- (1) Problem - The turbine end bearing can have high thrust loads which can reduce its service life.
- (2) Cause - Applied inlet pressure that is built up in the unit's nozzle cavity generates the thrust loads and subsequent temperature rise that put wear on the turbine bearing, which reduce normal bearing life.
- (3) Solution - Reducing the thrust loads will increase bearing life and starter reliability. Venting the inlet housing to lower the air pressure on the turbine rotor hub will reduce the thrust load on the turbine bearing. This will increase bearing life.
- (4) Substantiation - Testing was conducted that showed a decrease in the thrust load on the turbine end bearing when the cavity in the center of the inlet housing is vented. Lower bearing loads increase bearing life.

- A. Use the procedure in DISASSEMBLY of the CMM to remove the inlet housing.
- B. To change the inlet housing, (Figure 1 and Figure 2) do these steps.
 - (1) Drill holes as per View L in Figure 2. Fixture 63001014 can be used.
- C. Apply nickel plating to the inlet housing as follows:
 - (1) Mask the vented inlet holes.
 - (a) Cut a PN 69494J153 or 69494J154 preformed packing to form a string or noodle.
 - (b) Insert the string or noodle into the vent hole at one end, guiding it through the hole until it exits at the other end.
 - (2) Mask the inlet housing sleeve using lead or aluminum tape.
 - (3) Mask the housing by immersing it in lacquer per Henco-Mask Type I, or equivalent.
 - (4) Nickel plate to a thickness of 0.0005 to 0.0008 inch (0.0127 to 0.0203 mm).

NOTE: Nickel plate over nickel plate is not permitted, except fade out permissible over a 0.160 inch (4.064 mm) around vent holes.
