## V2500-A5 SERIES PROPULSION SYSTEMS SERVICE BULLETIN

This document transmits the Revision 1 of Service Bulletin V2500-ENG-80-0021

STARTER/TAI DUCT SYSTEM – REPLACEMENT OF BEARING LINK ASSEMBLIES (FOR CONTROLLED SERVICE USE)

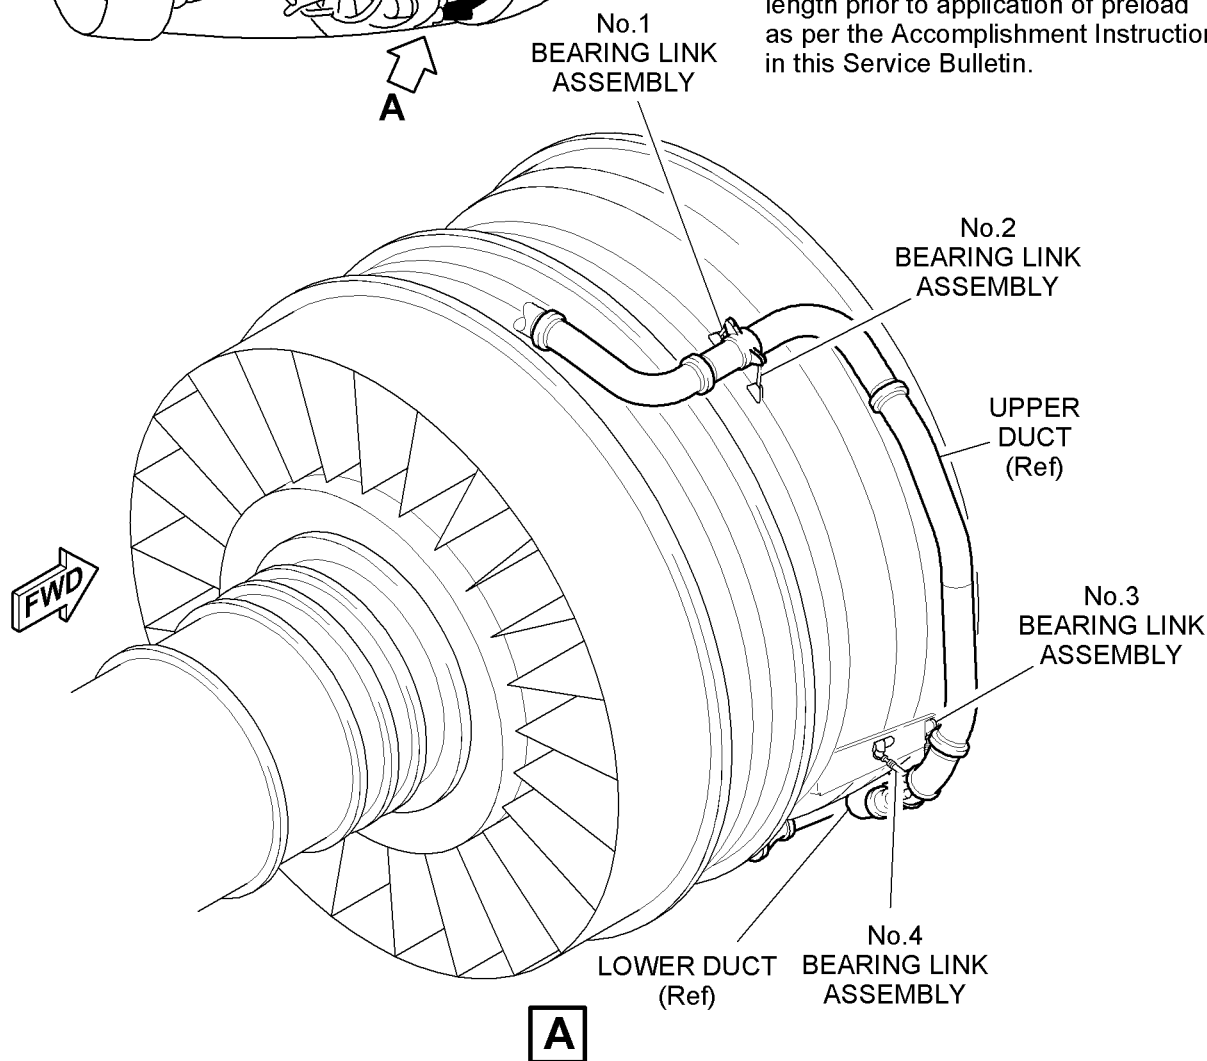
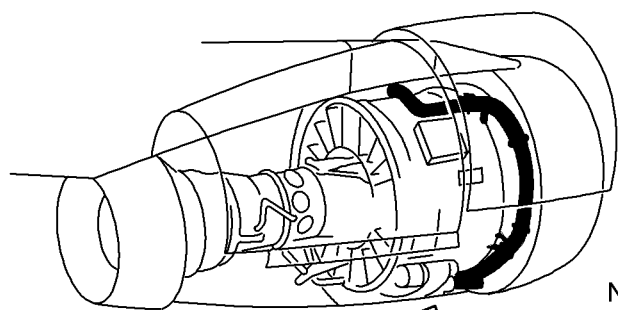
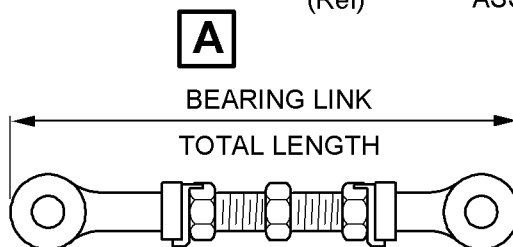
Replacement of Starter Duct Bearing Link Assemblies  
Figure 1

There have been reports from operator's of excessive wear to the link rod bearings associated with the Starter duct and the Thermal Anti-Icing (TAI) systems.

The accomplishment instructions in this Service Bulletin introduce pre-load into the Air Starter and TAI duct support linkages, and hence remove the opportunity for the bearings to vibrate and promote wear. Pre-loading in the linkages will not have a detrimental effect on flight safety with respect to the Air Starter and TAI system for the duration of the test.

- (a) Adjust the central connecting rod nut at position one to make the overall length of the bearing link an approximate nominal length of 4.65 in. (118,00 mm).

- (b) Adjust the central connecting rod nut at position two to make the overall length of the bearing link an approximate nominal length of 5.55 in. (141,00 mm).

- (j) Adjust the length of the bearing link at position three to the nominal length of 3.04 in. (77.4 mm) as shown.

- (k) Adjust the length of the bearing link at position four to the nominal length of 4.59 in. (116.5 mm) as shown.

- (n) If required, shorten the length of the bearing link at position three by the application of a half turn (180 degrees) in a clockwise direction. This will cause a positive axial preload when the link is re-installed.

- (o) Shortened the length of the bearing link at position four by the application of a full turn (360 degrees) in a clockwise direction. This will cause a positive axial preload when the link is re-installed.

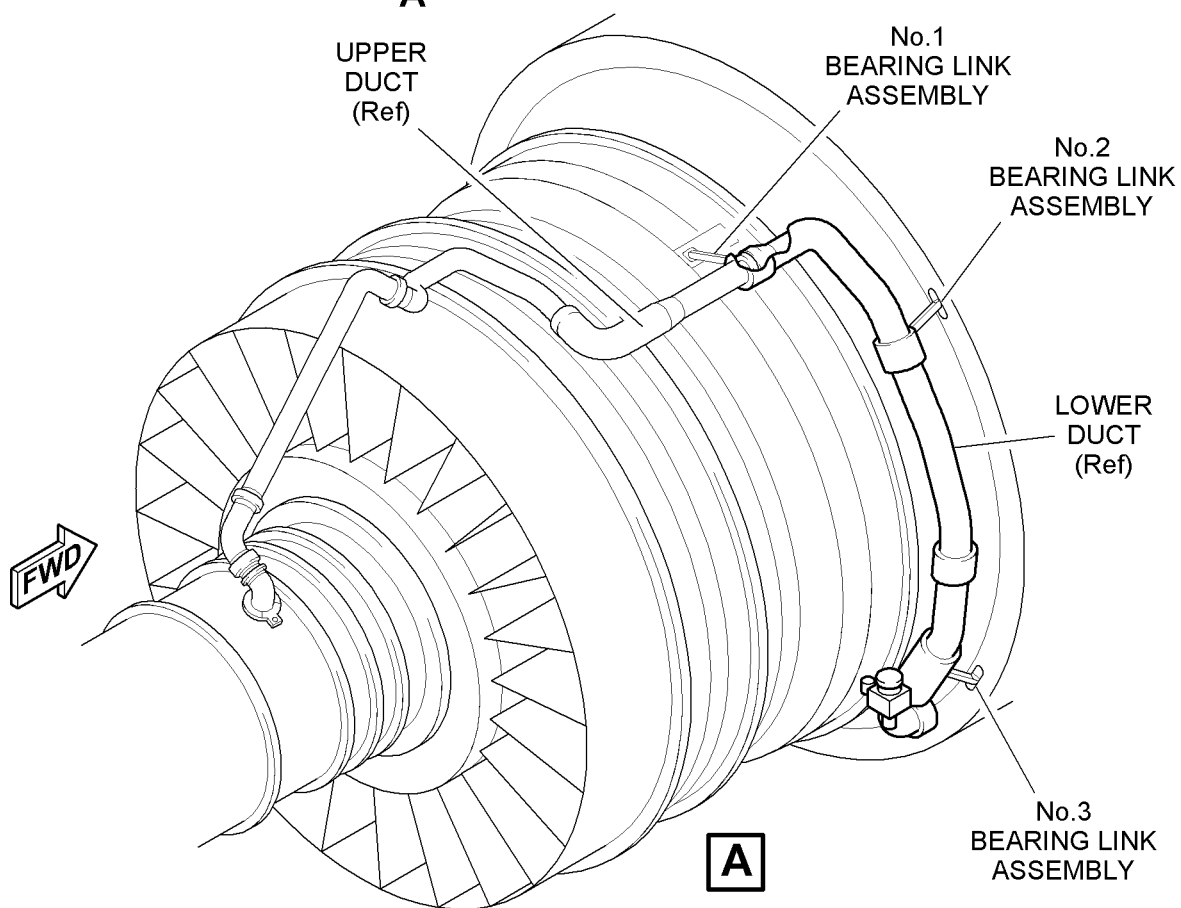
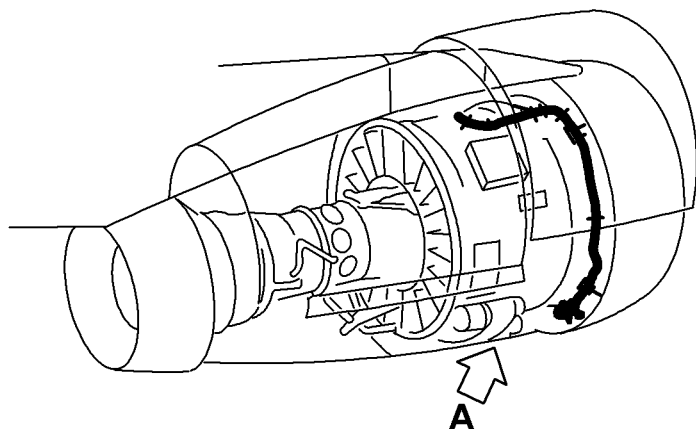
Replacement of TAI Bearing Link Assemblies  
Figure 2

REMOVE AND REPLACE  
EXISTING BEARING LINKS AND  
ATTACHING HARDWARE

- (a) Adjust the central connecting rod nut at position one to make the overall length of the bearing link an approximate nominal length of 5.37 in. (136.5 mm).
- (b) Adjust the central connecting rod nut at position two to make the overall length of the bearing link an approximate nominal length of 5.84 in. (148.34 mm).
- (c) Make further adjustments to the bearing link at position one to set the link to a length that just permits you to put in the bolts at the end of the bearing link. Tighten the bearing link bolts in accordance with the Aircraft Maintenance Manual, TASK 80-13-49-400-010.
- (d) Make further adjustments to the bearing link at position two to set the link to a length that just permits you to put in the bolts at the end of the bearing link. Tighten the bearing link bolts in accordance with the Aircraft Maintenance Manual, TASK 80-13-49-400-010.

**NOTE:** Make sure that there is a minimum clearance of 0.23 in. (6.0 mm) between the gimble insulation and the fan case after you torque the connecting rods.

- (j) Adjust the length of the bearing link at position three to the nominal length of 4.20 in. (106.68 mm) as shown.
  - (k) If required, shorten the length of the bearing link at position three by the application of a half turn (180 degrees) in a clockwise direction. This will cause a positive axial preload when the link is re-installed.
